# Warranty Field Campaign

| <b>Campaign Number:</b><br>c2024 | <b>Revision:</b> | <b>Released Date:</b> 01-May-2018 |

## L9 2017 VG Turbo Speed Sensor Harness Routing Campaign

# L9 Turbo speed sensor harness routing

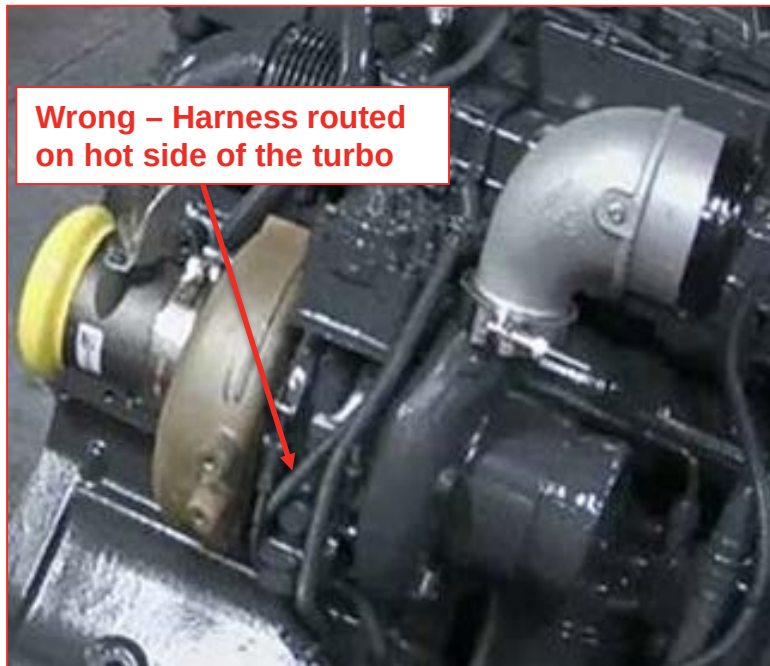
This campaign is being issued to address an incorrectly routed turbocharger speed sensor harness on certain L9 CM2350 L116B Engines, and authorizes the field to replace the harness and route correctly.

Image A – Incorrect routing

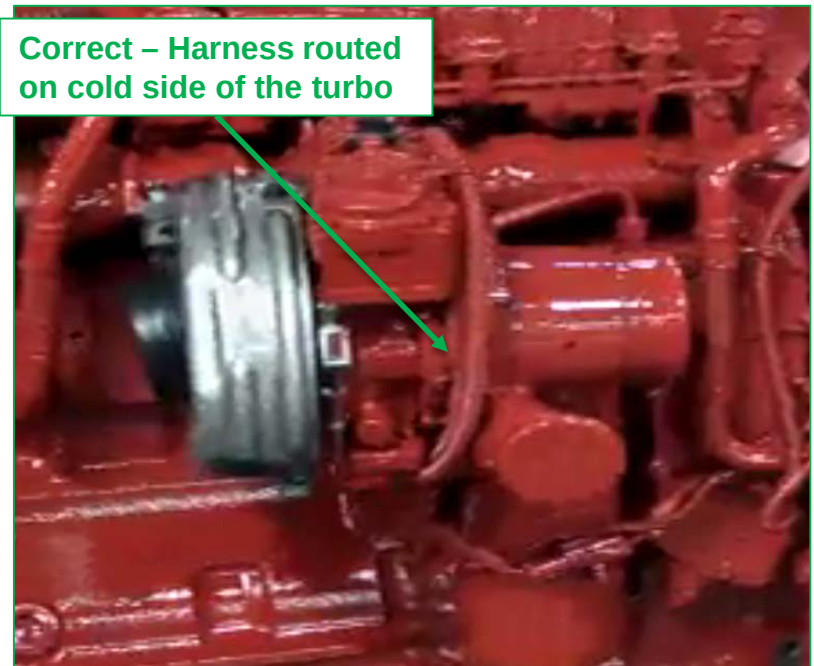
Image B – Correct routing

1. Remove and Install the Turbo speed sensor harness PN 4034198. Please refer to the L9 CM2350 L116B Service Manual, Section 019-390 Turbocharger Speed Sensor.
2. Please refer to Attachment B. Route the new harness as illustrated in Routing Image B.
