Mack Model Cabover , Conventional

Volvo Model VNR , VNX , VNL , VNM , VHD , VAH

Engine family 11L Engine , 13L Engine , 16L Engine , Mack , MP7 , MP8 , MP10

Title Selective Catalytic Reduction (SCR) Efficiency And NOx Sensor Diagnostic Trouble Codes (DTC) P225C, P225E, P221A and P2201: **NOx Sensor Diagnostic Information TO BE USED BEFORE SENSOR REPLACEMENT - OBD13 And Newer Emissions (Commonly Model Year 2014 And Newer)**

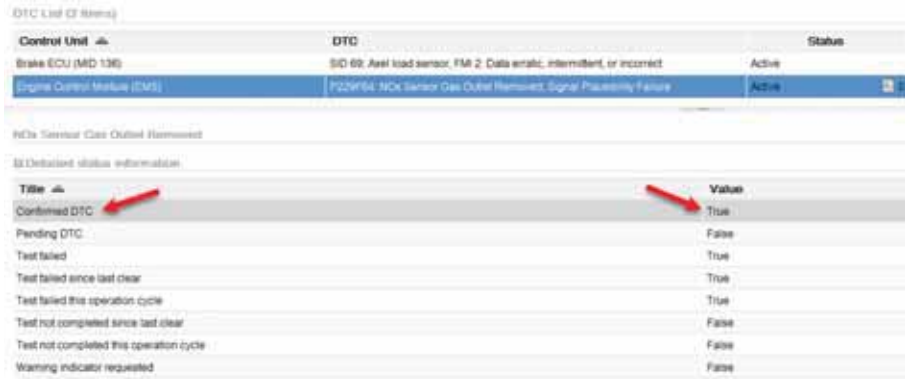
- Review the Detailed Status Information for the relevant code on the DTC Readout.

- If Confirmed DTC is **TRUE**: Proceed with diagnostics
- If Confirmed DTC is **FALSE**: Disregard and focus on other symptoms or DTCs relevant to the complaint.

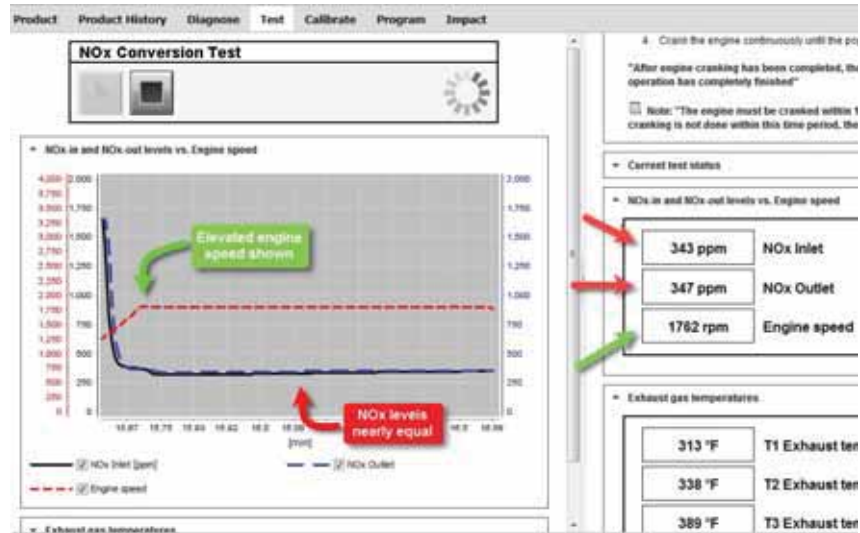
- Inlet and Outlet NOx values should be within 40 parts per million (ppm) of one another just before the engine shuts down. Shown below is an example of how a graph

with two properly functioning sensors will look:

3. If no issues are found with the sensor readings from the NOx Conversion review, the sensors are not the source of the conditions causing the codes to log. Further diagnostic steps of other components will need to be performed to determine the cause of the faults.

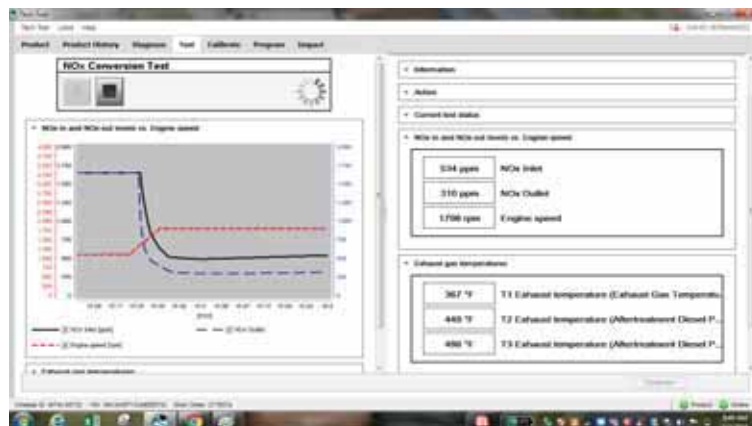
Multiple cases of the conditions shown in the screenshot below have been observed:

- During the high speed portion of the test, inlet NOx levels remain above 500 ppm, and outlet NOx levels are approximately 300 ppm as expected.
- DTC P220E may be generated when this condition is observed.

- **If the above condition is present:**

- Replace the Inlet NOx Sensor
- Have the old NOx sensor sent to Nataraj Bhat:

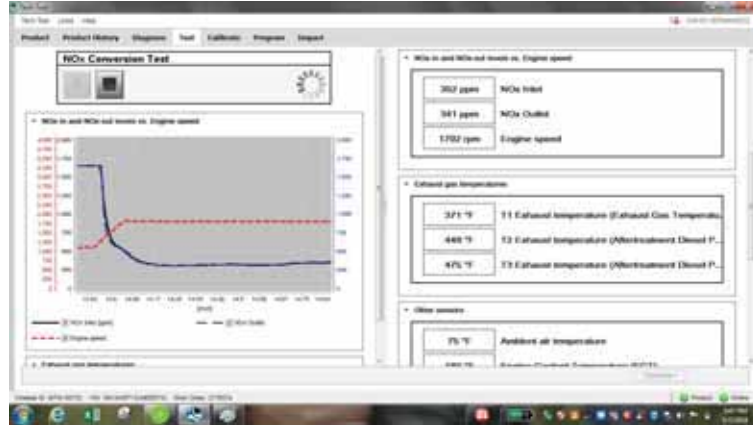
Replacement of the sensor returns values to the expected range:
