SERVICE BULLETIN

Classification: EL15-002i	Reference: NTB15-009i	Date: May 23, 2018
------------------------------	--------------------------	-----------------------

NAVIGATION SYMPTOMS WHEN SD CARD IS MISSING OR WRONG CARD INSTALLED

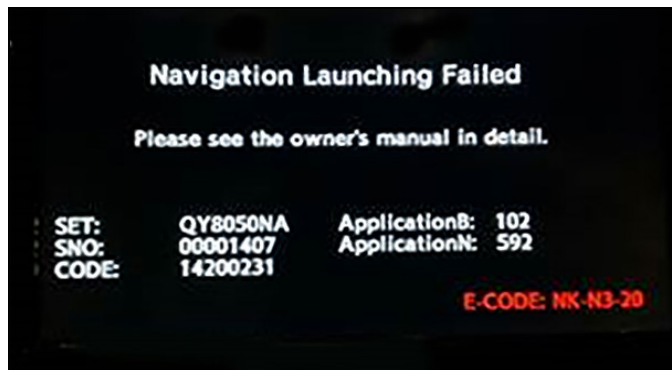
If the wrong SD Map Card has been inserted into the Navi/audio unit:

- A “Navigation Launching Failed” screen will be shown (Figure 1).

- **Mixed up with other SD Map Cards**
 - Continue to insert individual SD Map Cards until one can be found that the error message in Figure 1 is not displayed.

- Check the “Unit code” (page 3) and then look up the correct SD card part number with **SD Card Numbers by Unit Code** starting on page 5.

- Check the ECU Part Number (page 4) with CONSULT-III plus (C-III plus) under **Diagnosis(One System) / MULTI AV / ECU Identification**, and then look up correct SD card part number with **SD Card Numbers by Unit Code** starting on page 5.
- **Lost**
 - Order a new SD Map Card from Nissan. This is not covered under warranty.
 - Use the Unit Code, or the Multi AV ECU part number to determine the correct SD Card Part Number to order. Refer to **SD Card Numbers by Unit Code** starting on page 5.
