CAMPAIGN BULLETIN

State Specific Bumper Performance Label Dealer Inventory

Reference: PC622
Date: May 25, 2018

PC622 – ALTIMA (L33), LEAF (ZE1), ROGUE SPORT (J11); BUMPER PERFORMANCE LABEL

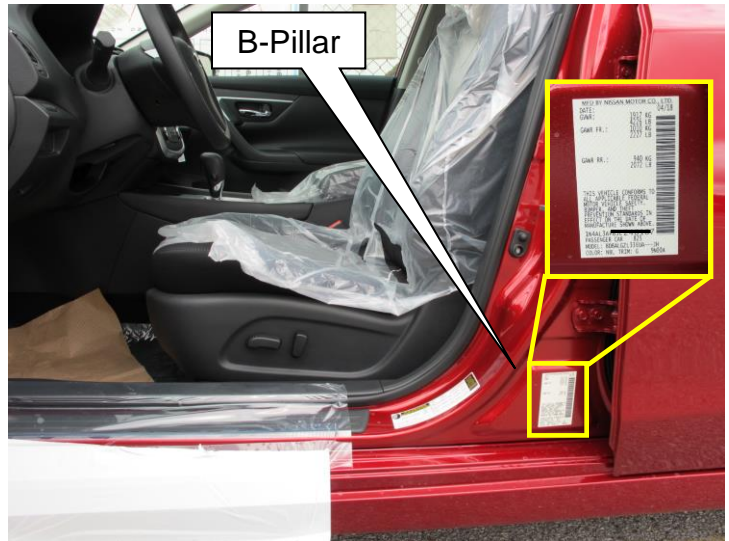
Figure 1

1. Verify the VIN of the affected Vehicle (Figure 1).
 - VIN Certification label located on the Driver's Side Door B-Pillar.

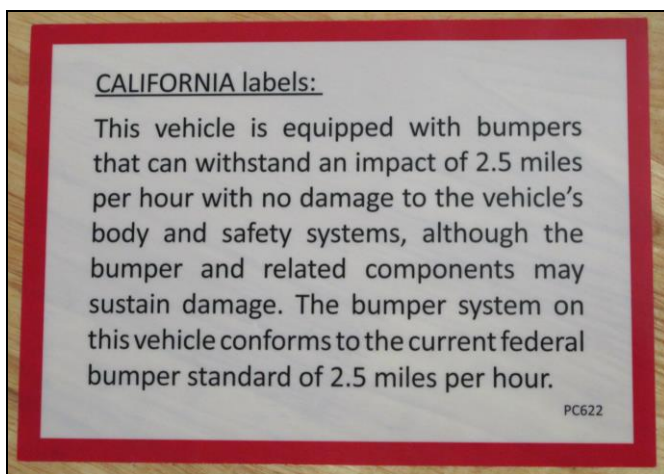
Figure 2

2. Ensure you have the correct label(s) based on your state.
 - California Bumper label is in standard format (Figure 2)
 - Hawaii Bumper label is in all "CAPS" (Figure 3)
