**DATE:** 5-30-18

**APPLIES TO:** This service bulletin applies to certain model year 2016 through 2019, K2 and K3 model motorhome chassis built between 12/19/2014 and 2/20/2018.

**CONDITION:** Minimal clearance between the tag axle tire and diesel exhaust fill support bracket.

**CORRECTION:** Rework the DEF fill bracket to gain adequate clearance.

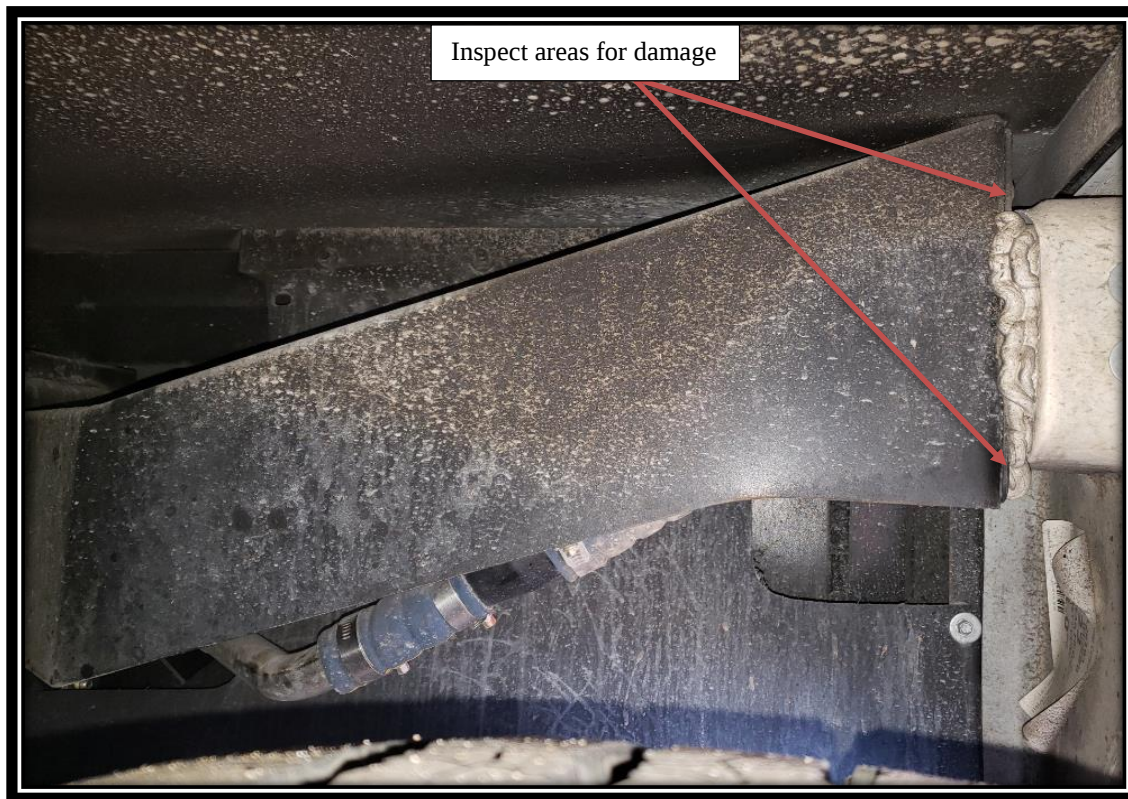
**FIG. 2-1**

5. Locate DEF fill support mounted in rear of tag axle wheel well and inspect for damage. Refer to FIG. 2-1.
  - a. Pay special attention to bracket and body interface at location of plastic DEF fill.
  - b. If damage has occurred to plastic DEF fill it should be replaced.
  - c. If DEF fill is damaged contact Customer Service (P/N 908-1272-01 {PIA in 2772-LL2-001} is not part of the service kit)
