**DATE:** 5-8-18

**APPLIES TO:** This service bulletin applies to model year 2018 K3 and K4 motor home chassis equipped with gauge panels supplied by Silver Leaf built between November 11, 2016 and September 28, 2017.

**CONDITION:** The dash may produce unintended warnings or messages.

**CORRECTION:** The digital dash must be updated to newest software version and its corresponding data collector module must be replaced. To complete update to digital dash you will need an OmniScope Adapter.

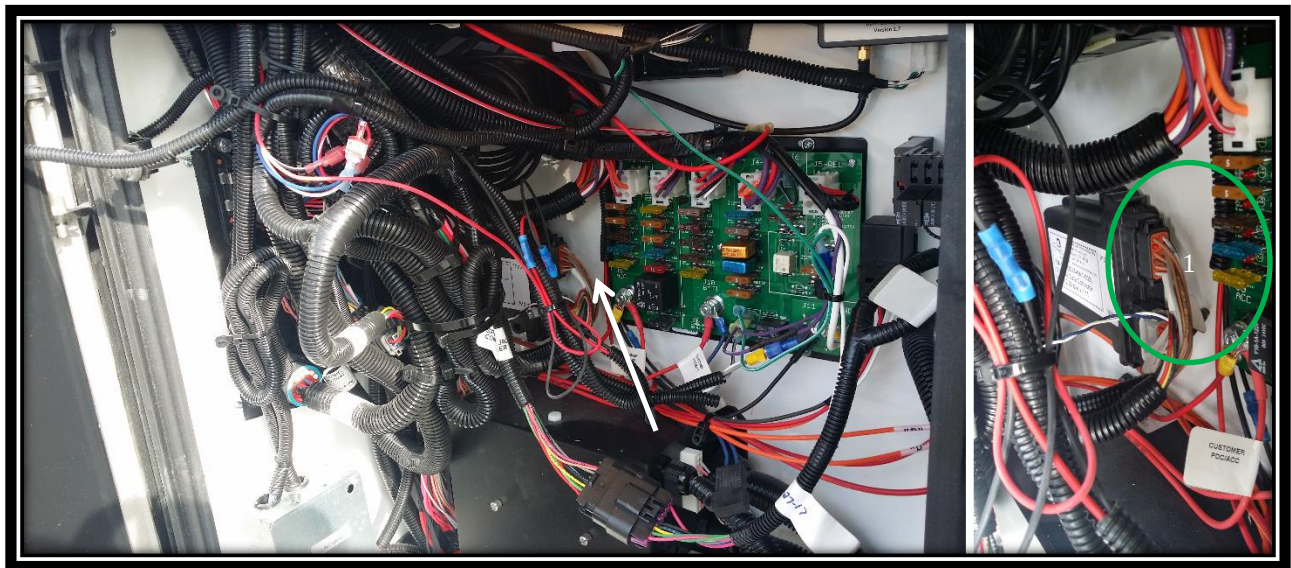
**FIG. 2-1**

1. Locate TM120, which is located on wall of front electrical compartment. Refer to FIG. 2-1.

2. Unplug TM120 module from harness.
3. Remove TM120 module from vehicle, retain all mounting hardware for reuse. (TM120 must be Returned to Spartan).

4. Install new TM120 module using retained mounting hardware.
5. Connect harness back up to new module.

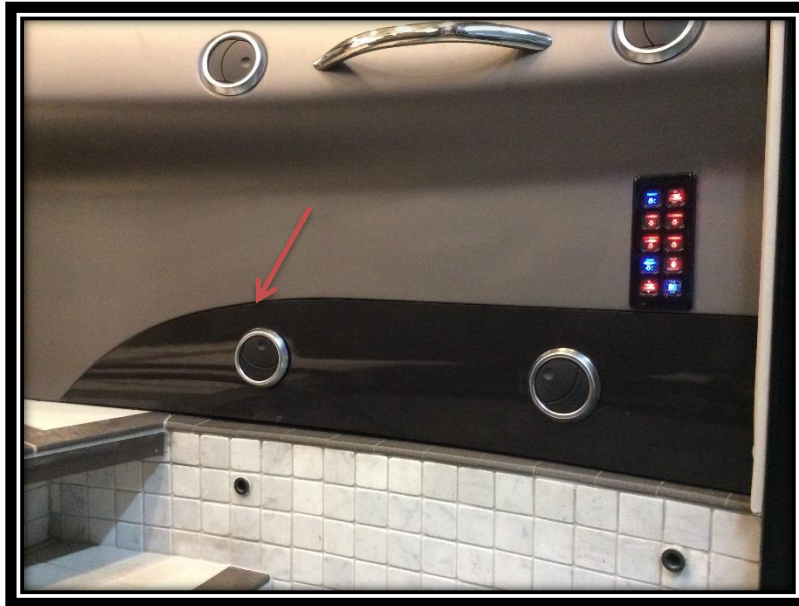
**FIG 3-1**

1. Remove black panel, which will be affixed with Velcro, located on dash console directly above stairs. Refer to FIG. 3-1.

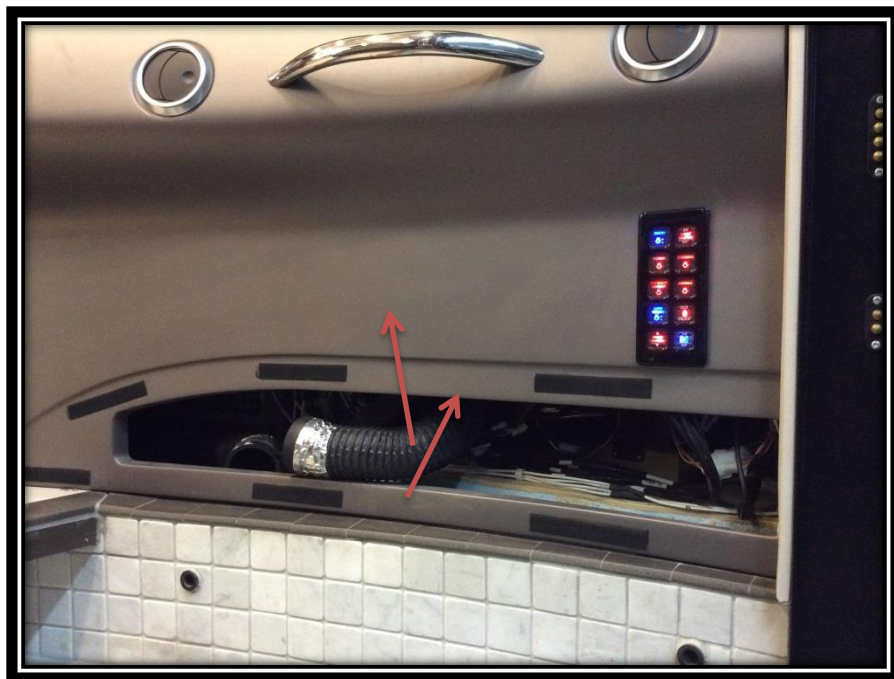
**FIG. 4-1**

2. Remove HVAC vents from removed panel. Refer to FIG. 4-1.
3. Locate TM120 module, located against back wall inside dash. Connectors are oriented up. Refer to FIG. 4-2.
