SERVICE INFORMATION BULLETIN

APPLICABILITY: 2016-2018MY Forester NUMBER: 04-20-18

2015-2016MY Impreza 2.0L DATE: 05-31-18

SUBJECT: Steering Angle Sensor- Part Change Information

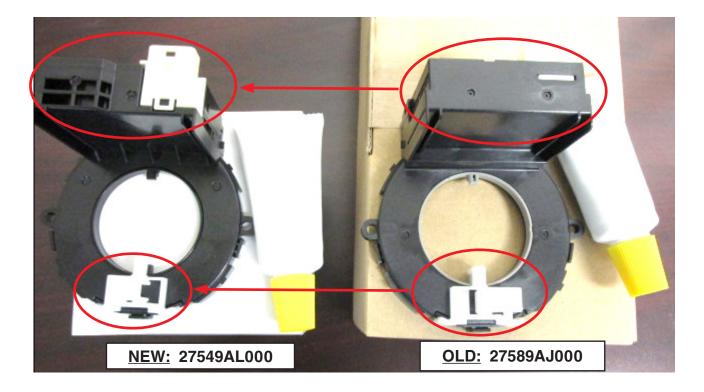
The photos below show the most easily identifiable features to the Steering Angle Sensor to help differentiate between the old and new-style parts.

IMPORTANT: When Sensor replacement is necessary on a model applicable to this bulletin, always replace the old part with the same style as originally equipped. Once inventory of the old-style part has been exhausted, the old part number, 27589AJ000 will be superseded to 27549AL000.
