SERVICE BULLETIN

APPLICABILITY: 2014-2016MY Crosstrek Hybrid (HEV) Models **NUMBER:** 11-180-18
SUBJECT: DTCs P0A78 and P1C2A- ECM Reprogramming **DATE:** 05/30/18
 File Availability

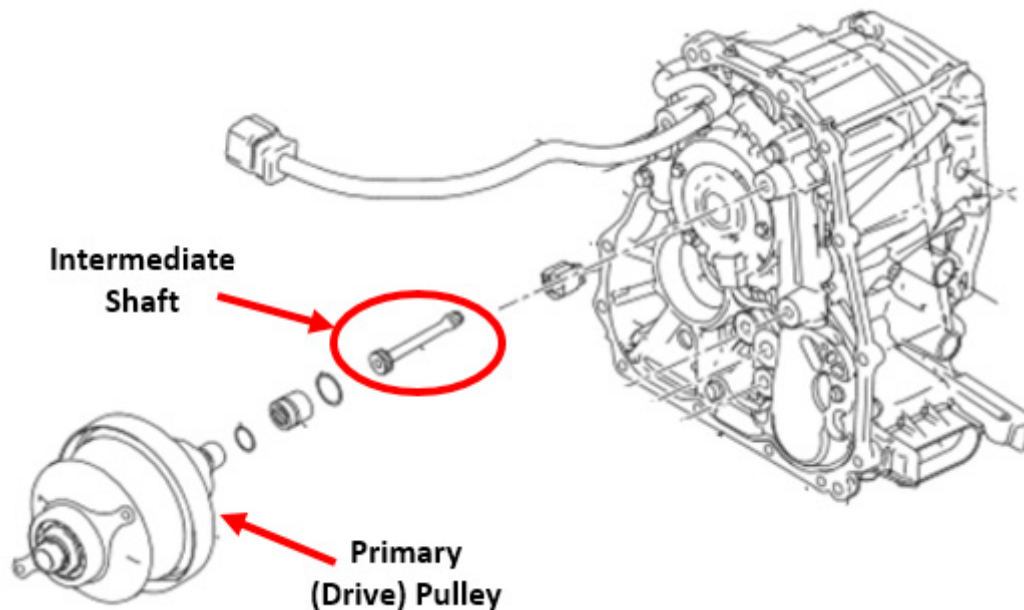
In the event of a Drive Motor and / or Inverter malfunction, DTC P0A78 AND P1C2A may set at the same time. This is a RARE occurrence. As a result, the drive motor could be supplied with a higher than specified level of current and damage (twist from over-torque) the CVT's Intermediate Shaft (see below) which is located inside the primary (drive) pulley.

VERY IMPORTANT: In the unlikely event DTC P0A78 **AND** P1C2A are detected and set at the same time, follow the diagnostic procedures for **BOTH** DTCs to determine the fault **BEFORE** proceeding with reprogramming the ECM. In this case, the following 4 components must be replaced together **as a set** following the procedures supplied in the applicable Service Manual.

- Drive Motor Control Module (DMCM)
- Inverter Assembly
- Inverter wiring harness (between the DMCM and the Inverter)
- CVT Intermediate Shaft.
