SERVICE BULLETIN

APPLICABILITY: 2015-2016MY Impreza 4-Door
2015-2018MY WRX

NUMBER: 12-241-18

SUBJECT: Trunk Lid Lock Assembly Interchangeability Information

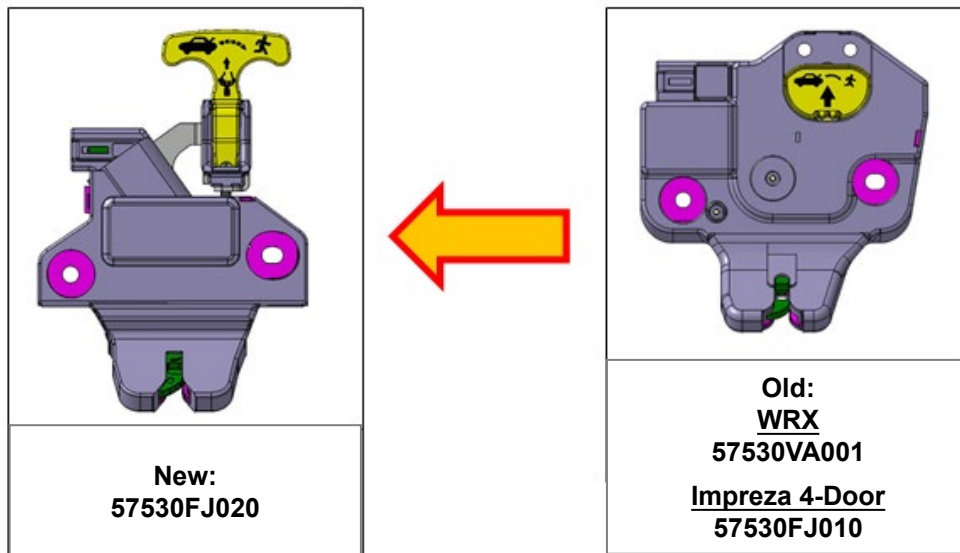
The new “T-Handle” style trunk lid lock was incorporated into production starting with VIN **F9828714**.

The new “LOCK ASSEMBLY-TRUNK LID” part number is **57530FJ020**.

NOTE: Never use an “Old-style” (p.n. 57530VA001 or 57530FJ010) assembly to replace a T-Handle style lock.
