Subject MIL ON P314A and/or P0C73, Corrosion Present in A9 Inverter Water Pump Connector		Market USA
Service Category Vehicle Interior	Section Meter/Gauge/Display	
Applicability 14-16MY Highlander HV14-2016MY Highlander HV

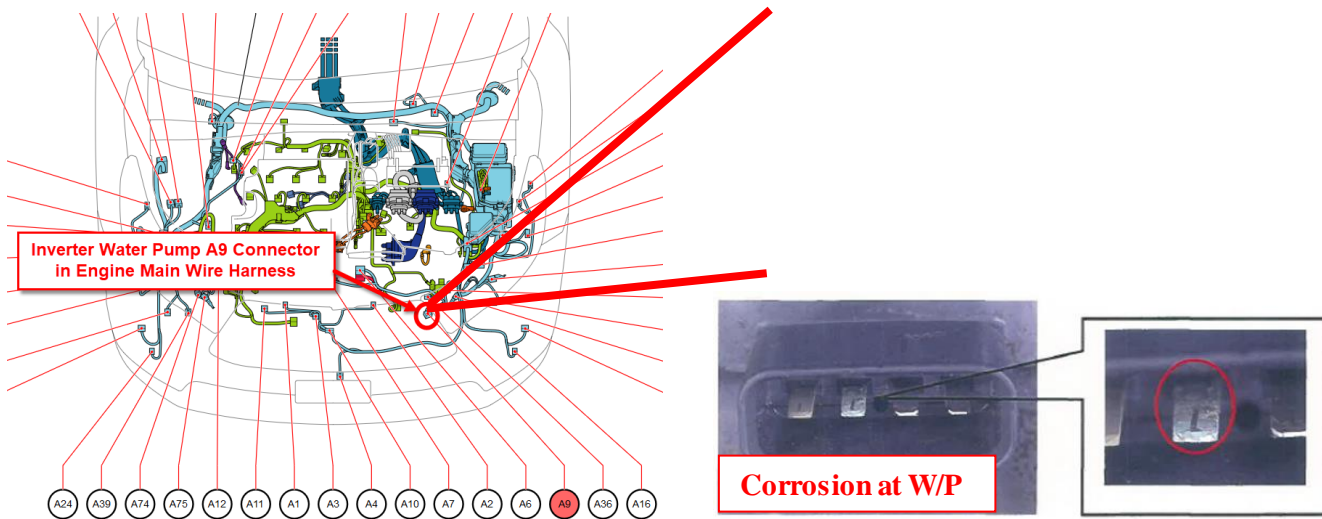
Water can enter in through deicer harness, wick down to the common shared ground junction A72 and then wick from the A72 ground connector to inverter water pump connector.

- 1) Inspect A33 windshield deicer connection-to-engine main wire harness for evidence of corrosion.
- 2) Check if windshield is non-genuine Toyota windshield. Toyota genuine windshields will have a "Toyota" marking on label and a Toyota part number on the deicer harness. The deicer harness and windshield come as an assembled unit.
- 3) Toyota recommends that windshields only be replaced with Toyota genuine parts. Toyota genuine windshields are equipped with seals for prevention of water intrusion to the engine room main wire harness.
- 4) If corrosion is found in the A33 connector and the windshield is a Toyota genuine part, please contact TAS.

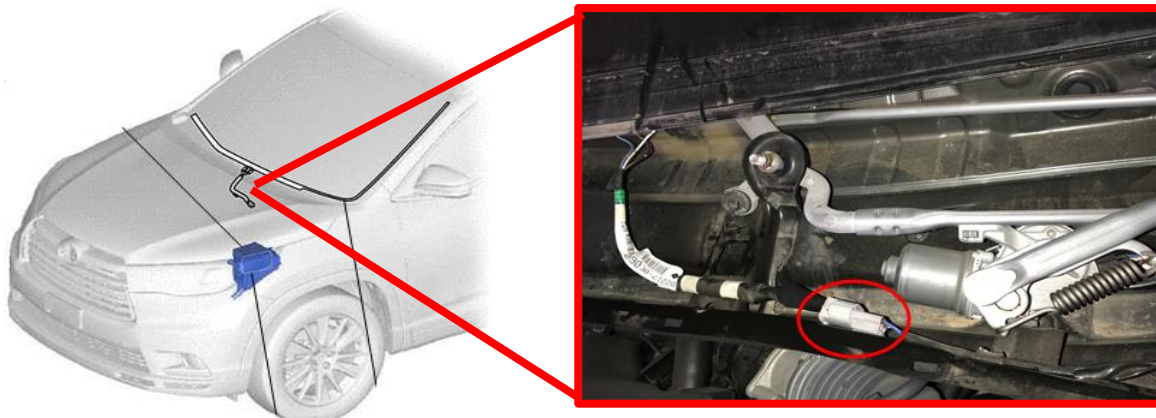
Windshield Deicer Harness (Located in cowl area):

Vehicles may experience a MIL ON condition exhibiting codes P314A and/or P0C73 with evidence of water (corrosion) at the A9 inverter water pump connector. This condition may be caused by vehicles being equipped with an aftermarket windshield assembly with a poorly sealed or damaged deicer harness.
