April 2018  
FL756AB  
NHTSA #17V-761  
Transport Canada #17-583

## Subject: Brake Light Pressure Switches

**Models Affected: Specific Freightliner Cascadia and Western Star 4700, 4900, 5700, 6900 model vehicles manufactured March 27, 2007, through November 21, 2017.**

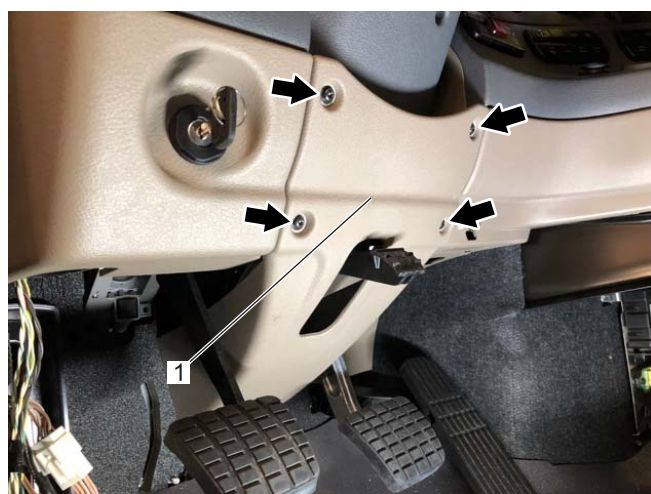
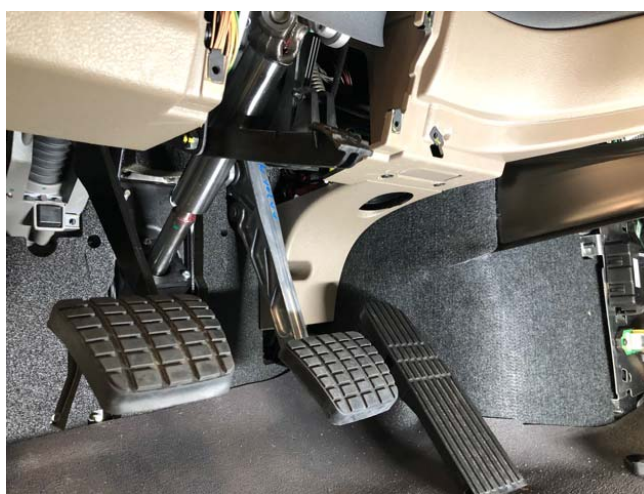
**Fig. 1, Column Cover, Cascadia Vehicles**

A. The column cover is installed; remove the four screws.

B. The column cover is removed.

1. Check the base label (Form WAR259) for a completion sticker for FL756 (Form WAR260) indicating this work has been completed. The base label is usually located on the passenger-side door, about 12 inches (30 cm) below the door latch. If a completion sticker is present, no work is needed. If a completion sticker is not present, proceed to the next step.
2. Park the vehicle on a level surface, shut down the engine, and apply the parking brake. Chock the tires.
3. For Cascadia vehicles, remove the four screws attaching the column cover to the dash, then remove the cover. See [Fig. 1](#), Ref. A.

For Cascadia vehicles, use the four screws and install the column cover. See [Fig. 1](#).

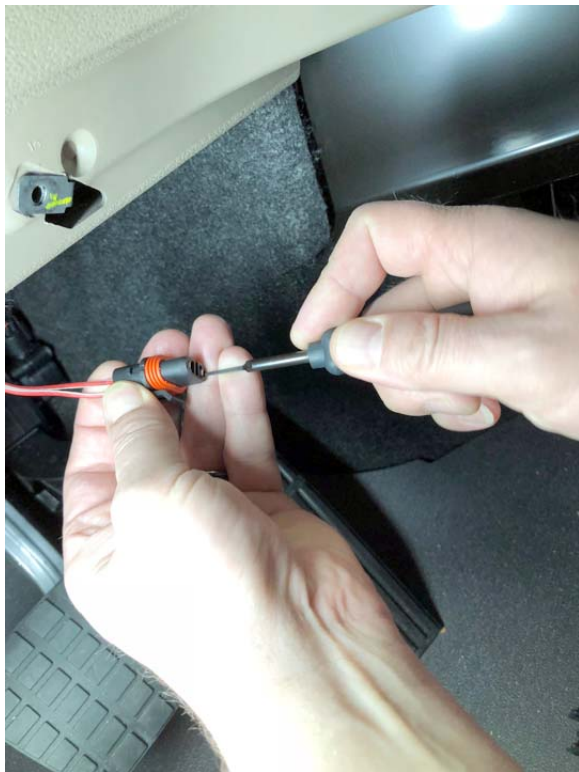
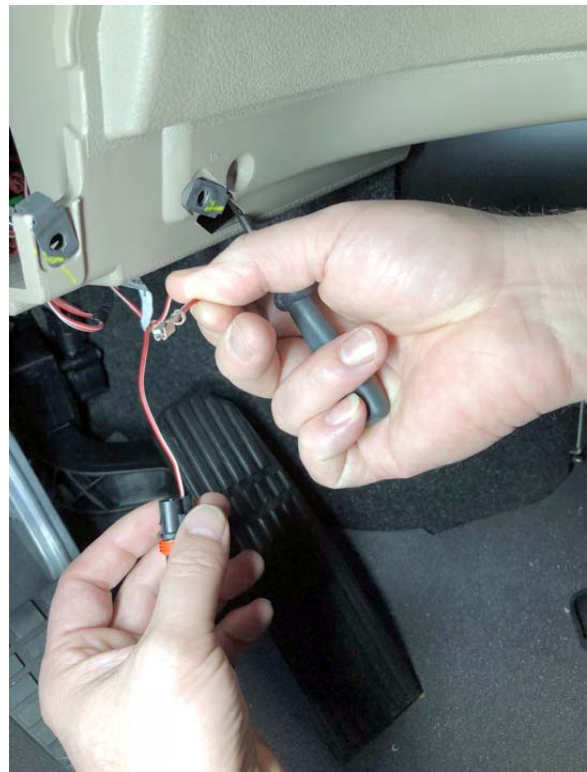
**Fig. 7, Removing the Connector Pin**

- Removing the connector pin.
- The connector pin is removed from the switch connector.

- Using the automotive connector terminal removal tool (DKI0CHA17002-1), remove one of the pins from the connector. See [Fig. 7](#).
