MIL "ON" DTC P2820

YEAR(S)	MODEL(S)	ADDITIONAL INFORMATION
2016	iM	Transmission(s): CVT

Some 2016 model year iM vehicles may exhibit a MIL "ON" condition with Diagnostic Trouble Code (DTC) P2820 present, indicating a Pressure Control Solenoid (shift solenoid valve SLP) Performance condition. The Engine Control Module (ECM) (SAE term: Powertrain Control Module/PCM) logic has been updated to prevent this condition. Follow the Repair Procedure in this bulletin to address this condition.

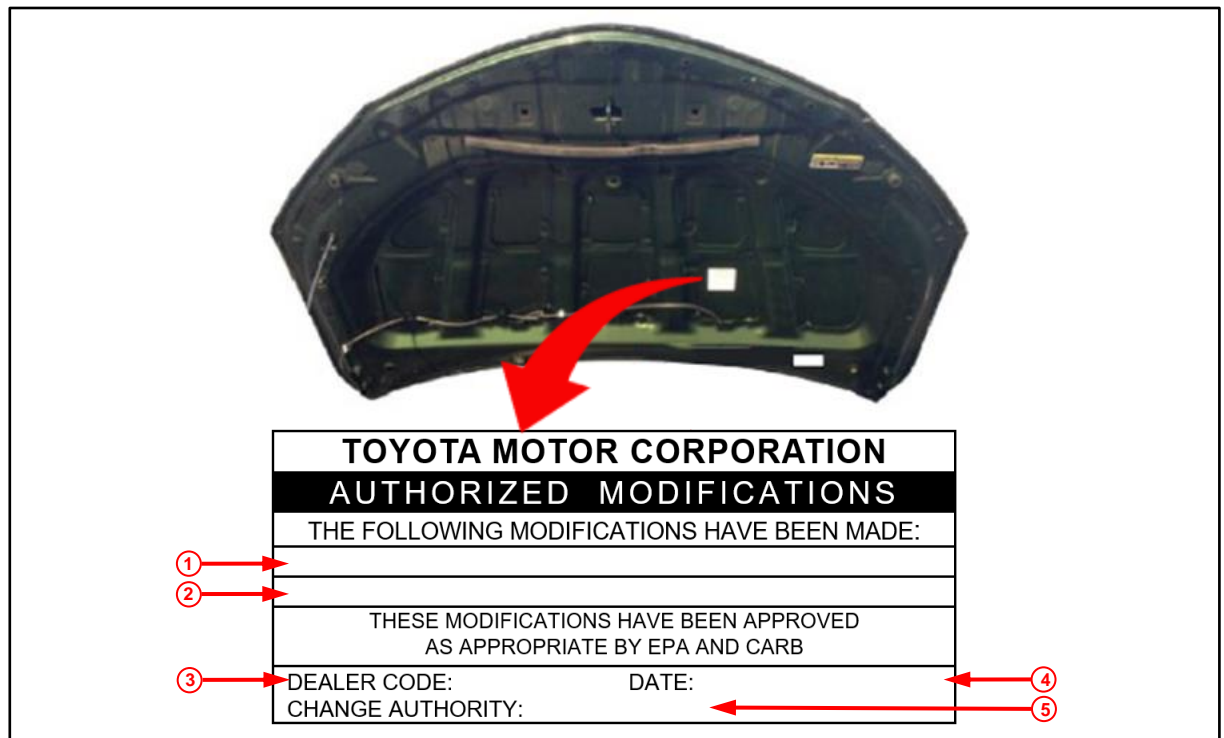
Figure 1. Location of Authorized Modifications Label for 2016 iM

- Check for the Authorized Modifications Label affixed to the vehicle in the location shown below. Confirm if the ECM (PCM) calibration has been updated.

6. Prepare and install the Authorized Modifications Label.
 - A. Using a permanent marker, enter the following information on the label:
 - ECM part number [Refer to the **Parts Information** section for the **NEW PART NUMBER**]
 - Calibration ID(s) [Refer to the **Calibration Information** section for the **NEW CALIBRATION ID**]
 - Dealer Code
 - Repair Date
 - Change Authority [**This bulletin number**]
 - B. Install the Authorized Modifications Label on the vehicle at the location shown in Figure 1. The Authorized Modifications Label is available through the MDC, P/N 00451-00001-LBL.
7. Perform the Techstream ECT Reset Memory Utility.
8. Test drive the vehicle to confirm the repair.
