2nd row seat chirp/squeak noise from the rear seat latches

2011-2018MY Sienna (8 passenger type)

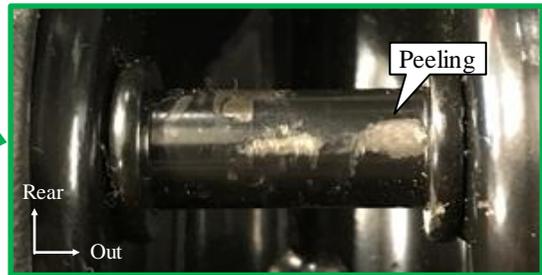
Fig.2 Rear inboard striker

Some vehicles may experience a condition in which the 2nd row seat, with center seat, exhibits a chirp/squeak noise from the rear seat latches (floor area). This condition is present while driving over rough or bumpy roads. Upon further inspection, after removal of the LH 2nd row seat, the rear inboard and outboard strikers may show signs of the coating peeling off as shown in Fig.2 and Fig.3.

1. Please document the following:
 - a. Photograph the 2nd row, rear inboard and outboard strikers as shown in Fig.2 and Fig.3.
 - b. Inspect condition of cushion bumper attached to rear inboard and outboard seat latches and photograph as shown in Fig.5 or Fig.6.
