Door Check "Pop" Noise When Opening/Closing Doors

Service Category Vehicle Exterior

Section Door/Hatch

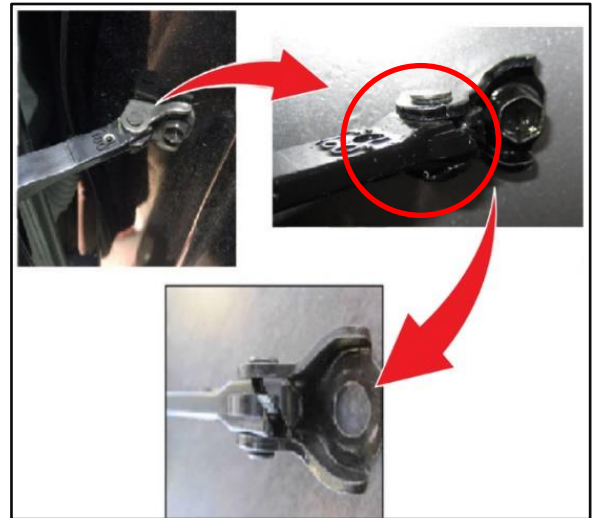
Figure 1.

Some 2008 – 2018 model year Sequoia and 2007 – 2018 model year Tundra vehicles may exhibit a popping noise during RH or LH front door operation. This noise may be due to a fracture/crack in the plastic over mold of the door check arm by the pivot area. Follow the Repair Procedure in this bulletin to address this condition.

2. Visually inspect for a fracture/crack or ANY damage on the plastic resin of the check arm by the pivot area.

Is there a fracture/crack or ANY damage on the plastic over mold of the check arm?

4. Replace the check arm assembly.

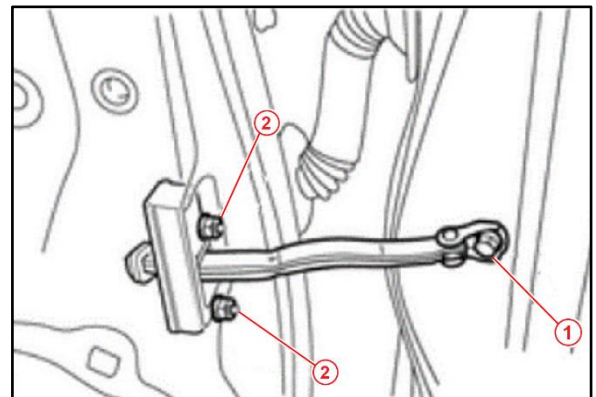
Figure 2.

3. Confirm the torque value of ALL three check arm mounting fasteners:

Bolt (1):

Torque: 29 N*m (296 kgf*cm, 21 ft*lbf)

Nut (2):

Torque: 8.5 N*m (87 kgf*cm, 75 in*lbf)

1	Bolt
2	Nut
