# Technical product information

| Topic | Emission control warning displayed - (DTC) P227900 - Intake air leak |

## Bentayga W12

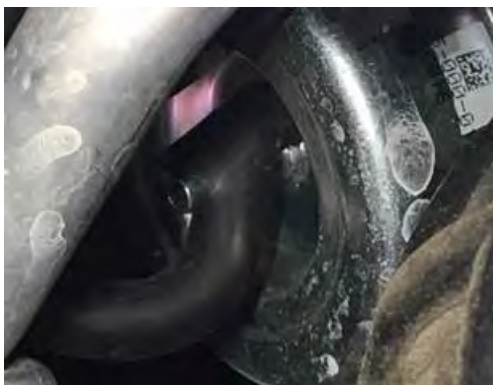
Figure 1

In the event that the above customer concern is reported and Diagnostic Trouble Code (DTC) P227900 Intake air system leak is recorded in the engine control module, then there are two known issues that should be considered as part of your investigation and fault rectification.

1. Split vacuum hose onto the waste-gate (see Figure 1), confirmed with visual inspection or smoke test. Replace the failed pipe to resolve the issue
2. Failed waste-gate diaphragm, the use of a Mityvac is recommended to confirm the presence of an internal leak in the turbocharger waste-gate or smoke test. Once confirmed the turbo charger assembly must be replaced
