# Shunt Tube/Alternator Bracket Bolt Interference

# 20-21

Freightliner  
Service Bulletin

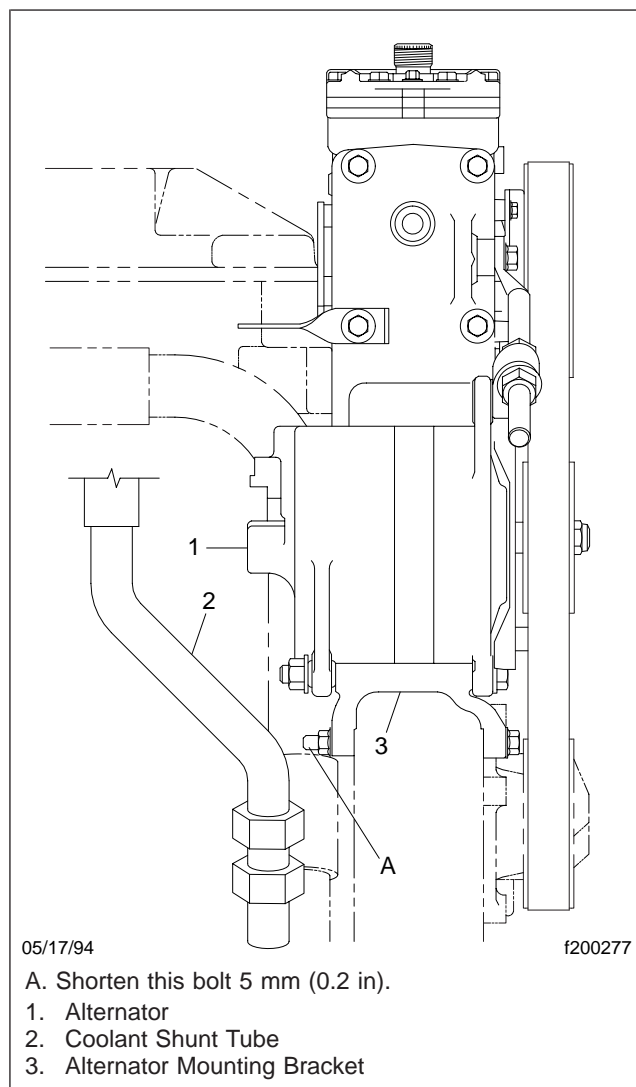
Fig. 1

As of February 4, 1994, production changed over to a new steel shunt tube on DDC Series 60 engines, to eliminate routing problems. The new steel shunt tube may rub on the lower bolt of the alternator mounting bracket (one of the fasteners between the bracket and the engine). See Fig. 1. On FLB COE and FLD Conventional vehicles, the M10 x 1.5-145 mm bolt may possibly rub a hole in the shunt tube, causing loss of engine coolant. Production is now inspecting vehicles to ensure this interference does not occur, and by the end of May 1994, a shorter (140 mm) bolt will be installed in place of the current 145 mm bolt. This will prevent any interference problems.

If this interference problem is encountered in the field, remove the alternator mounting bracket bolt (with nut and washer), and grind approximately 5 mm (0.2 in) off the threaded end. If the shunt tube has been damaged, replace it as well. The tube (A05-16317-000) is available through the PDCs.
