Description of Revisions: *This bulletin replaces the previous version dated October 1997. The list of affected vehicles has been clarified to include vehicles built from August 15, 1997 through July 9, 1998, with engines rated 500 horsepower or greater, and equipped with certain Horton fan drives.*

General Information

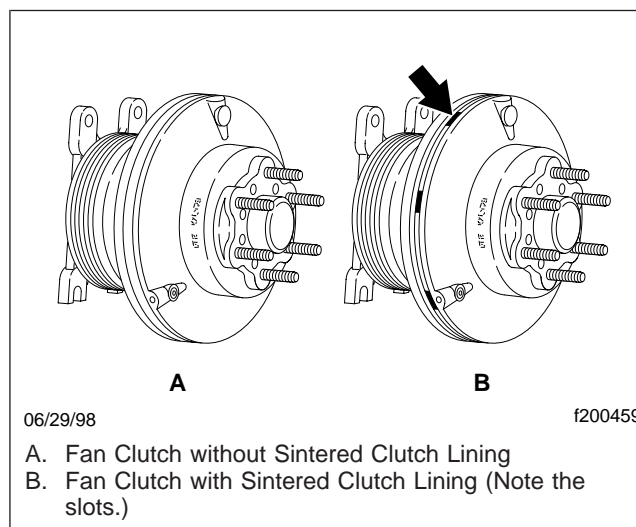
Fig. 1, Horton Fan Clutches

Horton fan clutches with 32-inch 9-blade fans deliver extra cooling power. Therefore, more torque is required from the fan clutch. If a vehicle is dyno tested or otherwise subjected to extended fan-on times early in its service life, the clutch lining may not be broken in properly, leaving it susceptible to slippage. This slippage can create heat, resulting in a blown Horton System Sentry plug.

As of July 10, 1998, all production plants have been installing Horton fan clutches with a sintered clutch lining on engines rated at 500 horsepower or greater. See **Fig. 1**. This lining is better suited to handle the increased torque from the 32-inch fan.

If the System Sentry plug blows or there are other signs of excessive fan clutch heat or slippage, first check for correct fan control operation and air leaks. If all checks okay, install the sintered clutch lining. For instructions, see *Group 20* of the **Heavy-Duty Trucks Service Manual**, the **Business Class Trucks Service Manual**, or the **Century Class Trucks Workshop Manual** for fan clutch disassembly and assembly. In addition to the sintered lining, a seal kit will also be required for reassembly. See **Table 1** for parts needed.
