20-34

Fan Shroud Interference on FLD Vehicles

Freightliner
Service Bulletin

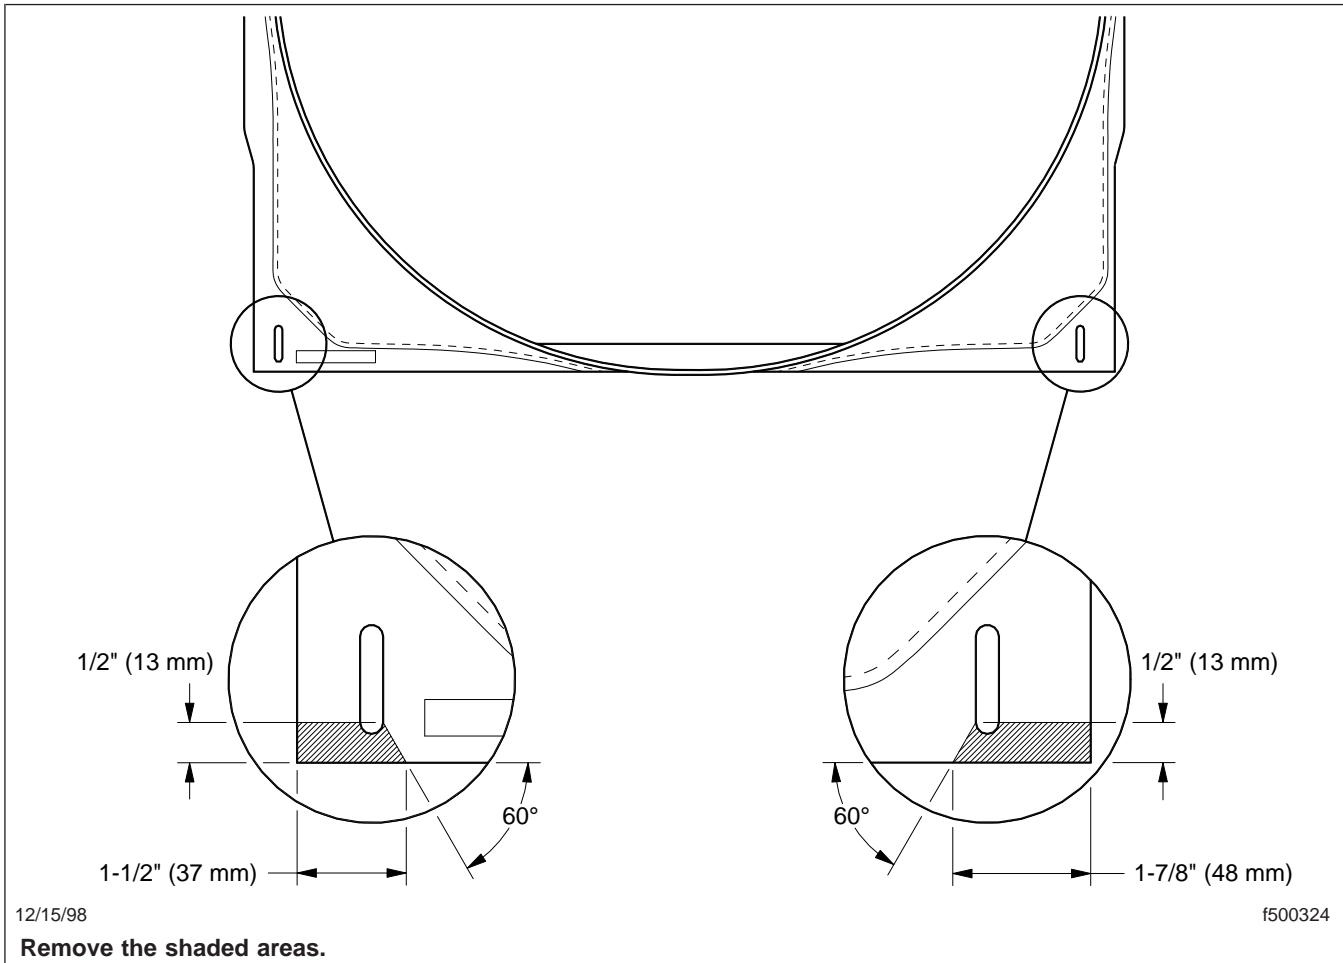
Fig. 1, Removing the Lower Corners of the Fan Shroud

FLD Conventionals built up to December 2, 1998, and equipped with a 30-inch or 32-inch fan may have problems with the fan shroud interfering with the fan blades. In some cases, the interference is caused by an incorrect shroud adjustment that can be corrected by a simple readjustment. In other cases, the interference is due to the bottom of the shroud contacting either the top of the frame-rail extensions or the top corners of the frame rails. In these cases, the shroud cannot be correctly adjusted without first modifying either the shroud itself or the frame rails.

5. If the shroud is contacting the frame-rail extension, go to the step for removing the lower corners of the fan shroud.

6. Remove the lower corners of the fan shroud.
 - 6.1 Remove the four fasteners holding the shroud in place.
 - 6.2 Using either a cutting wheel or a die-grinder, remove the bottom corners of the fan shroud, as shown in [Fig. 1](#).

- 6.3 Install the fan shroud, making sure that there is at least 1/4-inch (6 mm) clearance between the fan blades and the top and bottom of the shroud. Tighten the fasteners firmly.

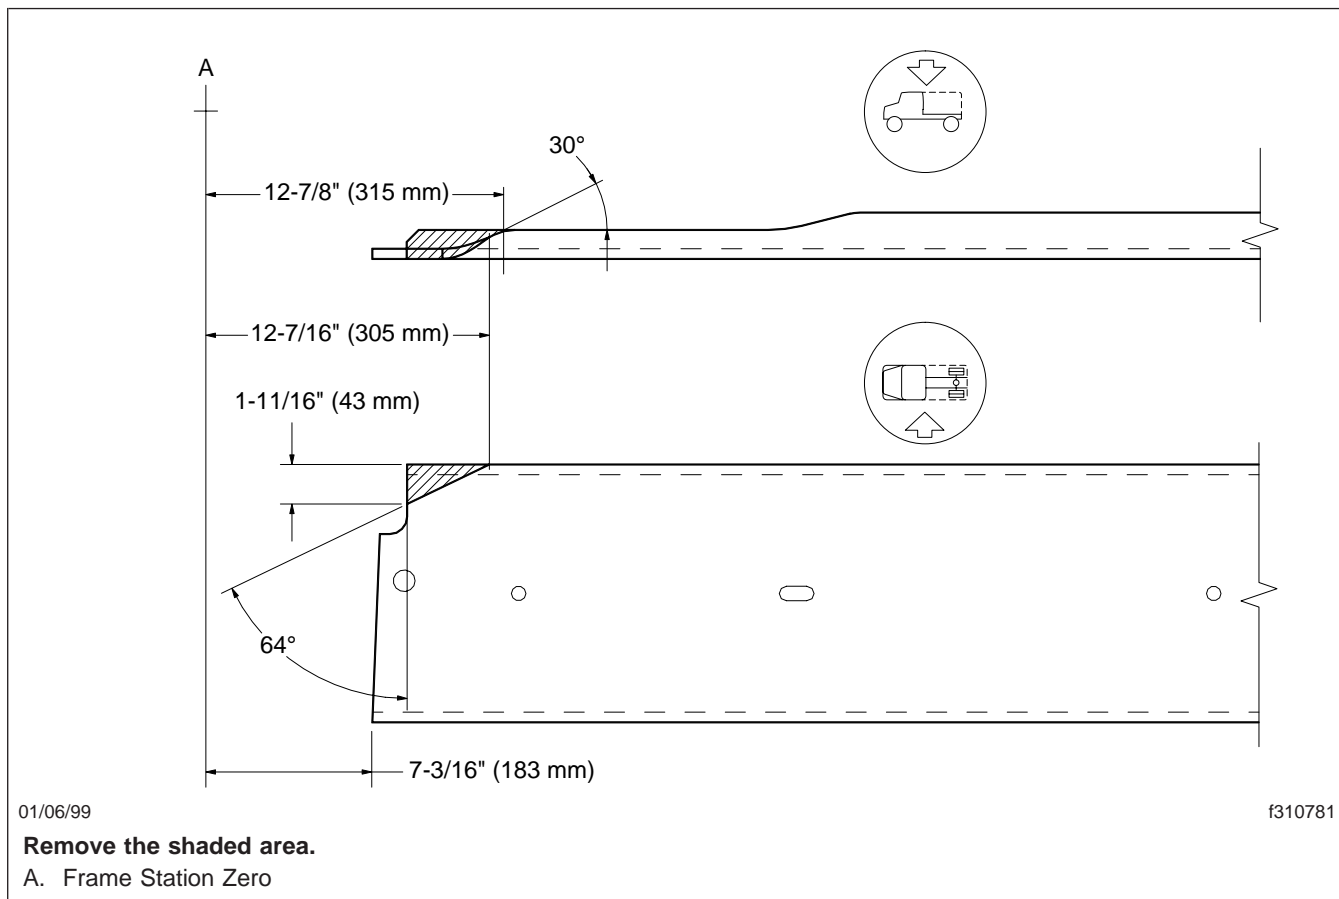
Fig. 2, Removing the Frame-Rail Corners (left frame rail shown)

If the clearance is still not correct, check for the cause of the interference. On vehicles equipped with engines of 500 horsepower or greater, check for contact between the shroud and the upper corners of the frame rails. On vehicles with smaller engines, check for contact between the shroud and the frame rail extensions.

If the shroud is contacting the upper corners of the frame rails, go to the step for removing the upper corners of the frame rails.

- 7.3 Using either a die-grinder or a cutting wheel, remove the upper corner of the frame rail, as shown in [Fig. 2](#).
 - 7.4 Repeat the procedure for the other frame rail.

- 7.5 Install the fan shroud, making sure that there is at least 1/4-inch (6 mm) clearance between the fan blades and the top and bottom of the fan shroud. Tighten the fasteners firmly.
