122SD and Coronado
Business Class M2
> Cascadia
108SD/114SD

**Freightliner
Service Bulletin**

General Information

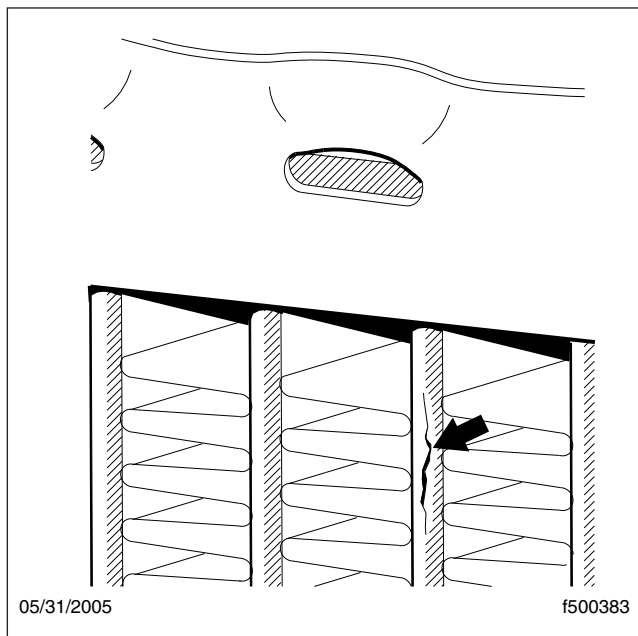
DTNA analysis has determined with some vehicle configurations, and at certain operational speeds, a radiator resonance can occur. This resonance can result in cooling tube fractures and a coolant leak. After successful testing in DTNA labs, and in trials in the field, DTNA has developed a means to stop the radiator resonance with a TMA. In this application (similar to many automotive applications) a specific mass of cylindrical steel is attached to a tuned mold of rubber, creating a tuned mass absorber. This effectively counteracts vibrations, significantly limits radiator resonance, and greatly extends radiator life. Considering the benefit to radiator life, limited downtime, and cost compared to converting to an isolated radiator installation, DTNA recommends the installation of a TMA service kit (Z05-31778-000) when replacing 1625 sq in radiators.

Fig. 1, Crack in Coolant Tube

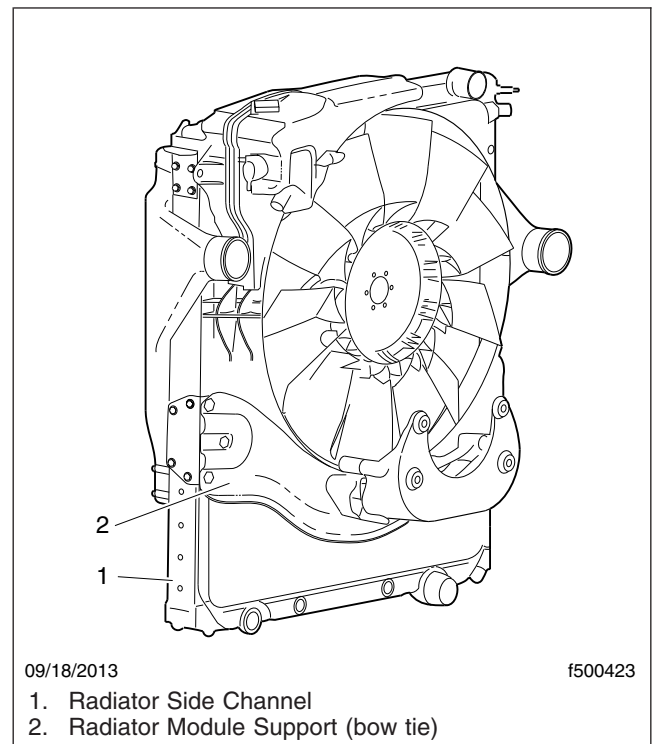
IMPORTANT: This procedure applies **ONLY** to Cascadia vehicles with "bow-tie" mounted 1625 sq in radiators. See **Fig. 2**.

Fig. 2, "Bow-Tie" Mounted 1625 sq in Radiators

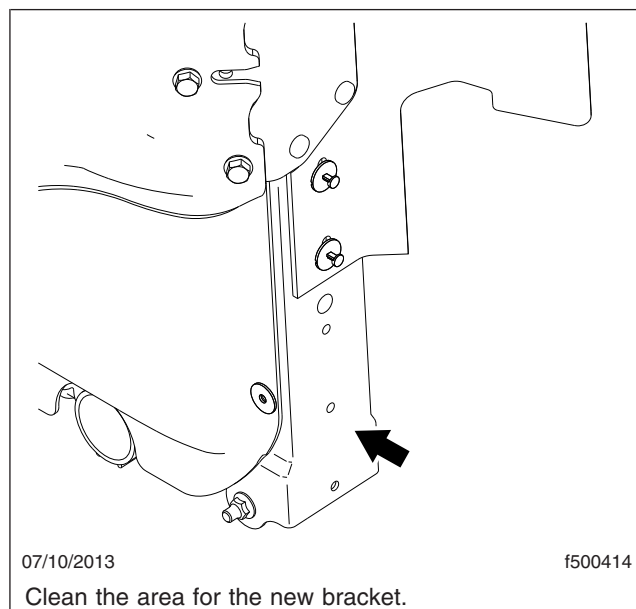
Fig. 3, Cleaning the Side Rail

2. If replacing the radiator, follow the instruction in **Subject 20.00, 100** of the *Cascadia Workshop Manual*.
If only adding a TMA, remove the bumper.
3. Remove and discard the right-hand lower radiator baffle, if installed.
4. Clean the radiator right-side channel surface as needed. See **Fig. 3**.

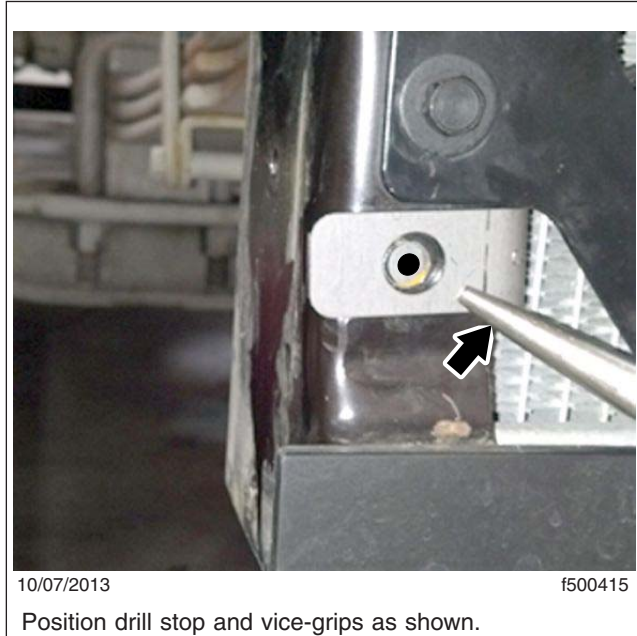
Fig. 4, Drill Stop Installation

5. Check the diameter of the mounting hole. If the hole is the correct size (15/32 inch [11.7mm]), go to step 7. If not, go to the next step.
6. Using needle-nose vice-grips, clamp the drill stop included in the kit over the existing hole in the radiator side channel as shown in **Fig. 4**.
7. Drill out the existing hole to 15/32 inch (11.7mm).
8. Insert a U-nut (23-13093-018) on the radiator channel over the new hole. See **Fig. 5**.

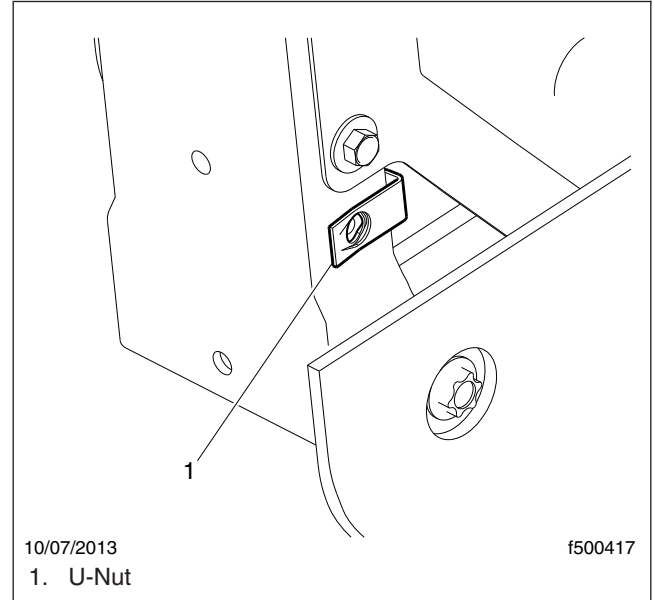
Fig. 5, U-Nut Installation

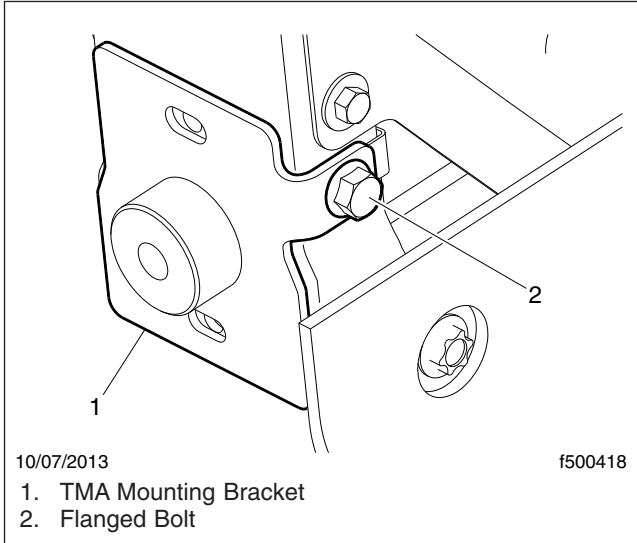
Fig. 6, Positioning the TMA Mounting Bracket

9. Position the TMA mounting bracket and start a M8 flange bolt into the U-nut as shown in [Fig. 6](#). Do not tighten at this time.

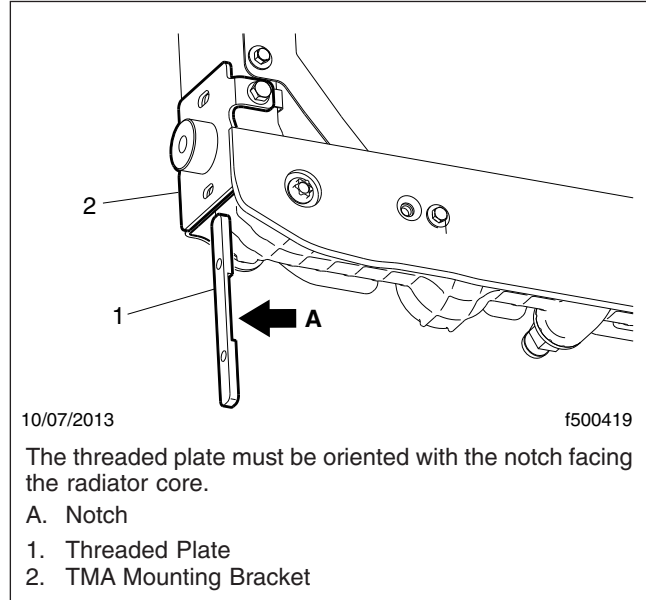
Fig. 7, Threaded Plate Installation

10. Slide the threaded plate up inside of the radiator side channel as shown in [Fig. 7](#). Make sure the notch is facing the radiator core.
11. Install the two remaining M8 flange bolts through the bracket into the threaded plate as shown in [Fig. 8](#). Tighten all three M8 flange bolts 17 lbf-ft (23 N·m).
12. Install the TMA, retaining bracket, spacer, and M12 flange bolt. Tighten the flange bolt 60 lbf-ft (81 N·m). See [Fig. 9](#) and [Fig. 10](#).
13. Install the bumper. For instructions, see **Group 31** of the *Cascadia Workshop Manual*.

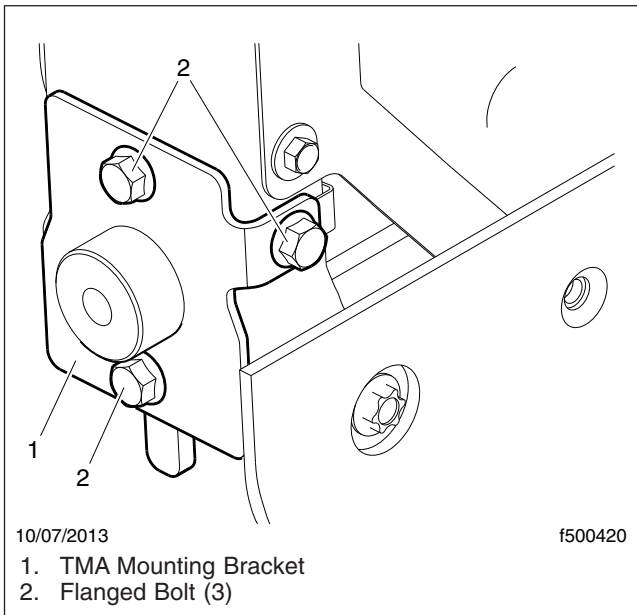
Fig. 8, Final TMA Mounting Bracket Installation

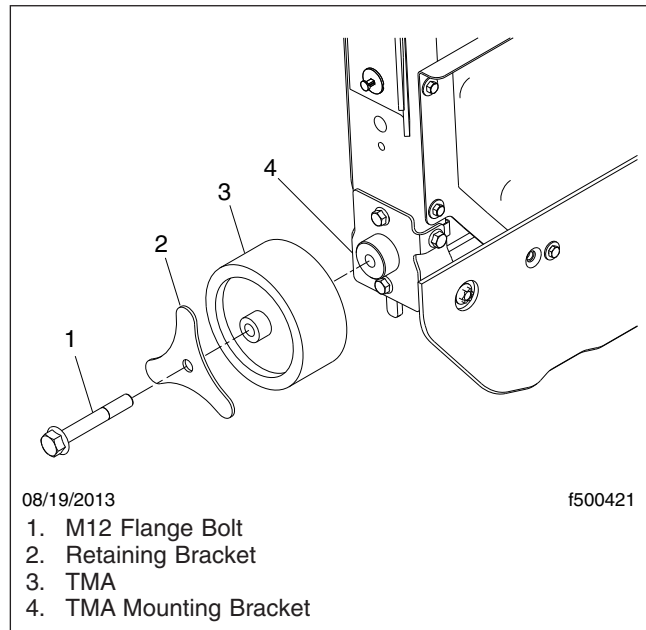
Fig. 9, TMA Installation (exploded)

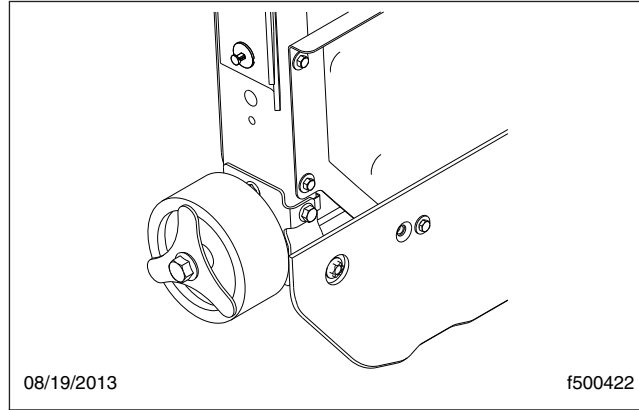
Fig. 10, TMA Installation
