122SD and Coronado
Business Class M2
Cascadia
> 108SD/114SD

**Freightliner
Service Bulletin**

General Information

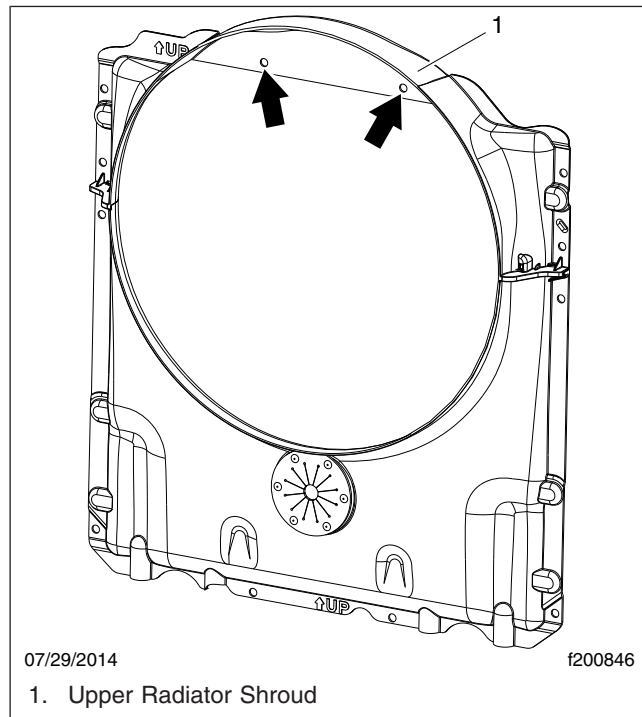
Fig. 1, Fastening Points

If the upper radiator shroud on a Freightliner 114SD equipped with a DD13 engine comes loose, it may be due to loose plastic push rivets (23-12274-003) that attach the shroud to the upper radiator tank. See [Fig. 1](#) for the push rivet location. If needed, replace the push rivets with metal J-nuts, fender washers, and 1/4–20 x 0.5 bolts.

When installing the shroud, use the 1/4–20 x 0.5 bolts listed in [Table 1](#). Using longer bolts will damage the radiator, which may lead to engine damage.

1. Park the vehicle on a level surface, shut down the engine, and set the parking brake. Chock the tires.
2. Remove the upper fan shroud. Discard the plastic push rivets.
3. Install J-nuts on the radiator at the two fastening points. See [Fig. 1](#). For the correct part numbers, see [Table 1](#).
4. Using fender washers and 1/4–20 x 0.5 bolts, attach the upper fan shroud to the radiator. For the correct part numbers, see [Table 1](#).
