Freightliner  
Service Bulletin

**Description of Revisions:** *This bulletin replaces the version dated October 2014. The VMRS component code has been updated from 016-008-088 to 016-008-023.*

## General Information

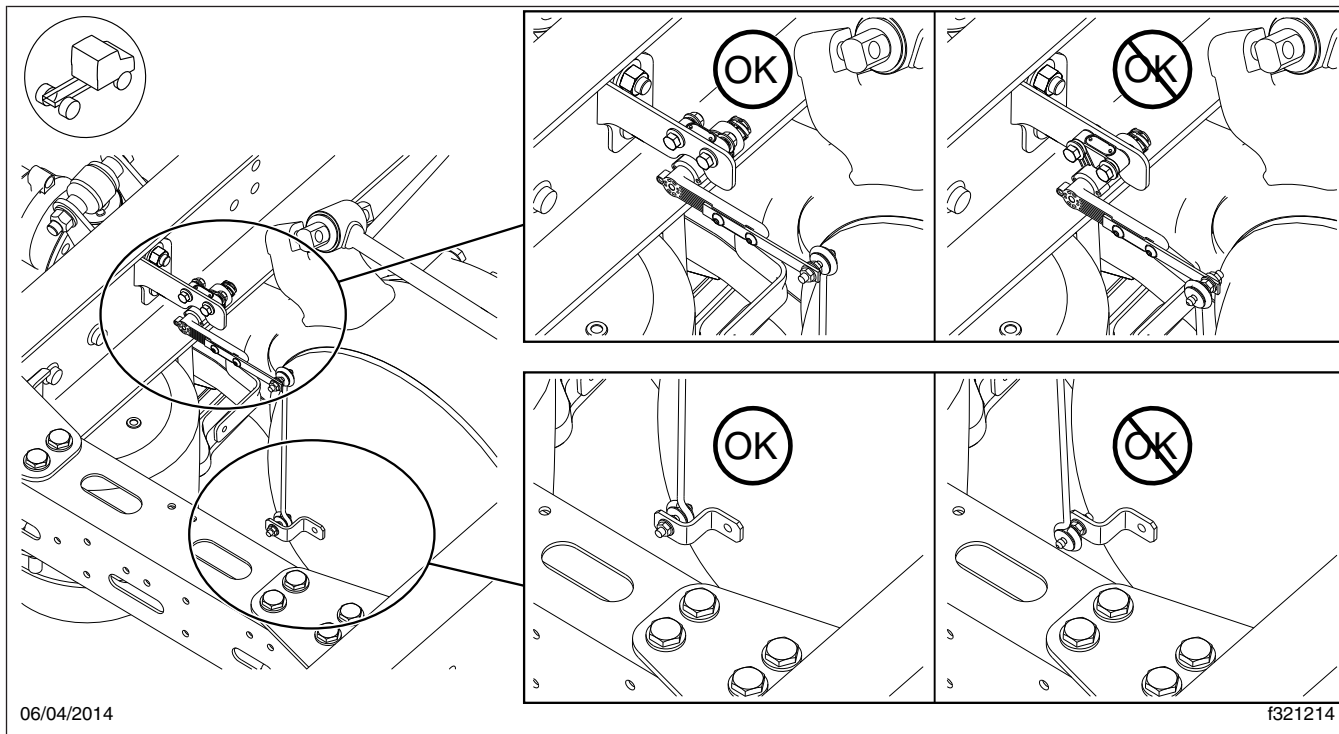
**Fig. 1, Inspection of the Ride Height Sensor Installation**

Ride height sensor arms have broken on some vehicles equipped with Meritor WABCO Electronically Controlled Air Suspension (ECAS) due to incorrect installation of the sensor, linkage, and/or Z-bracket. In these cases, the sensor was mounted aft rather than forward of the bracket, and/or the Z-bracket was attached to the axle housing outside of the correct location, which resulted in air lines or other components impeding the full travel of the arm. When the sensor, linkage, and Z-bracket are installed in the correct position, the arm should be clear of all components during travel.

6. Compare the ride height sensor position of the vehicle to [Fig. 1](#). The sensor should be installed on the forward side of the sensor bracket, and the linkage rod should be on the forward side of the Z-bracket on the axle. The linkage rod should be upright, with no fore-aft tilt, as shown in [Fig. 2](#).

If the sensor or linkage rod are out of position, reposition them to match [Fig. 1](#). While the sensor is off the vehicle, inspect it for damage. If any cracking is found on the arm or body, replace the sensor.

10. Reconnect the linkage, making sure it matches the installation in [Fig. 1](#). Turn the key on and use the ECAS remote control to lift the suspension enough to remove the height blocks.

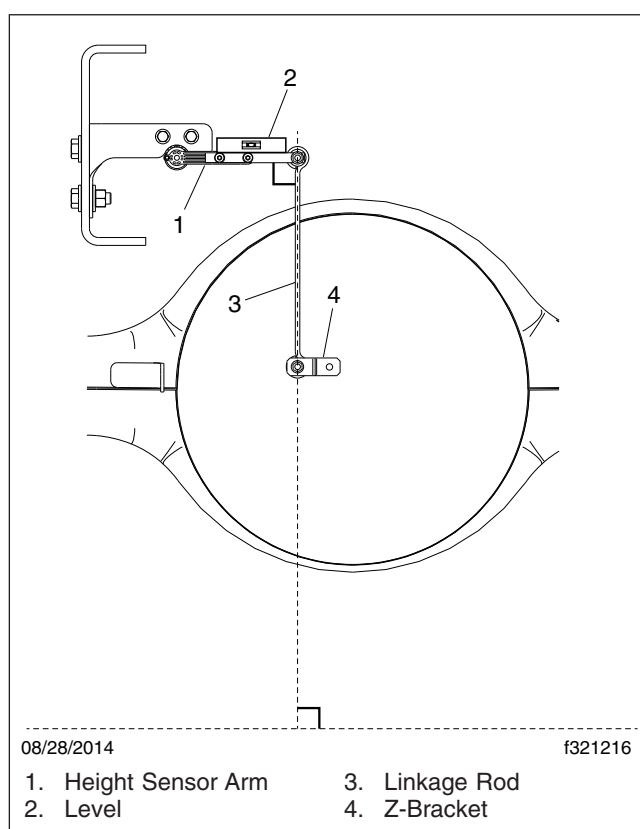
**Fig. 3, Correct Position of the Arm, Linkage, and Z-Bracket**

7. Check the position of the height sensor arm and linkage rod. See [Fig. 3](#). Check that the arm is level using a level, then use a plumb bob or carpenter's square to check that the linkage rod is at a 90° (right) angle to the level sensor arm.

If the arm is level, and the linkage rod is 90° to the arm and perpendicular to the ground, no further work is necessary.

If the arm is not level, and/or the linkage rod is not 90° to the arm, check the position of the Z-bracket as follows.

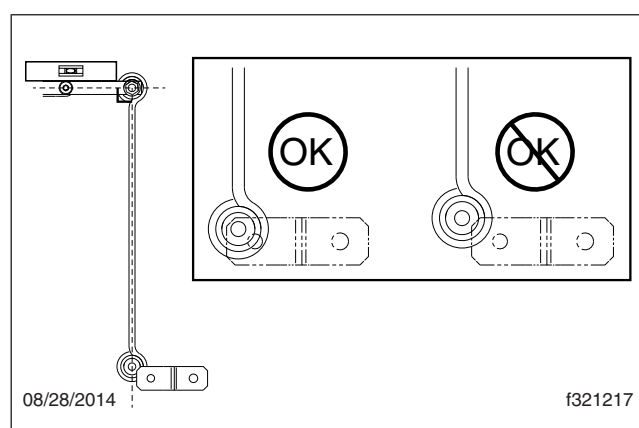
**Fig. 4, Permissible Variation in Z-Bracket Position**

- 7.2 Pin the arm to the sensor body using a 5/32-inch drill bit. If the arm isn't level when pinned, loosen the mounting fasteners and adjust the position of the sensor body on the frame bracket until the arm is level.
- 7.3 With the height sensor arm level and the linkage rod at 90°, check if the linkage end hole is within the perimeter of the Z-bracket mounting face. See [Fig. 4](#).

If the end hole is within the perimeter of the Z-bracket mounting face, as shown in [Fig. 4](#), the component positions are sufficient. No further work is necessary.

If the end hole is not within the perimeter of the Z-bracket mounting face, as shown in [Fig. 4](#), install a new Z-bracket in the correct position. See **Positioning the Z-Bracket**.
