Alternator Remote Sense Wiring

FLA COE FLB COE FLD Conventional Business Class FLC 112 Conventional Century Class Conventional Argosy COE Cargo Columbia 122SD and Coronado > Business Class M2 Cascadia
> 108SD/114SD New Cascadia Freightliner Service Bulletin

15-020

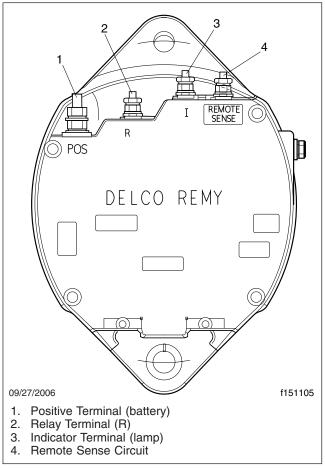
Fig. 1, Delco Remy 36SI

On EPA10 vehicles, and later, the remote sense wire and the indicator light wire may be on the wrong alternator posts. Vehicles with reversed wires may not start if the vehicle is parked and the engine is shut down for extended periods of time, due to parasitic battery drain.

4. Check the voltage at the indicator light terminal on the alternator. See Fig. 1, Fig. 2, or Fig. 3.

YES \rightarrow The remote sense and indicator light wires are reversed. Continue with step 5.

- 5. Disconnect the negative battery cables at the main battery pack.
- 6. Swap the remote sense and indicator light wires. Verify the repair, then continue with step 9.
- 7. Check the voltage at the remote sense terminal.
