Diesel Exhaust Fluid (DEF) Pressure Line Disconnected at the Doser Connection

49-040

Freightliner
Service Bulletin

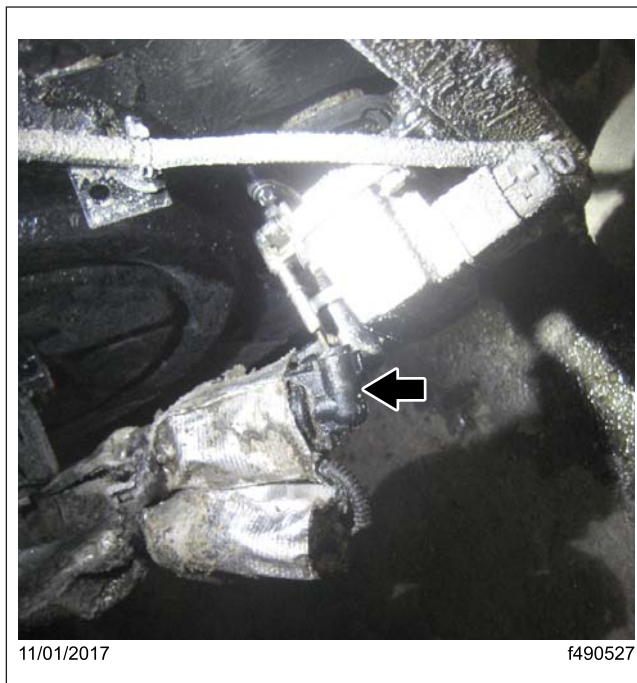
On some GHG14 and GHG17 vehicles equipped with a Detroit one-box aftertreatment system (ATS), the DEF pressure line may be pushed off the doser connection by frozen DEF in extreme cold climates. See [Fig. 1](#). Going forward, vehicles equipped with a Detroit Diesel one-box ATS will have a zip tie installed through the doser mounting bracket and around the DEF pressure line.

Fig. 1, Broken DEF Line

Installing the zip tie (part number 23-09796-509) prevents the DEF pressure line from being pushed off. The zip tie can be installed as a preventive measure or can be installed after the DEF line is disconnected, without replacing the DEF line.

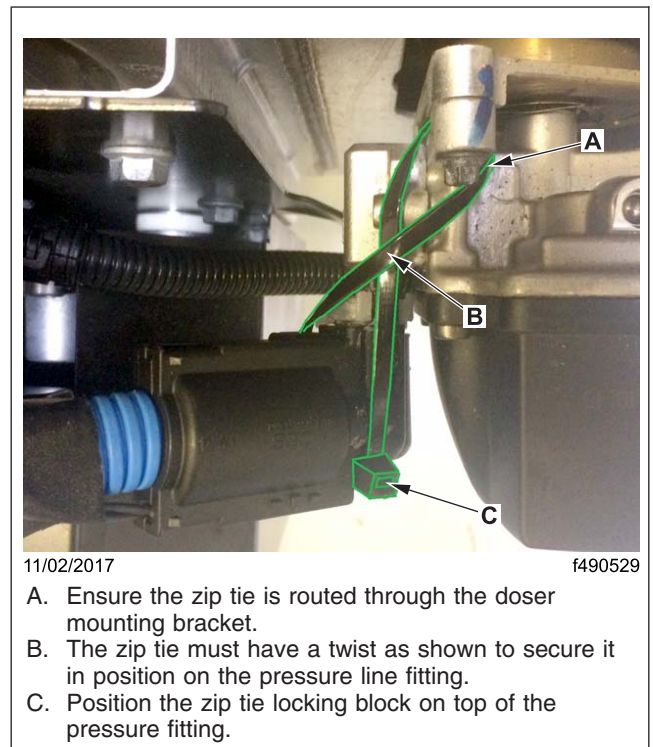
Fig. 2, Installing a Zip Tie on the DEF Pressure Line and Doser

1. Park the vehicle on a level surface, shut down the engine, and set the parking brake. Chock the tires.
2. Locate the DEF pressure line on the ATS.
3. Install a zip tie through the doser mounting bracket and around the DEF pressure line as shown in [Fig. 2](#).
