Freightliner  
Service Bulletin

Vehicles equipped with DDEC IV have a relative-humidity-sensor wiring harness. On many vehicles this harness is routed too close to the exhaust tubing, which can result in heat damage to the wiring. This harness must be rerouted, and if damaged, replaced. Follow the instructions under "Procedure," below.

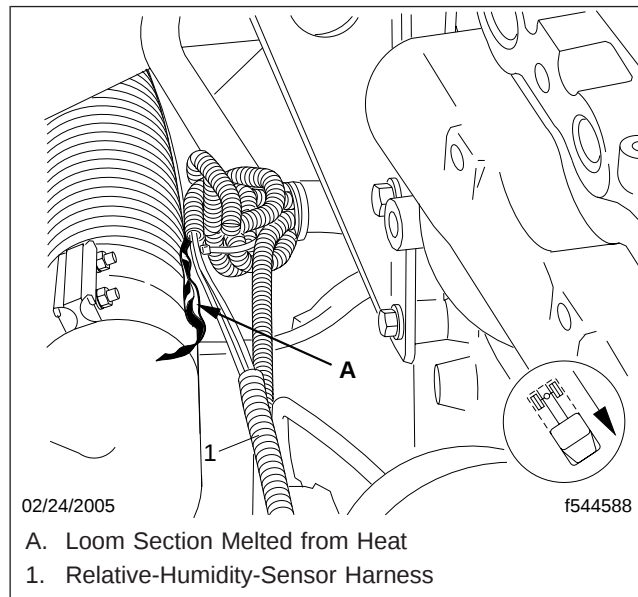
Fig. 1, Heat-Damaged Harness

3. For Argosy vehicles, tilt the cab.  
For all other vehicles, tilt the hood.
4. Find the relative-humidity sensor and its wiring harness on the air intake tubing. Check for heat damage from the exhaust. See [Fig. 1](#).

If there is any heat damage, install a new harness and reroute it, as instructed in the next step.

If the harness is not damaged, reroute it, as instructed in the next step.

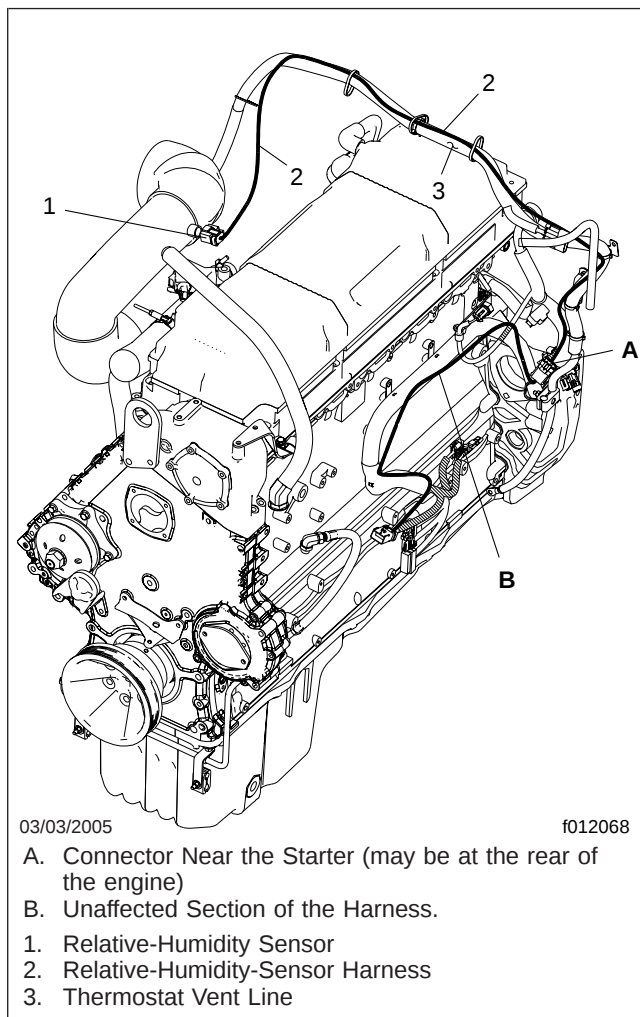
**Fig. 2, Relative-Humidity-Sensor Harness (typical routing)**

NOTE: The harness is most likely to be routed around the rear of the engine and over the transmission. The connector to the second length of the harness may be at the rear of the engine, rather than at the starter. Some of the tie straps can be accessed through the fender wells on both sides of the vehicle.

5. Reroute/replace the relative-humidity-sensor harness. See [Fig. 2](#).
