# Condensation and Possible Water Entry Points in Headlamp Assemblies

# 54-251

**Freightliner  
Service Bulletin**

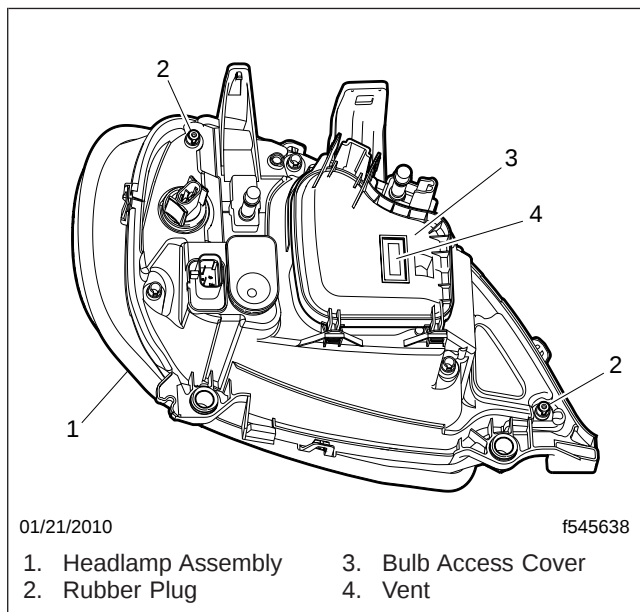
**Fig. 1, Water Protection Points**

- Verify that there are two rubber plugs installed in the headlamp assembly as shown in [Fig. 1](#). Note that there are three other, similarly-sized round holes in the headlamp assembly which are closed and do not need plugs; see [Fig. 2](#).
- Verify that the bulb access cover (see [Fig. 1](#)) is attached securely to the headlamp assembly housing.
- On some headlamp assemblies, there is a vent (see [Fig. 1](#)) on the bulb access cover. If the cover is vented, verify that the vent holds fast to the cover and is not loose or poorly adhered.
- Verify that the electrical connectors for the turn signal and headlights have seals; see [Fig. 3](#). Missing or damaged seals can allow moisture into the headlamp assembly.
