# SS 1033297: WST 4900 Low Max Exhaust Pipe Installation improvements

### Applicable Vehicles

WST 4900 Low Max w/DD13 Engines

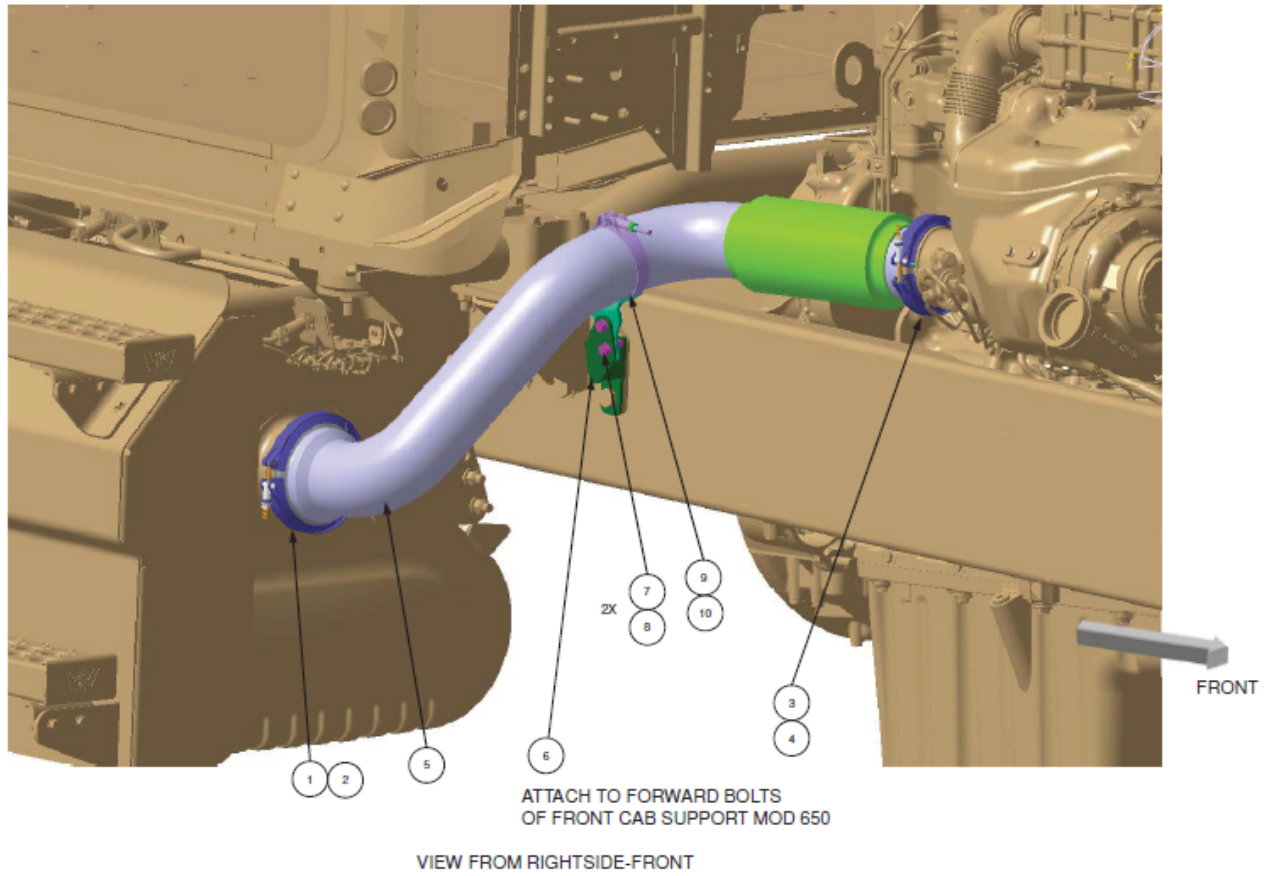
Early Failures of Exhaust Pipe from Turbo to ATS, Part Nr: 04-32700-000 .

Exhaust Pipes were installed in preloaded condition in the early production vehicles, due to the correct assembly sequence was not included in the initial installation drawing, which caused premature Exhaust Pipe Failures.

Exhaust Pipe Installation drawing has been revised and the installation sequence has been added to eliminate the preloading conditions in the exhaust pipes.

When replacing or inspecting the Exhaust Pipe installation follow the recommended sequence below included in installation drawing D04-32154-000:

1. REFER TO D04-21646 FOR CLAMP TORQUE SPECIFICATIONS
2. TORQUE ALL FASTENERS PER SPEC 49-00104 UNLESS OTHERWISE NOTED.
3. PROPER INSTALL SEQUENCE DURING PIPE INSTALLATION IS KEY TO PREVENT PRELOADING OF EXHAUST PIPE AND PREVENT FAILURES IN THE FIELD. ENSURE BELOW SEQUENCE IS FOLLOWED WHEN INSTALLING EXHAUST PIPE
  - A) ALIGN THE BELLOWS END OF EXHAUST PIPE CENTERLINE WITH THE ENGINE TURBO FLANGE AND THE OTHER FLARED END OF THE PIPE WITH THE ATS INLET FLANGE.
  - B) TIGHTEN BOTH MARMON FLANGE CLAMPS TO SPEC
  - C) BRING PIPE SUPPORT BRKT, 04-20376-000, UP TO THE BOTTOM OF EXHAUST PIPE AND TIGHTEN THE SUPPORT BRKT MOUNT BOLTS, THEN TIGHTEN THE PIPE SUPPORT CLAMP AROUND PIPE TO SPEC
