**MODEL:** Karma Revero**DATE:** May 2018**TITLE:** Exhaust Adjustment**First Release****PRIORITY:** On Complaint**APPLICABILITY:** MY17 and MY18 Revero**MARKET REGION:** North America**PURPOSE:** On complaint of a rattle or noise coming from the dash area.

# Technical Service Bulletin

**TB-18-12-02**

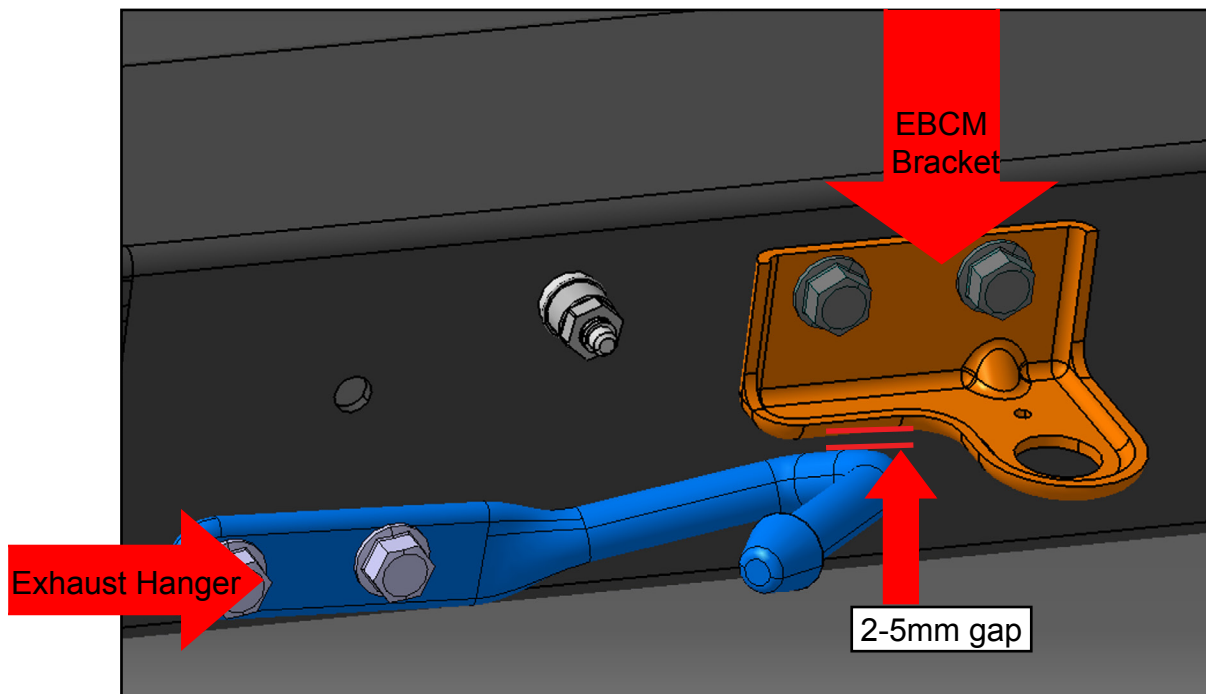
fig.1

When presented with a left side dash rattle noise, inspection of the exhaust hanger and the EBCM bracket should be performed. The two parts should be installed with a visible gap measuring 2-5mm (fig.1). If these parts are contacting one another, a vibration may be felt and heard in the passenger compartment.

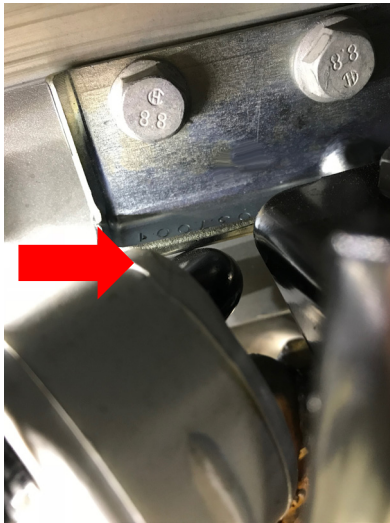
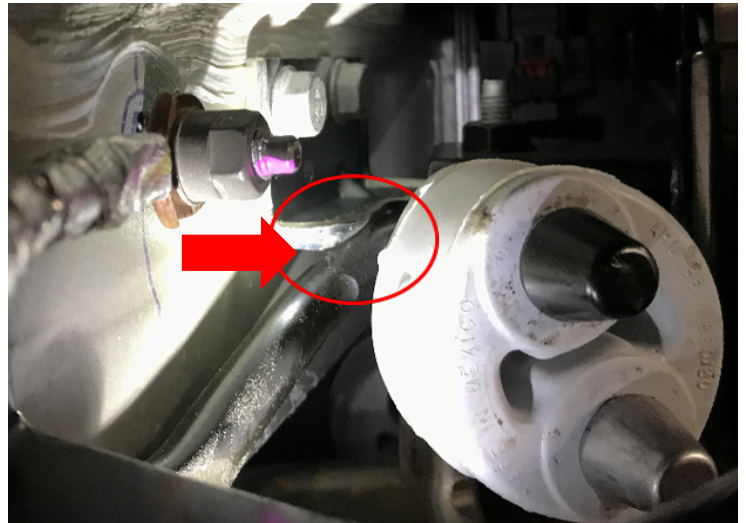
Out of specification or insufficient clearance and contact, of the two components is shown in (fig.2a, 2b). This may contribute to a passenger compartment “dash rattle”.

To correct the clash condition, removal of the exhaust muffler to expose the bracket is best practice. When exposed, loosen the bracket and place a large hex wrench or similar tool as a spacer to the EBCM bracket to maintain a clearance as specified above (fig. 3a) when reassembling.

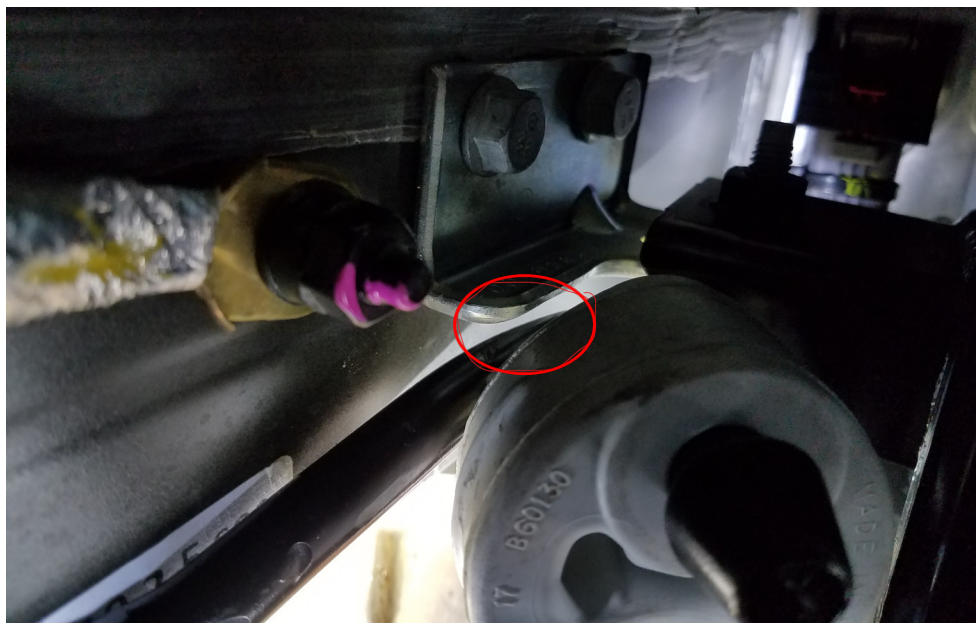
fig. 2c

Proper clearance between the two parts, the exhaust hanger and EBCM bracket is shown (fig.2c).

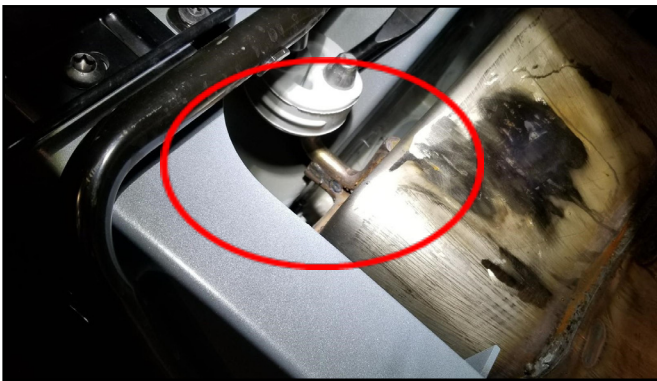
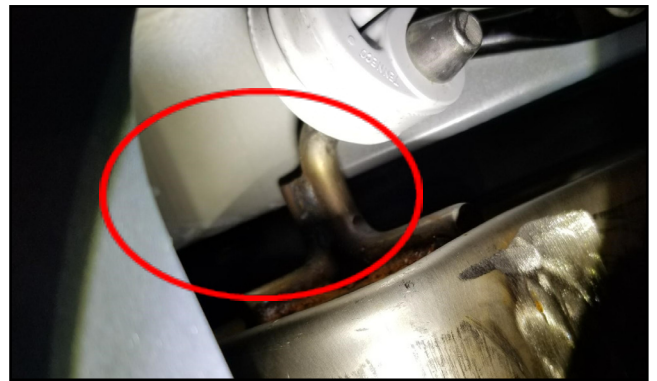
Should this concern present it self on the passenger side as a dash rattle, address the concern in a similar fashion. The exhaust hanger may be in contact with the vehicle frame (fig 4a and 4b). The remedy is to create a 2-5mm gap from the exhaust and the rail to relieve any interference.

There should be 9 mm clearance between the frame and the muffler. To aid in realigning this and ensure proper clearance, loosen the connection of the two side mufflers from the center attachments at the same time and realign them to the center muffler. The muffler should hang in the correct position. If the position is found to be correct, tighten the bracket as in (fig 3b.) and tight the driver side as directed above. The center muffer clamp torque is 55.0 +/- 8 Nm (fig. 4c)
