TECHNICAL BULLETIN 01 MAY 2018

501-14: Handles, Locks, Latches and Entry Systems

Emergency Key Barrel Cover Adrift

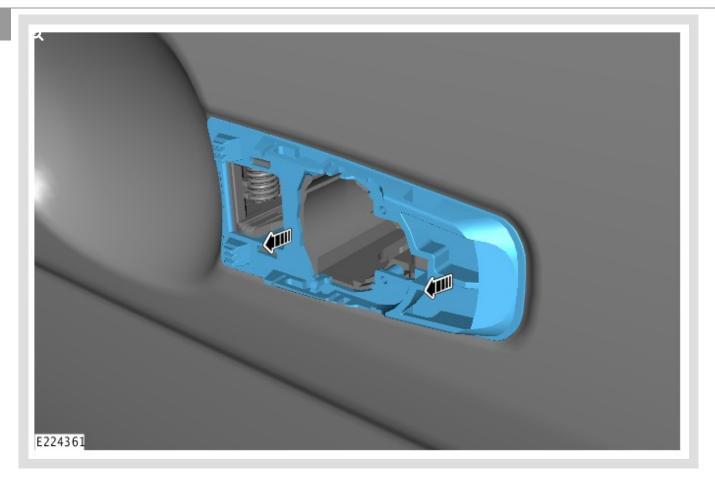
On vehicles with body color emergency key barrel covers, the cover in the driver's door exterior handle may become adrift.

This may be caused by insufficient retaining features on the driver's door exterior handle gasket.

Remove the front left door exterior handle gasket.
