H037NAS4

TECHNICAL BULLETIN

211-03: Steering Linkage

Service Action: Steering Gear Tie-Rod End Ball Joints

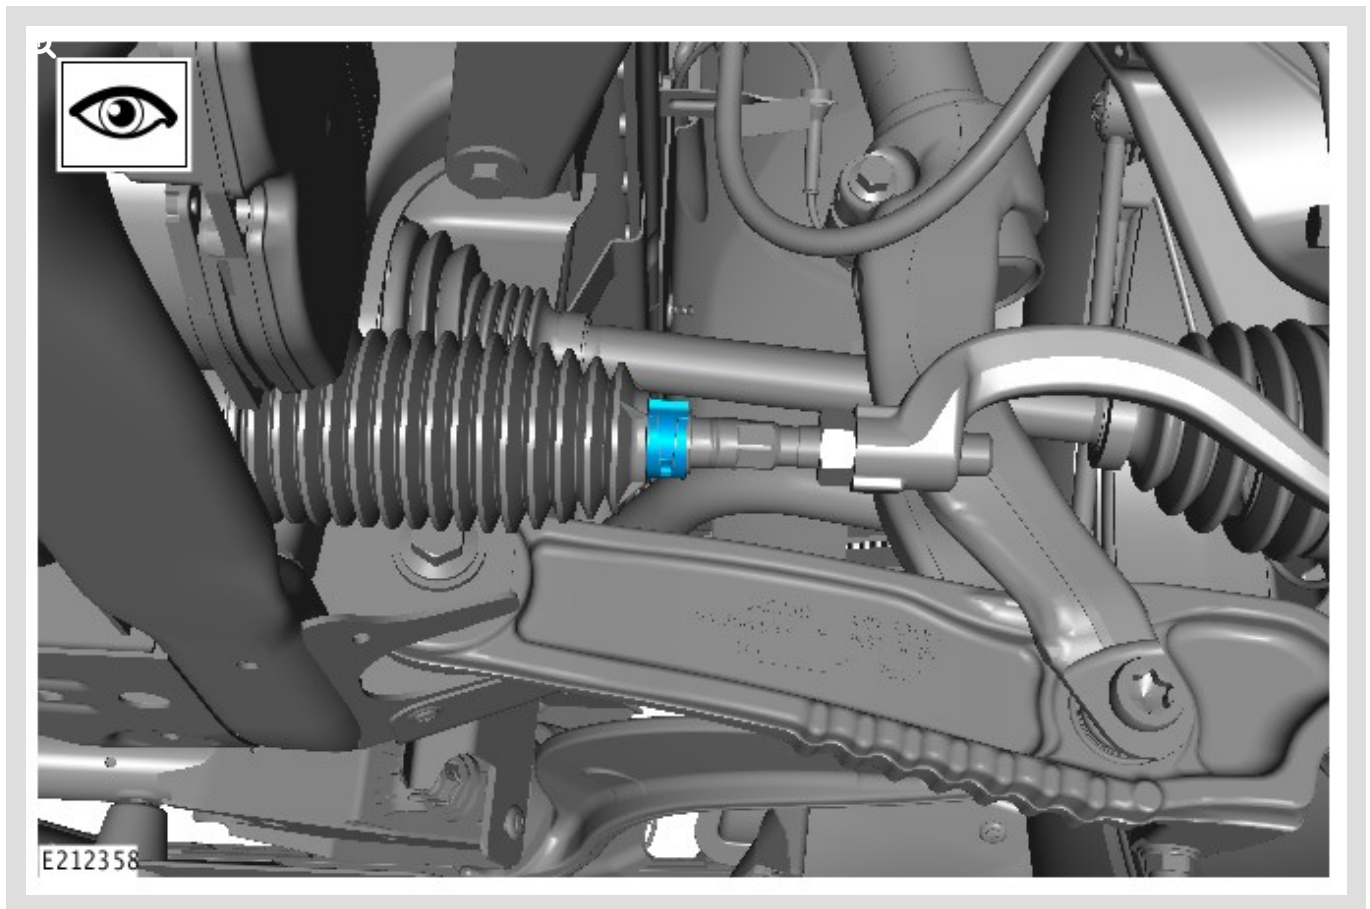
2

Right tie-rod shown; left tie-rod similar.

Inspect the tie-rod bellow clamp for a yellow paint mark indicating that the repair has previously been completed.

- If the identification mark is present, **go to Step 6.**
- If the identification mark is not present, **go to Step 3.**
