H114 UPS4118-1bNAS1

TECHNICAL BULLETIN

418-02: Wiring Harnesses

Update Prior to Sale: Unsealed Splices on Rear Axle and Cabin Harness

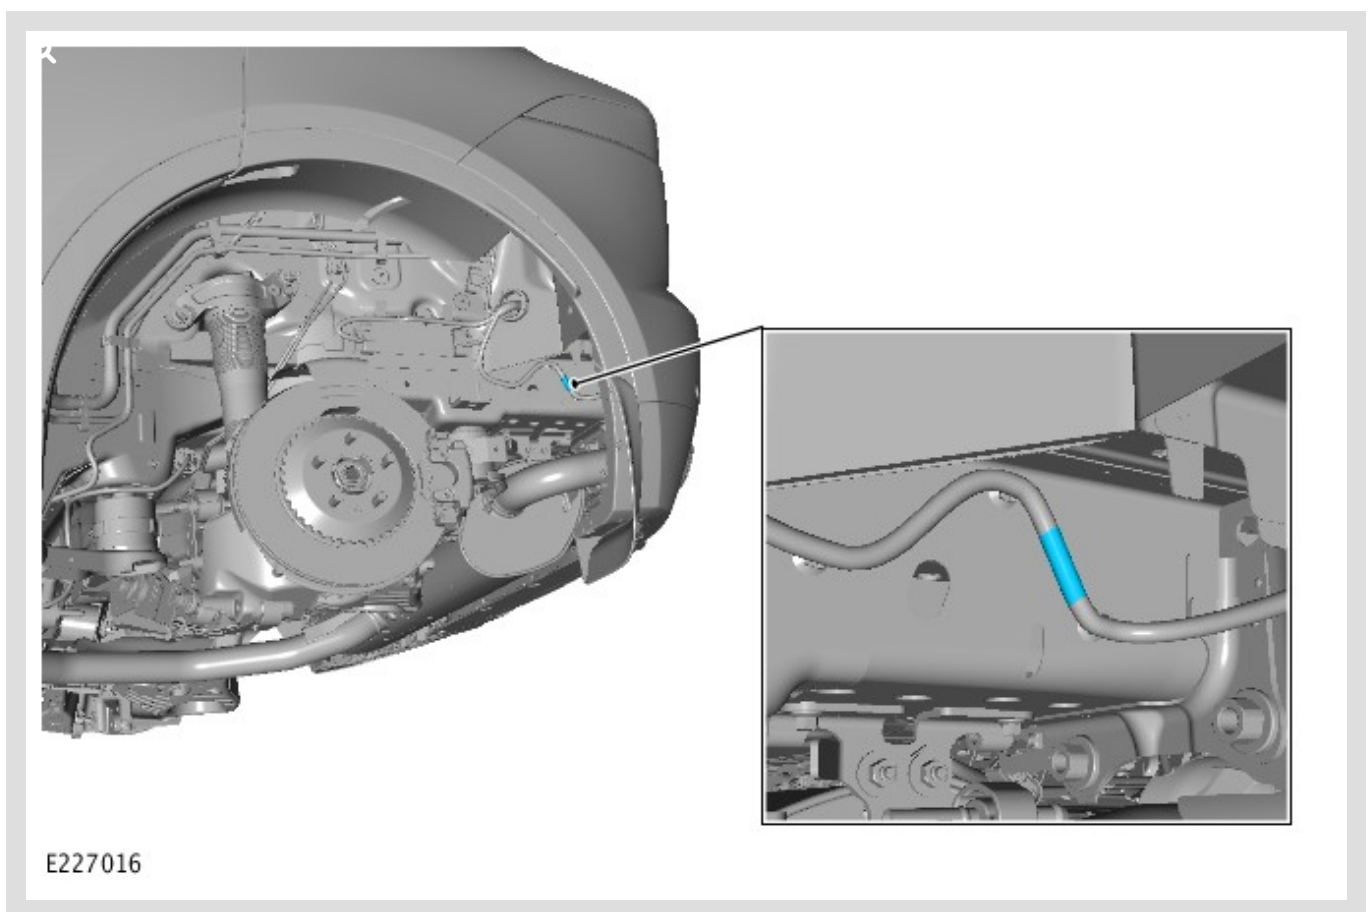
2

Unwrap the body wiring harness protection and access the body wiring harness located in the area shown.

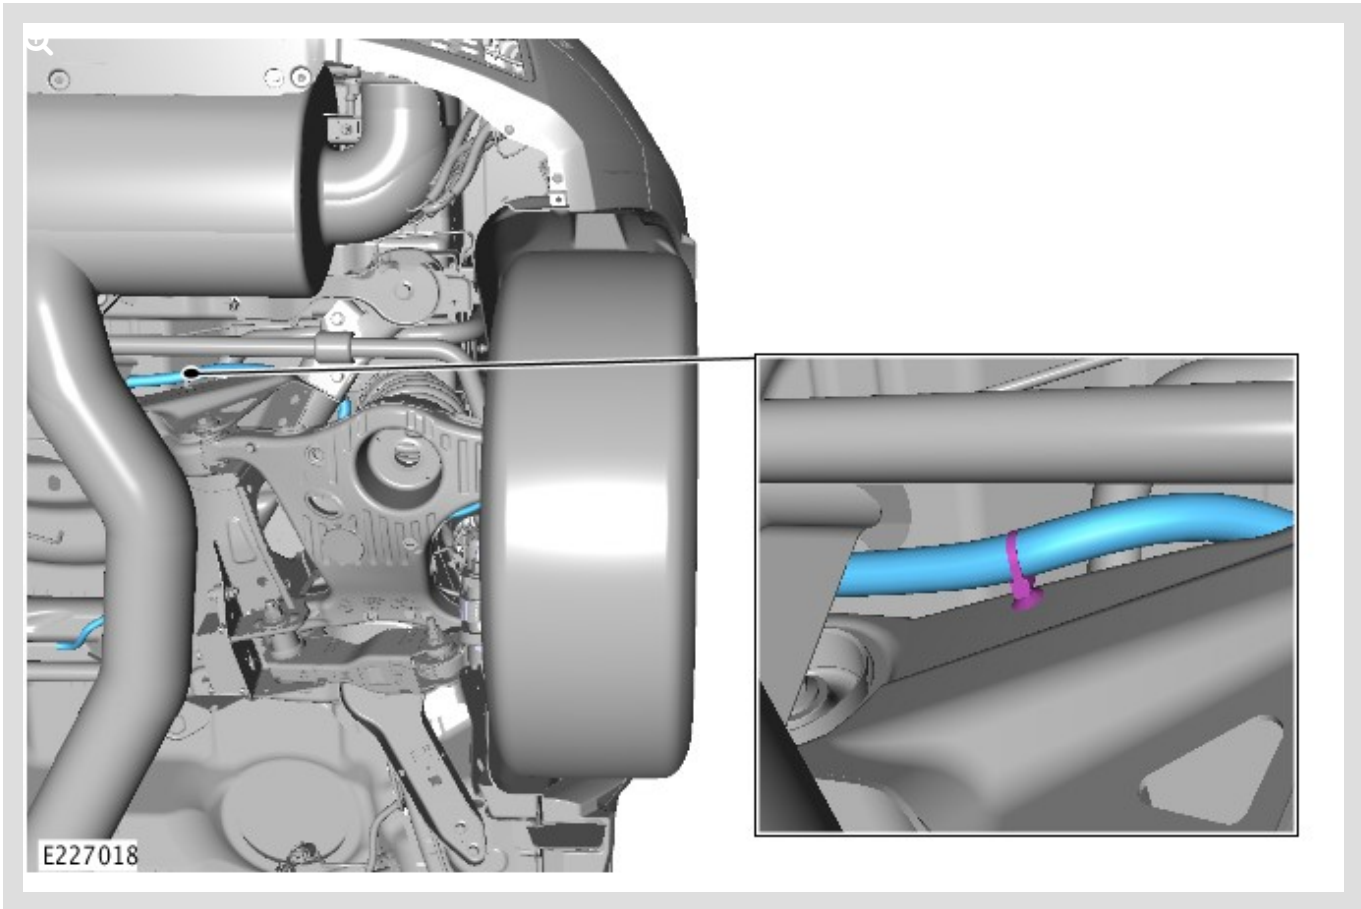
6

Locate the rear axle wiring harness.

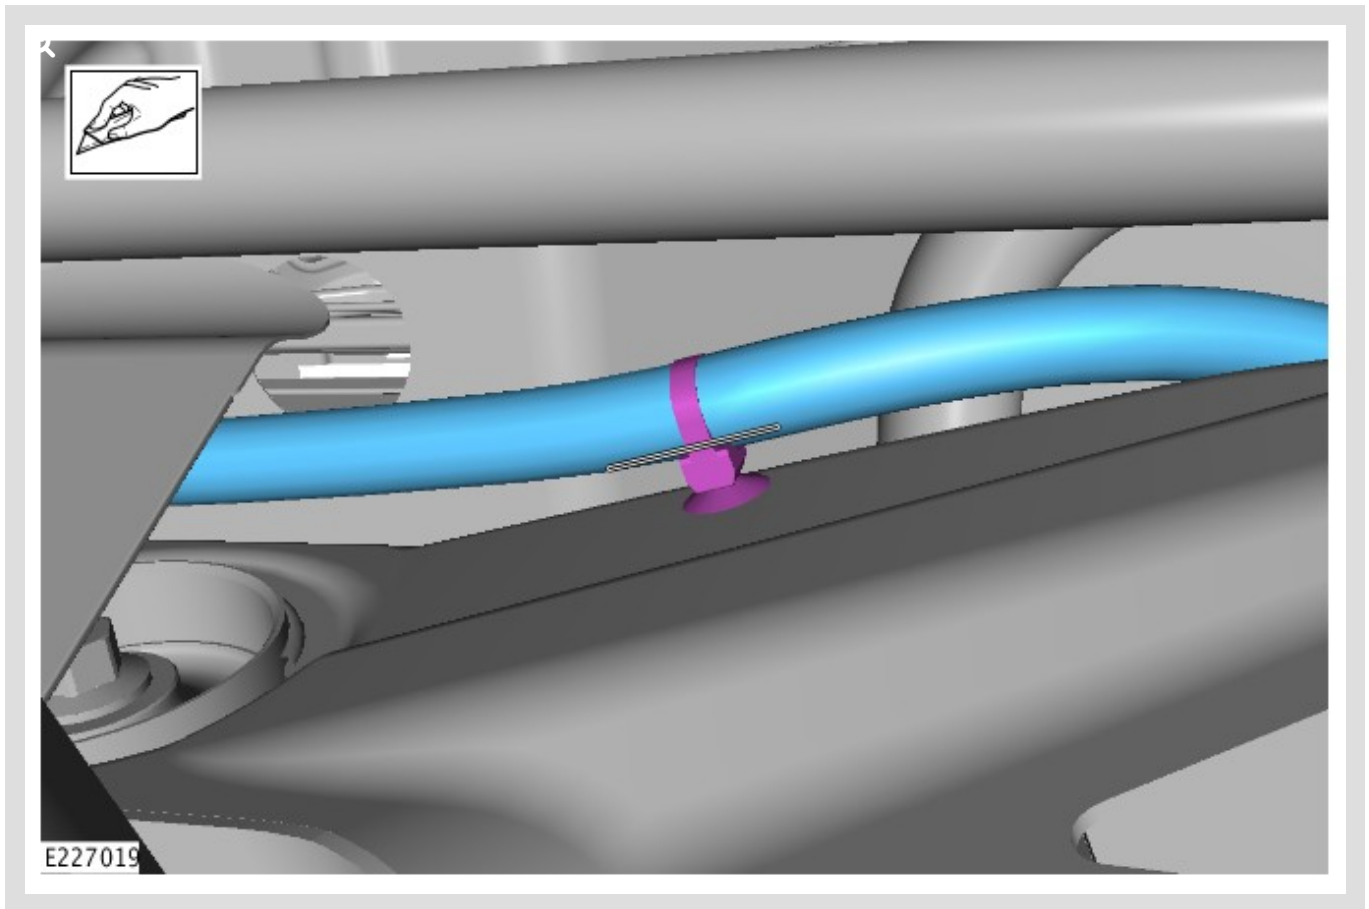
7

Access the rear axle wiring harness.

- 1 Cut the cable tie.
- 2 Remove the axle wiring harness protection.

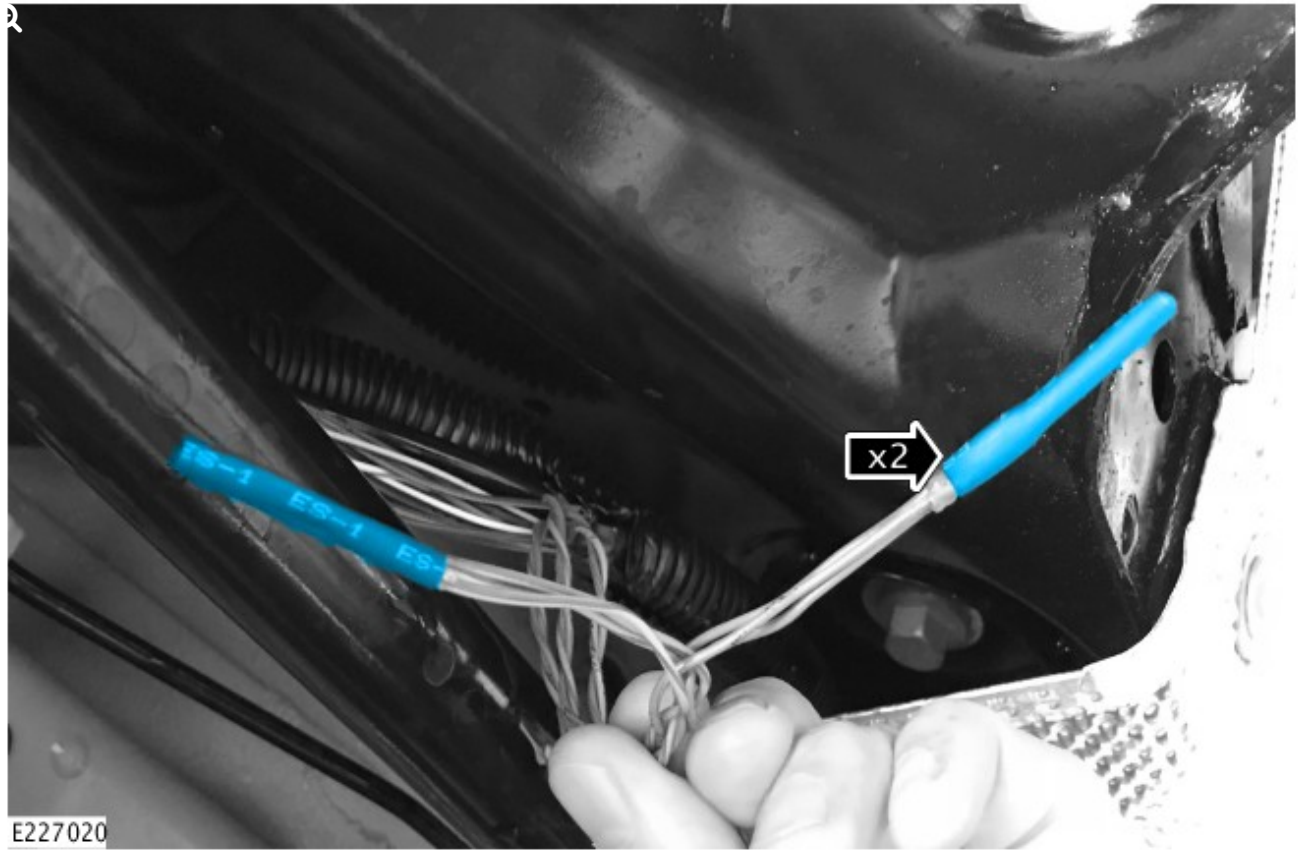
8 Locate splices **S4DB26GD**, **S4DB25GD**, **S4DB26GE**, and **S4DB25GE** (see TOPIx section Electrical Information - Electrical Wiring Diagrams - 205-02: Rear Drive Axle and Differential:).

Apply heat shrink to splices as shown:

- 1 S4DB26GD and S4DB25GD**
- 2 S4DB26GE and S4DB25GE**
- 3** Apply electrical tape.
- 4** Install the body wiring harness protection.
