H115NAS1

TECHNICAL BULLETIN

418-02: Wiring Harnesses

Service Action: Left Hand Drive (LHD) Engine Wiring Harness Not Secured

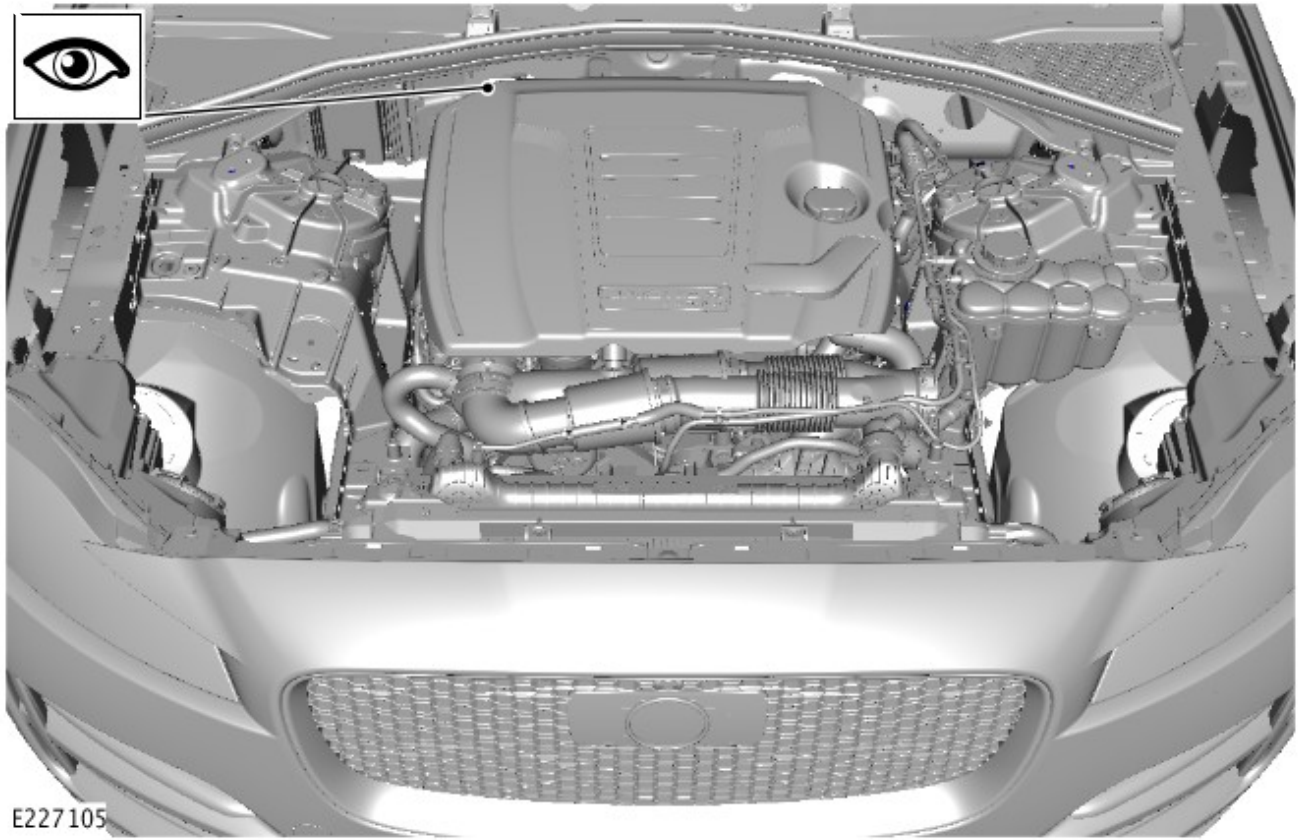
1

An issue has been identified on a limited number of vehicles within the listed Affected Vehicle Range where the underhood/engine compartment harness may not be secured, which could lead to abrasive damage and electrical faults.
