## JTB00527NAS3 TECHNICAL BULLETIN 23 MAY 2018

415-01: Information and Entertainment Systems

Disc Does Not Eject From The Digital Disc Player

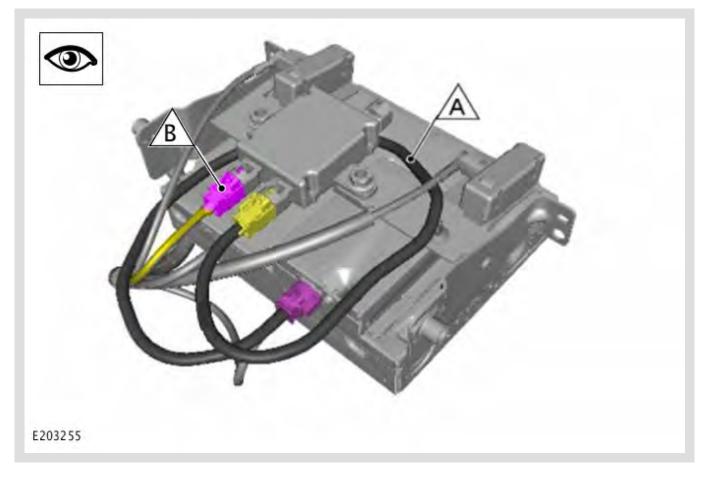
Visually inspect the wiring harness **A**.

- If the wiring harness is routed as shown, do not replace the harness.
  - Unplug connector 'B' and go to Step 39.
- If the wiring harness is not routed as shown, go to Step 29.
