# TECHNICAL BULLETIN 23 MAY 2018

415-01: Information and Entertainment Systems

Disc Does Not Eject From The Digital Disc Player

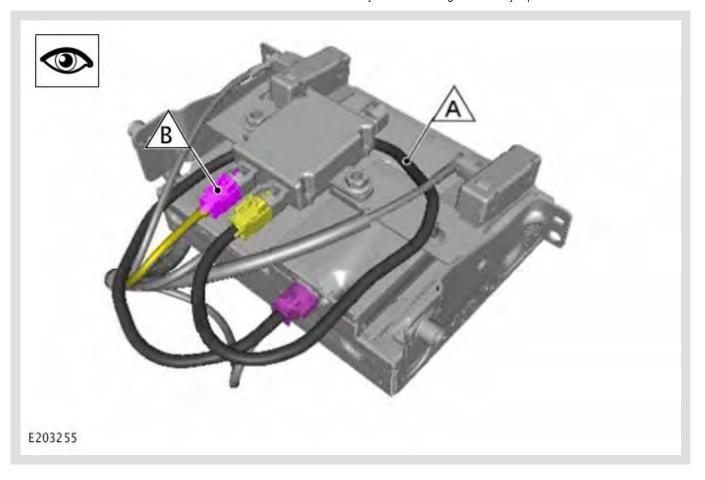
Visually inspect wiring harness 'A'.

- If the wiring harness is routed as shown, do not replace the harness.
  - Unplug connector 'B' and go to Step 32.
- If the wiring harness is not routed as shown, go to Step 22.
