MODEL
2017MY
Sportage (QL)
Cadenza (YG)

NUMBER
078

TECHNICAL SERVICE BULLETIN

SUBJECT: SERVICE ACTION: HECU BOLTS INSPECTION AND/OR REPLACEMENT OR HECU ASSEMBLY REPLACEMENT (SA287)

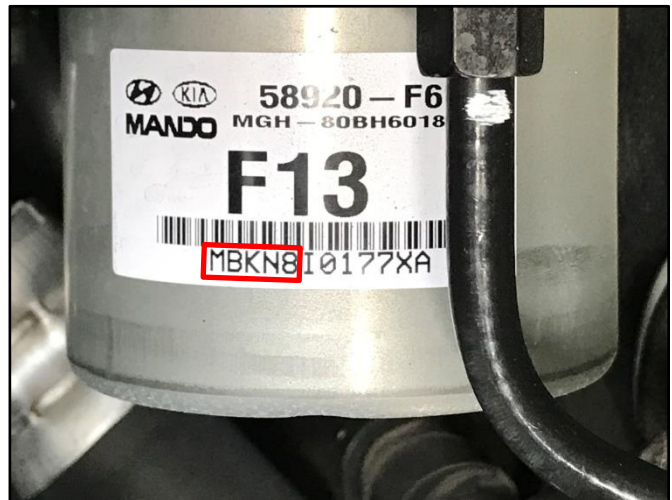
1. Check the HECU Lot number (first 3 digits) and Production Line number (4th and 5th digits). See table below.

Lot & Production Line Number shown is for demonstration purposes only.

Example shown: 2017 February 11

If the Lot and Production Line number is included in the affected range, replace the module mounting bolts. If the mounting bolts are damaged, replace the HECU assembly.

If the Lot and Production Line number is not in the affected range, inspect but do not replace the module mounting bolts. If the mounting bolts are damaged, replace the HECU assembly.

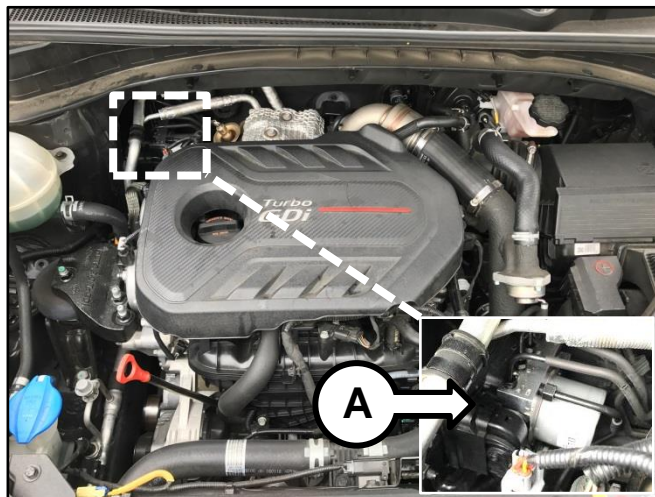
1. Locate the HECU (A). The location of the HECU is the same for both 2.0T and 2.4L on QL vehicles.

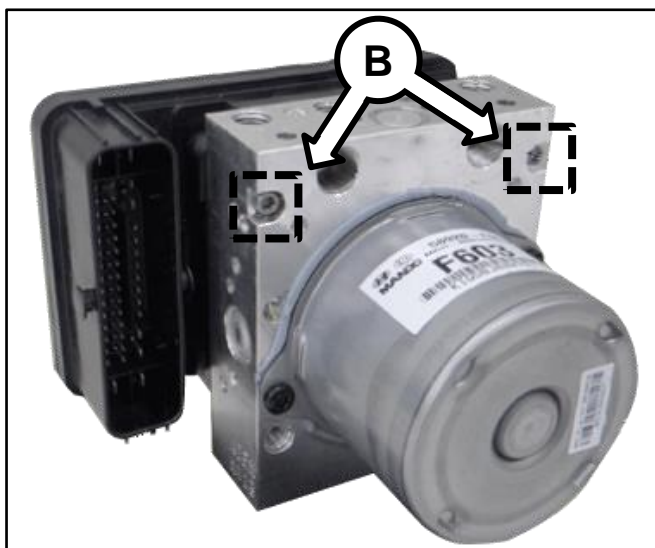
2. Inspect the two (2) HECU module mounting bolt heads (B) for any damage.

If either of the two (2) bolt heads is damaged or missing, replace the HECU assembly by referring to "Brake System → ESP (Electronic Stability Program) System → ESP Control Module → Repair procedures" chapter in the applicable Shop Manual.

If both bolts appear to be in good condition, proceed to the next step.

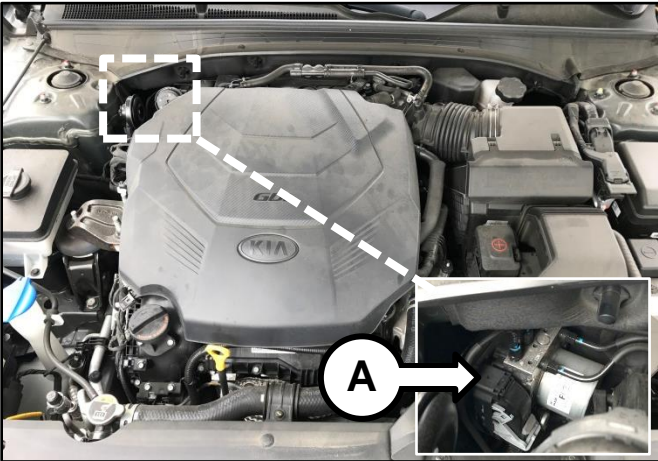
1. Locate the HECU (A).

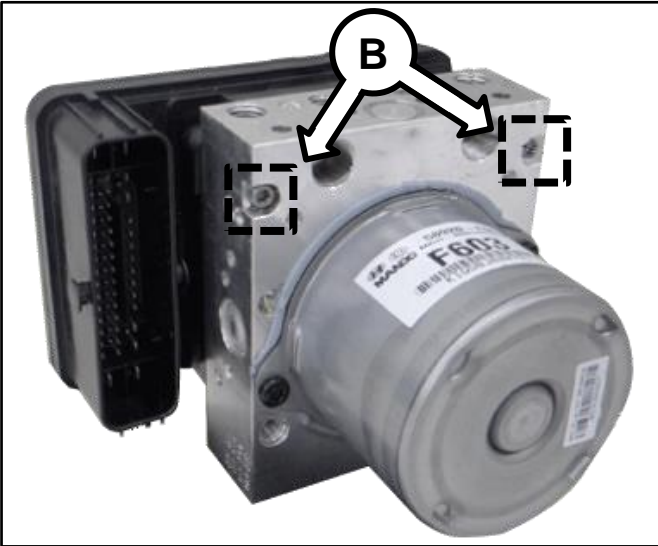
2. Inspect the two (2) HECU module mounting bolt heads (B) for any damage. If either of the two (2) bolt heads is damaged or missing, replace the HECU assembly by referring to “Brake System → ESP (Electronic Stability Program) System → ESP Control Module → Repair procedures” chapter in the applicable Shop Manual.

If both bolts appear to be in good condition, proceed to the next step to replace the two (2) HECU module mounting bolts (B).
