GROUP ELE	MODEL 2017-2018MY Niro (P/HEV)
	NUMBER 146	DATE May 2018
<b>TECHNICAL SERVICE BULLETIN</b>		
SUBJECT: SERVICE ACTION: FRONT WIRING HARNESS SECURING AND/OR REPAIR (SA343)

This bulletin provides information to secure and/or repair the front wire harness on some 2017-2018MY Niro (DE P/HEV) vehicles, produced from November 1, 2016 through April 26, 2018, which may exhibit a dash warning light(s) ON while driving, due to interference or damage from the harness rubbing against the lower steering shaft universal joint. Kia is requesting the completion of this Service Action on all affected vehicles prior to delivery. Before conducting the procedure, verify that the vehicle is included in the list of affected VINs.

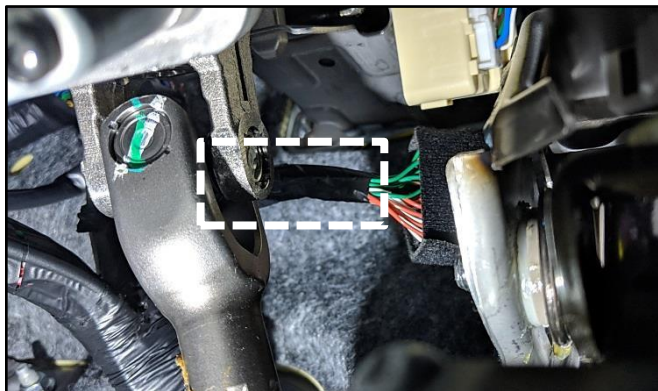
1. Locate the front cabin wiring harness interference area with the lower steering universal joint, shown above the brake pedal. Thoroughly inspect the wire harness for damage.

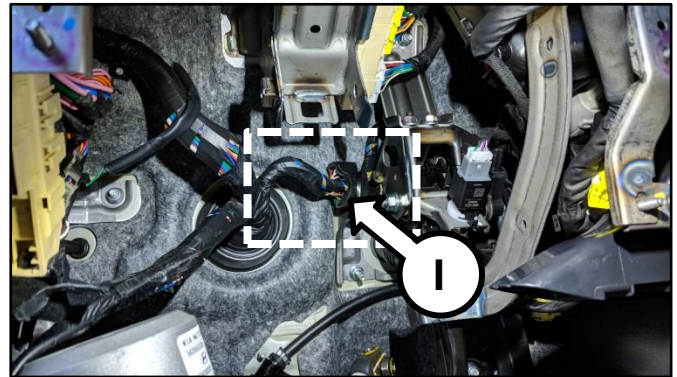
- Ensure enough space is available to access and repair the damaged front harness (I).

**Requirement:** Take one (1) KVID photo showing the damaged copper wire(s).
