MODEL  
2017-2018MY  
Cadenza (YG)

NUMBER  
188

SUBJECT: SERVICE ACTION: ELECTRIC THERMOSTAT  
ASSEMBLY REPLACEMENT (SA346)

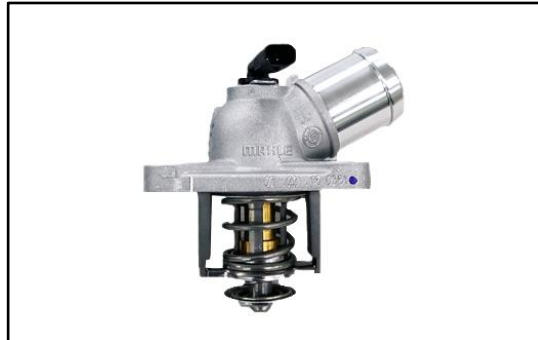
This bulletin provides the procedure to replace the electric thermostat (ECT) assembly on some 2017-2018MY Cadenza (YG) vehicles, produced from January 6, 2016 through August 10, 2017, which may exhibit a Malfunction Indicator Light (MIL) illuminated with one or more DTCs as listed below. To correct or prevent this concern, follow the procedure outlined in this bulletin to replace the ECT assembly. Before conducting the procedure, verify that the vehicle is included in the affected VIN list.

**P0128: Coolant Temperature Below Threshold Value**  
**P0597: Thermostat Heater Control Circuit Open**  
**P0598: Thermostat Heater Control Circuit Low**  
**P0599: Thermostat Heater Control Circuit High**
