Symptom - Body Exterior - Filler Flap is Jammed/Stuck: Reworking top centering bar on tank module (SY 32/18)

Model Line: **Panamera (97C) – Sport Turismo**

Model Year: **2018**

Subject: **Tank module**

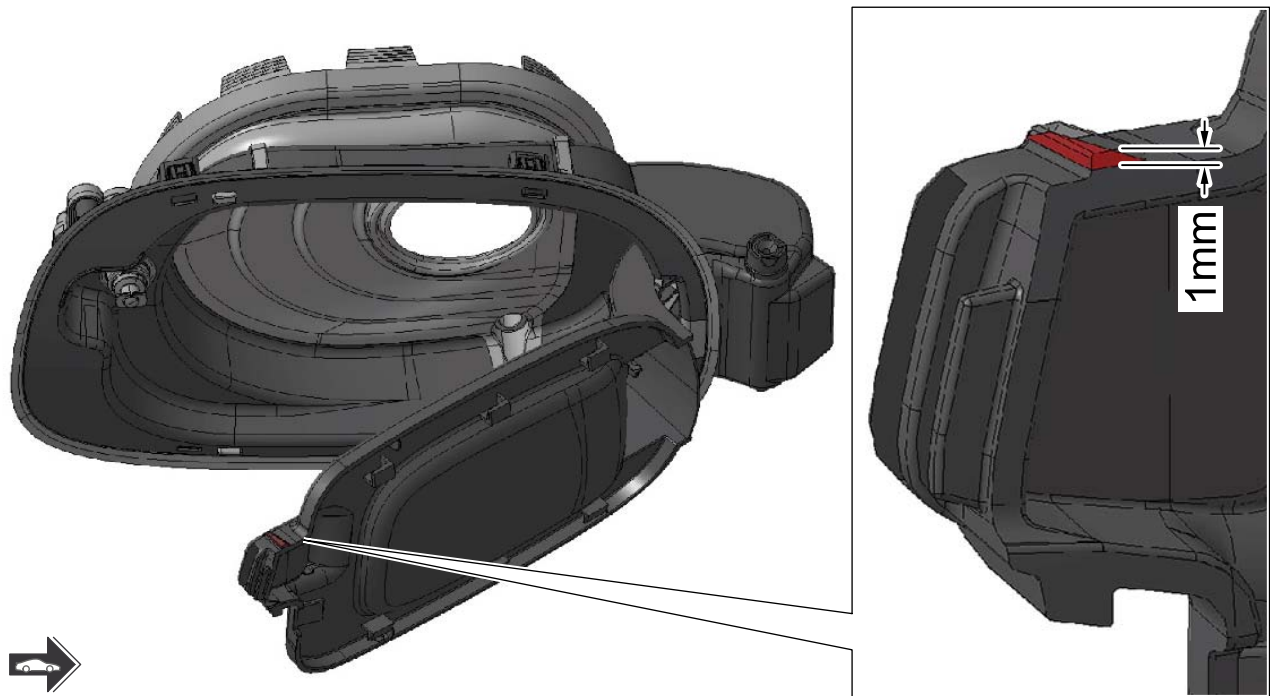
Symptom: The filler flap is difficult to open or close.

Cause: The gap dimension between the tank cap and seal may be too small, making it difficult to open or close the tank cap.

Reworking top centering bar on tank module

2.1 Remove 1 mm from the **top** centering bar using a suitable tool.
