Symptom - Body Exterior - Filler Flap/Charge Port Door is Jammed/Stuck: Replacing filler flap/charge port door (SY 49/18)

Vehicle Type: **Panamera (97A/97B)** Sedan (not Sport Turismo models)

Model Year: **As of 2017 up to 2018**

Subject: **Filler flap/charge port door**

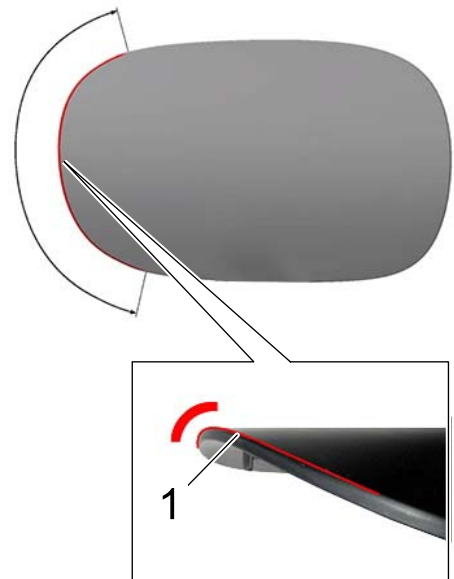
(Edge on filler flap/charge port door)

- There may be a visible and palpable edge on the upper side of the new filler flap/charge port door. In this case, remove the edge in the area marked in red ⇒ *(Edge on filler flap/charge port door)-1-* using suitable sandpaper.
