**Panamera 4 E-Hybrid (971) Cooling System Fault POC4A00**

Model	Model Year	Model Type	VIN Range	Vehicle-Specific Equipment
Panamera 4 E-Hybrid	2018	971	N/A	N/A

Revision	Release Date	Changes
0	May 24, 2018	Original document

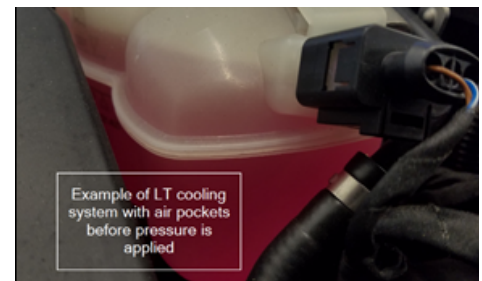
Figure 1

The coolant pump for the high voltage battery actively monitors its own speed and current consumption. For a given commanded speed, if the actual pump speed exceeds a defined value and the current consumption drops below a certain threshold, a dry run condition is detected. The pump communicates this to the high voltage battery control unit and fault code POC4A00 is stored. One possible cause of this is air in the low temperature cooling system. This fault can take several hundred miles to set.

- 1) Check for air in the low temperature cooling system:
  - a) With the ignition off and the system cool, remove the cap of the low temperature cooling system reservoir. Observe and record the coolant level in the reservoir.
  - b) Pressurize the low temperature cooling system to 1.0 Bar using the cooling system pressure tester. Record the approximate amount the coolant level dropped when system is under pressure.
  - c) If there is no air in the system, the coolant level will only drop approximately 4 to 7 mm. (This will vary with factors such as system temperature.)
  - d) If while under pressure, the coolant level drops more than approximately 7 mm, there is likely air in the system and it needs to be bled. (See figures 1 and 2.)
