**Countries:** CANADA, UNITED STATES **Document ID:** IK0800538  
**Availability:** ISIS, Fleet!SIS, IsSIR **Revision:** 1  
**Major System:** ELECTRICAL SYSTEM **Created:** 3/10/2017  
**Current Language:** English **Last Modified:** 5/29/2018  
**Other Languages:** NONE **Author:** Charles Schroeder  
**Viewed:** 1558

**Title: ProStar SCR Aftertreatment Harness Replacement****Applies To: ProStar with SCR (ISX and N13)**

The PDM in the Aftertreatment has been updated. When a harness with an old style PDM is replaced with a harness containing the updated PDM the harness installation changes. This article will outline the details of the installation.

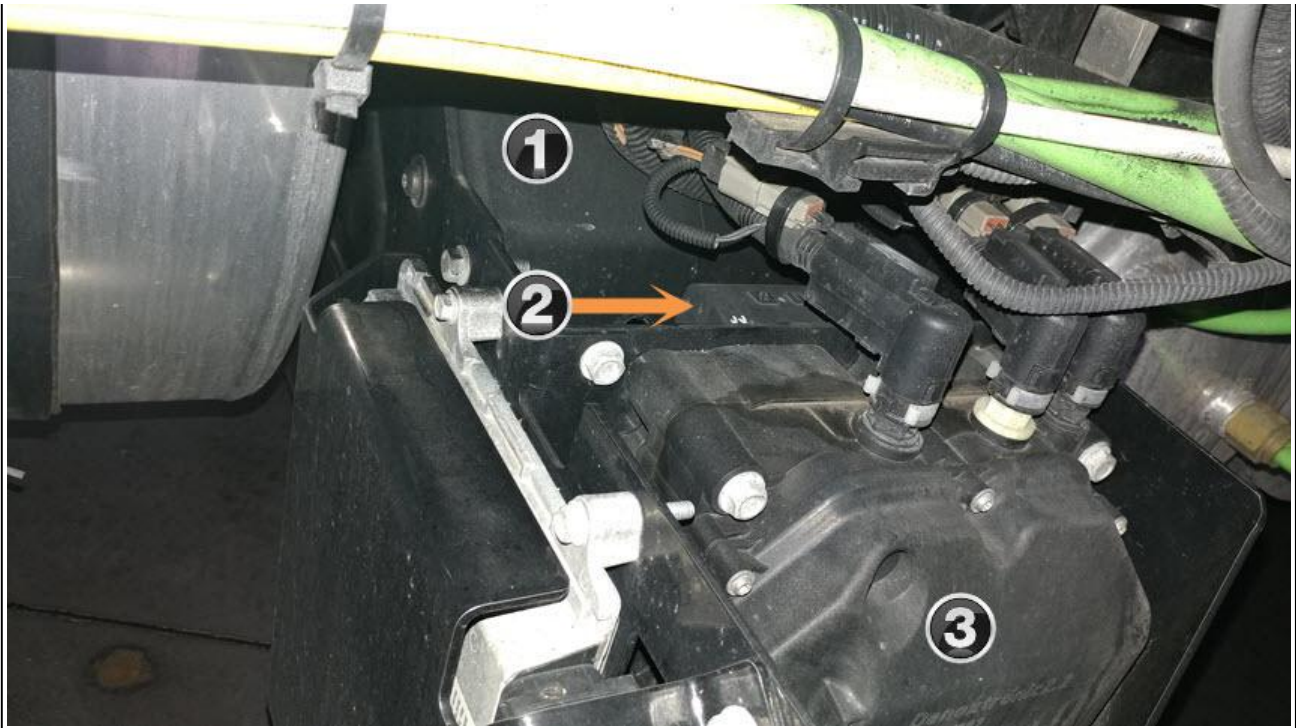
**Figure 1 - PDM Location on Vehicle**

1. DEF Tank
2. PDM Location
3. DEF Supply Pump

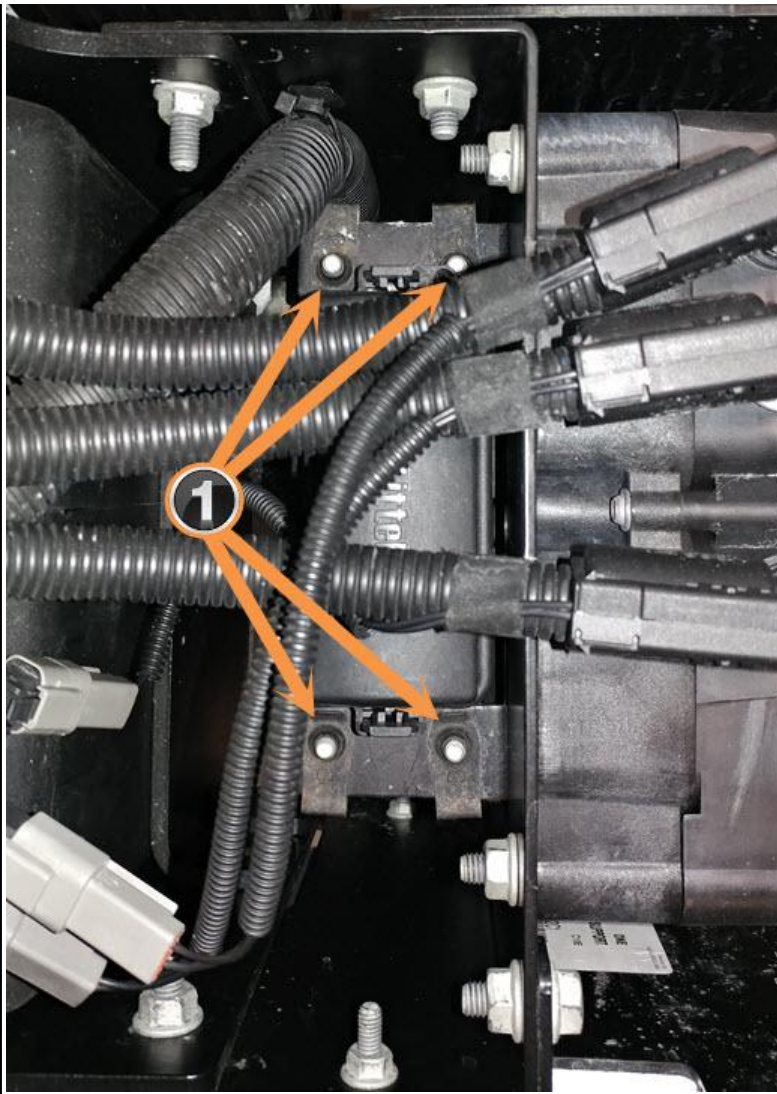
Figure 2 - Old Style PDM Original Mounting

The old style PDM mounts to the bottom of the mounting bracket. The PDM cover locking system on the updated PDM requires the updated PDM is mounted to the top of the mounting bracket. This requires the mounting nut orientation to change. See removal and installation steps below.

1. Original PDM Mounting

1. Use a 10mm wrench or socket to remove the 4 mounting bolts for the PDM (Figure 2)
2. The 4 Extruded U-Nuts (Figure 3) will need to have their orientation flipped 180° vertically

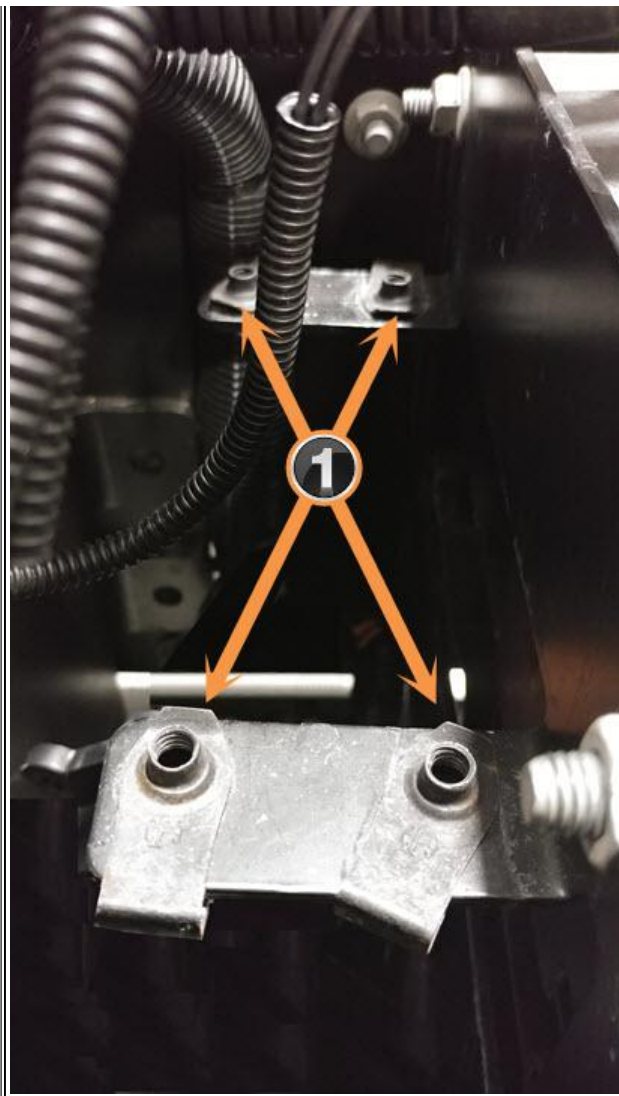
**Figure 3 - Original Orientation of Extruded U-Nuts**

**1. Original Extruded U-Nut Mounting**

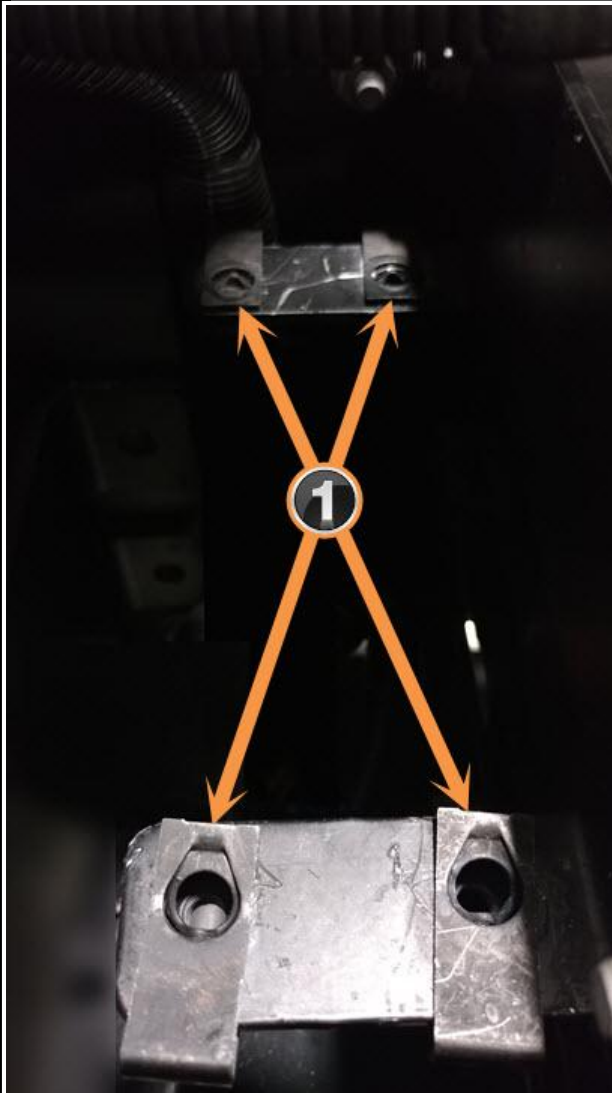
**Figure 5 - Proper Orientation of the Extruded U-Nuts for New PDM**

1. Extruded U-Nut Mounting for new PDM mounting

1. Re-install the Extruded U-Nuts with the orientation shown in Figure 5
2. Install the harness with new PDM on top of the mounting bracket, and install the 4 bolts as shown in Figure 6

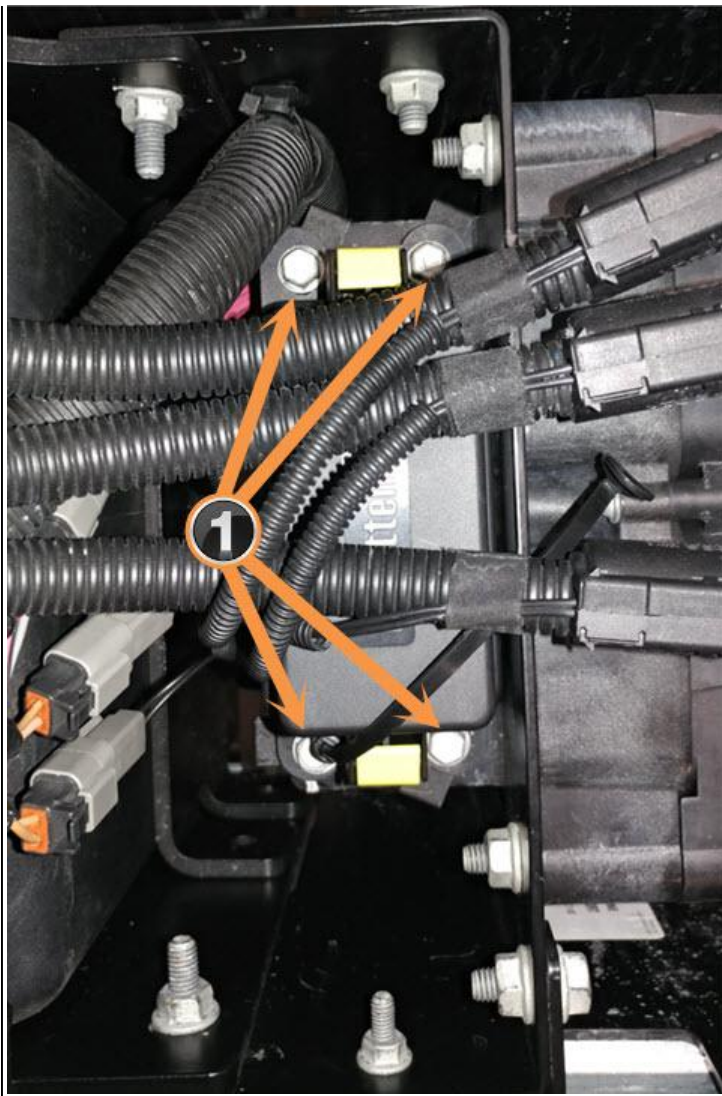
**Figure 6 - Proper Mounting for the New PDM**

**1. New PDM Properly Mounted**

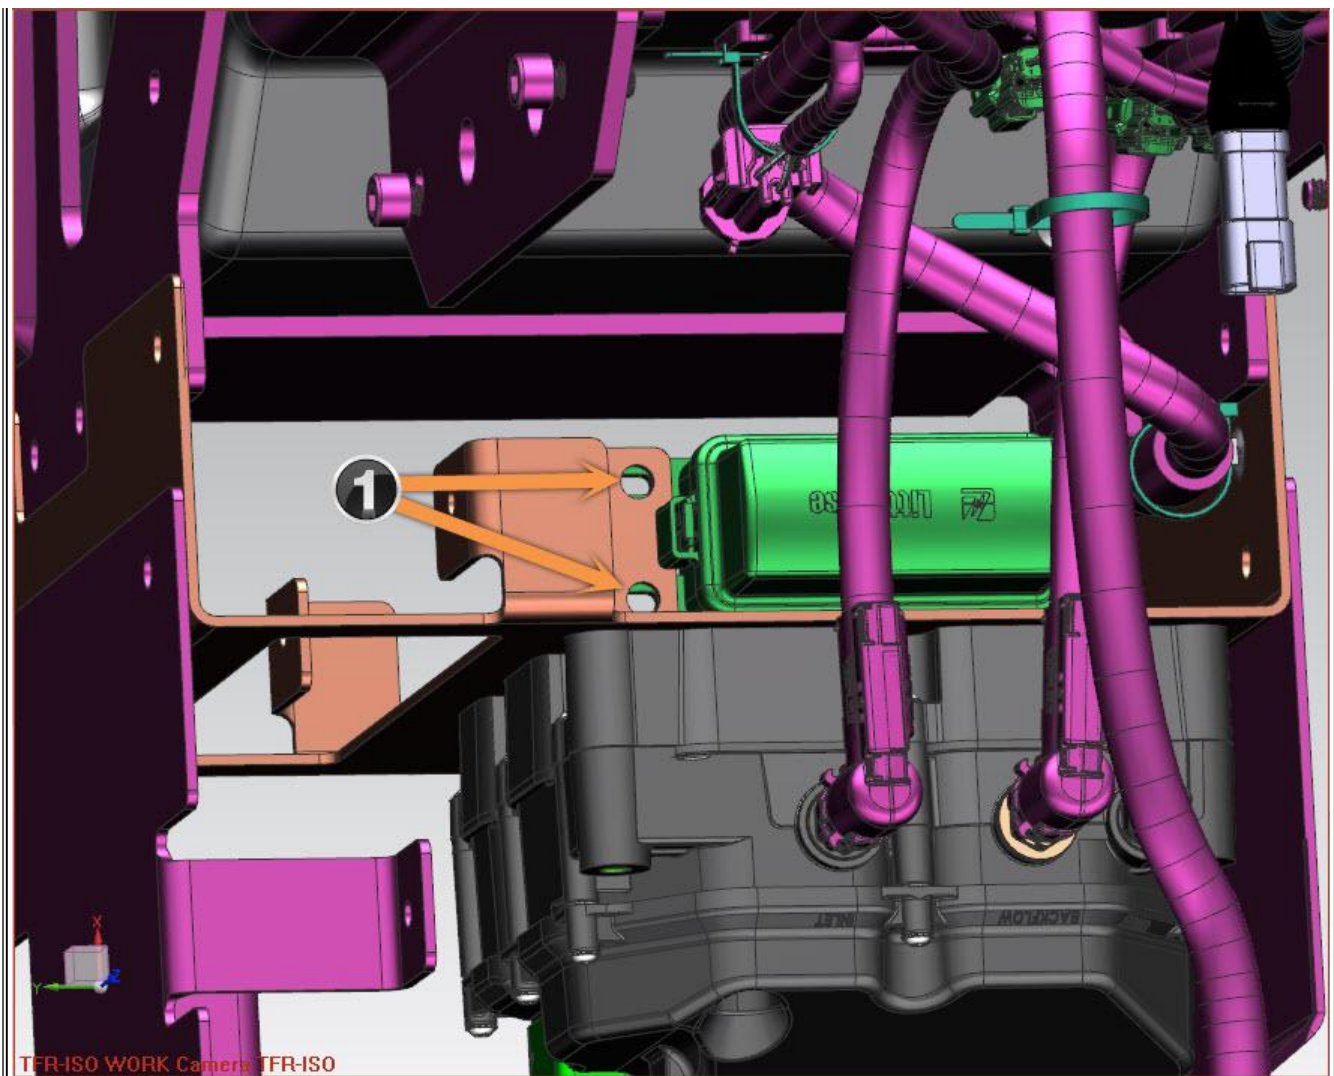
**Figure 7 - Original PDM Mounted Under Bracket**

1. PDM is mounted under the bracket

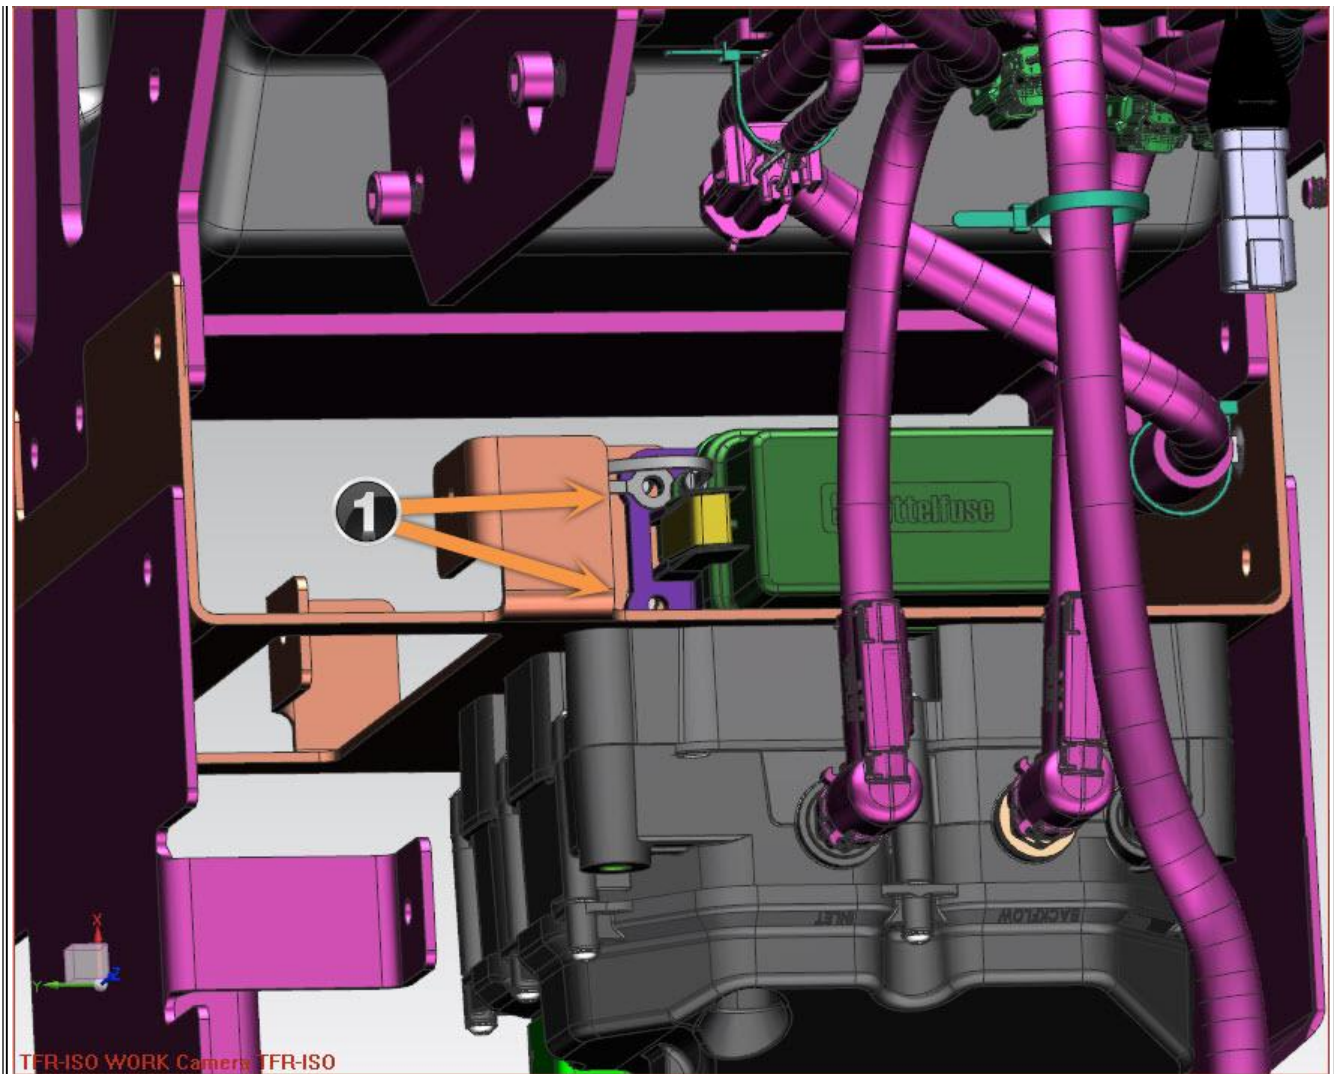
**Figure 8 - Updated PDM Mounted Above Bracket**

1. PDM is mounted above the bracket
