**Countries:** CANADA, UNITED STATES **Document ID:** IK0800565  
**Availability:** ISIS, FleetISIS, IsSIR **Revision:** 1  
**Major System:** ELECTRICAL SYSTEM **Created:** 3/28/2018  
**Current Language:** English **Last Modified:** 5/8/2018  
**Other Languages:** NONE **Author:** Jeff Novak  
**Viewed:** 102

**Title:** Rework Instructions for Feature Code 0012VYL Accessory Wiring for Road Speed

**Applies To:** WorkStar & DuraStar with ISL engine and 0012VYL built between 04/05/2017 and 06/16/2017

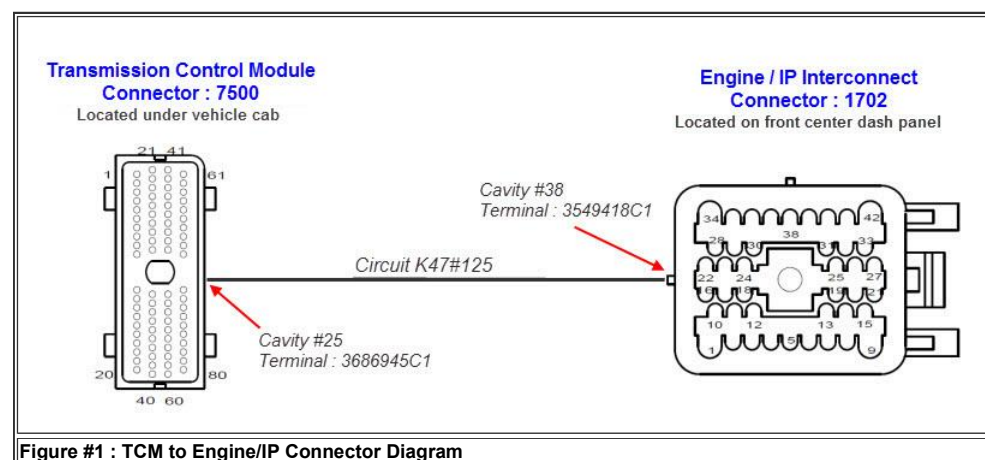
- Feature 0012VYL - Accessory Wiring for Road Speed does not function
- Salt spreader does not work

Step 1- Referencing the diagram below run 18ga wire from the TCM connector to the Engine/IP connector (Figure #1)

Step 2 - Disassemble the TCM connector and install the terminal on the wire end of the new circuit. Properly pin the terminal into cavity #25.

Step 3 - Disassemble the Engine/IP connector and install the terminal on the wire end of the new circuit. Properly pin the terminal into cavity #38.

Step 4 - Reconnect both connectors and secure the new circuit with wire ties.
