Title: Cummins ECM Programming Procedure for LT, HV, MV

Applies To: Cummins equipped LT, HV, MV

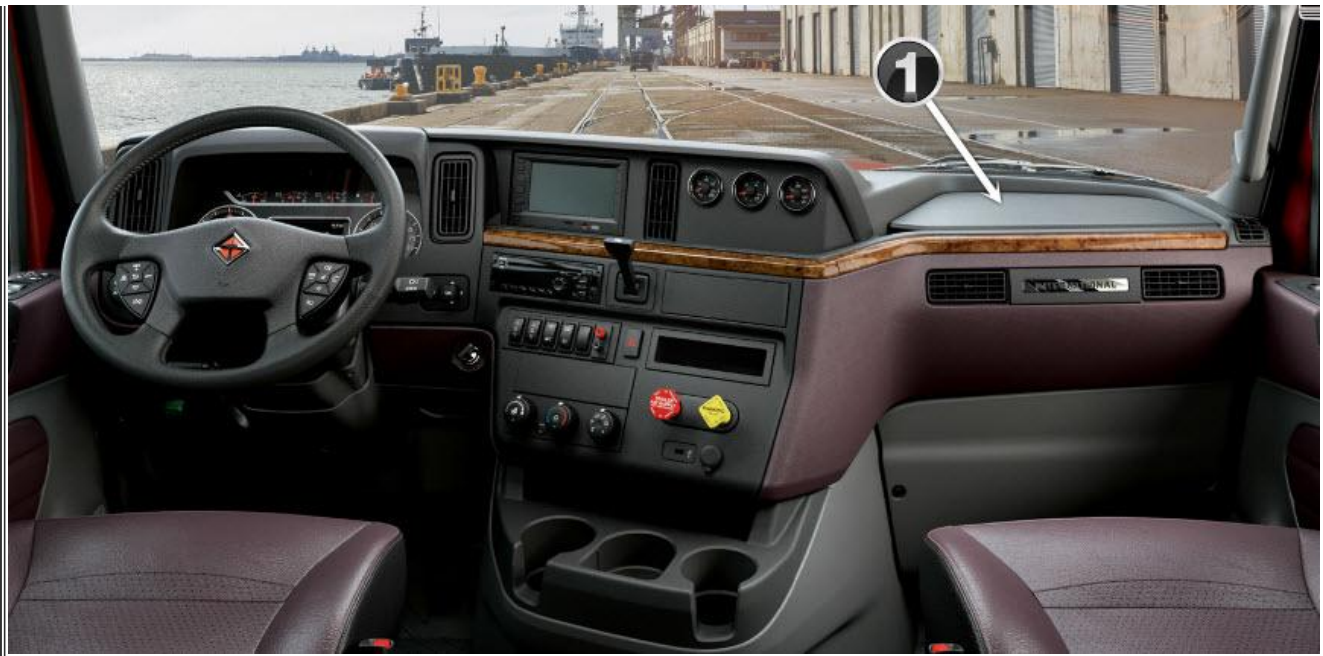
Figure 1 - Fuse Panel Location

1. Fuse Panel Cover

1. Remove the fuse panel cover located at the top of the dash on the passenger side of the vehicle.
2. Reference the fuse panel graphic and locate the fuse locations for **Driver Side Window/Door/Mirror** and **Passenger Side Window/Door**
3. Remove both fuses
4. Connect the the ECM using the vehicle 9-pin diangostic connector
5. Update the ECM calibration with INSITE
6. Once all programming is complete disconnect the service tool from the vehicle 9-pin diagnostic connector
7. Re-install fuses for Driver Side Window/Door/Mirror and Passenger Side Window/Door
