Reference	SSM73671
Models	F-PACE / X761 F-TYPE / X152 XE / X760 XF / X260
Title	Ingenium I4 2.0L Petrol Air Intake Elbow Air Leak
Category	Engine
Last modified	19-Apr-2018 00:00:00
Symptom	499000 Basic Engine
Attachments	1D7a Aj20P Throttle intake Elbow - SSM.pdf

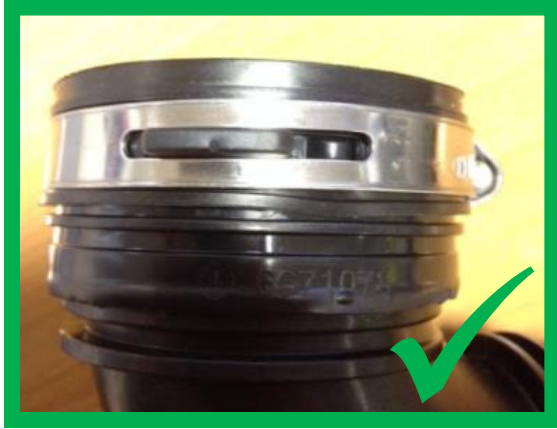
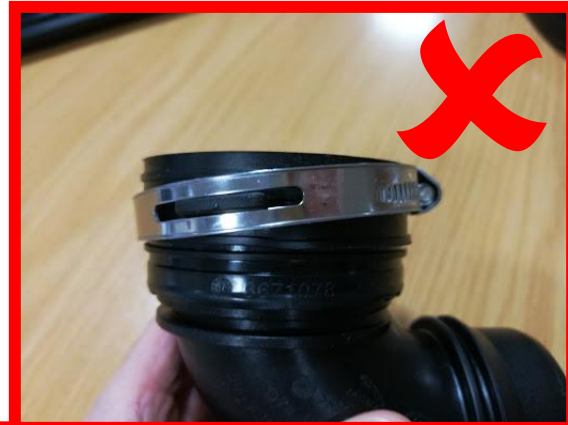
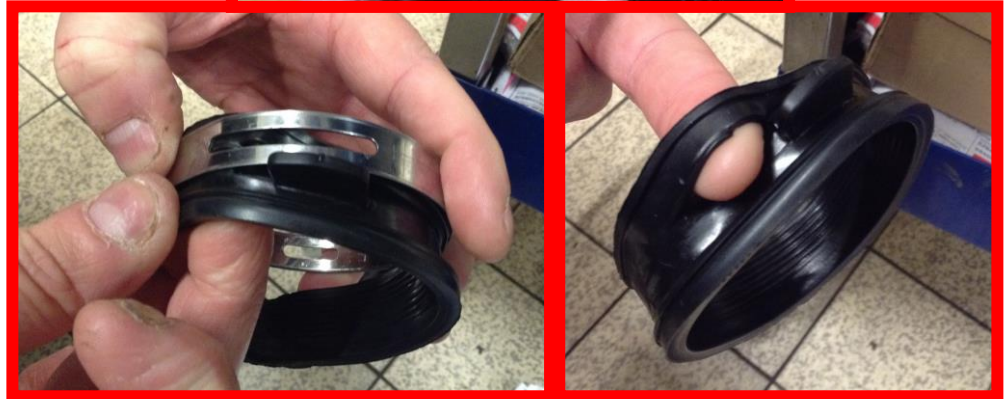
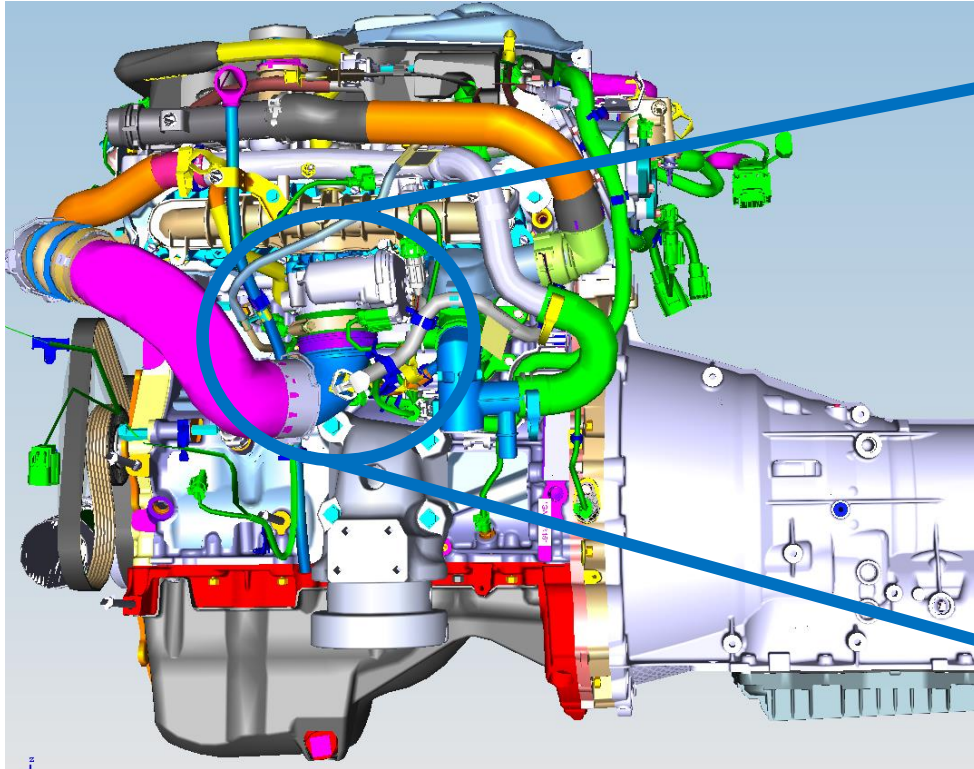
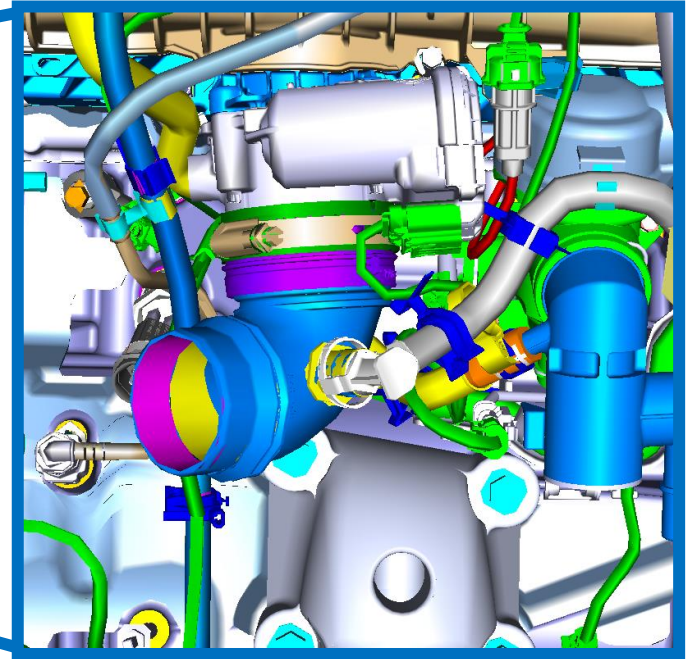
The air intake elbow below the throttle body may be been incorrectly fitted to the vehicle. This results in an air leak within the air intake system.

- Refer to attachment for details of correct and incorrect fitting of the air intake elbow.
- Check the intake elbow for correct fitment to the throttle body using the JLR approved smoke tester Jaguar Land Rover high pressure diagnostic leak detector (Part Number 95-0106).
