Reference	SSM72620
Models	F-PACE / X761
Title	X761 F-Pace Sliding roof panel inner cover both left and right hand side.
Category	Body
Last modified	20-Apr-2018 00:00:00
Symptom	107000 Interior Trim
Attachments	1SunroofSSM X761.pdf 2SunroofSSM X761.pdf

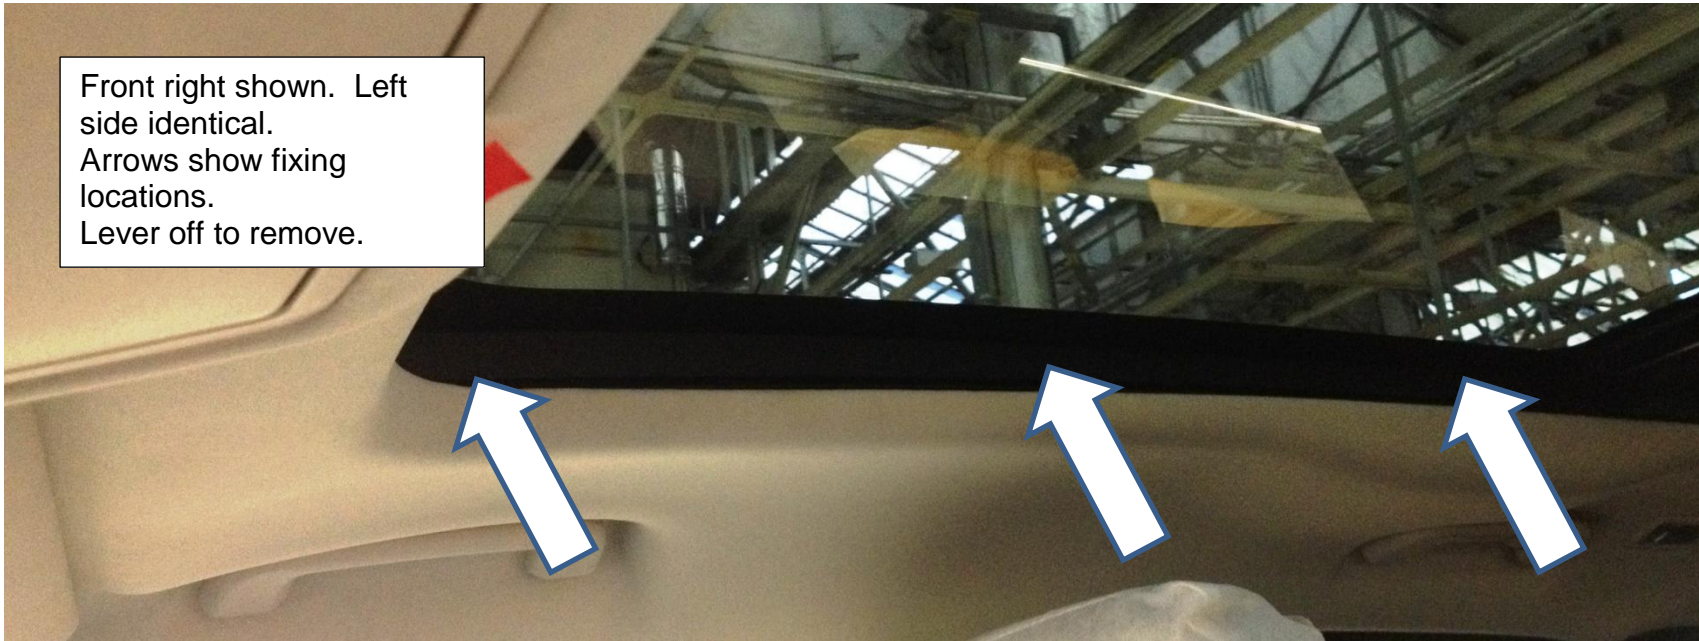
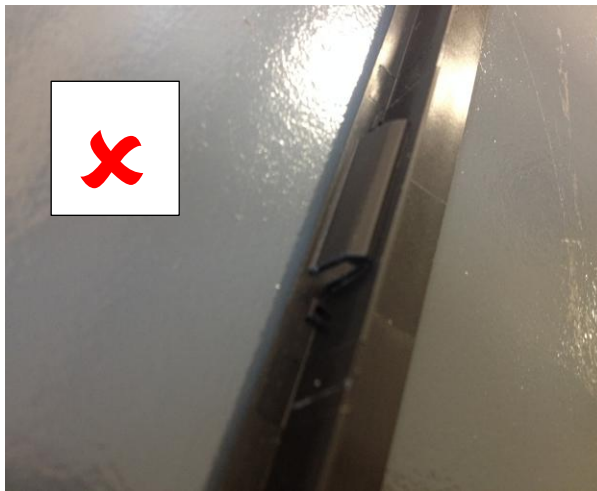
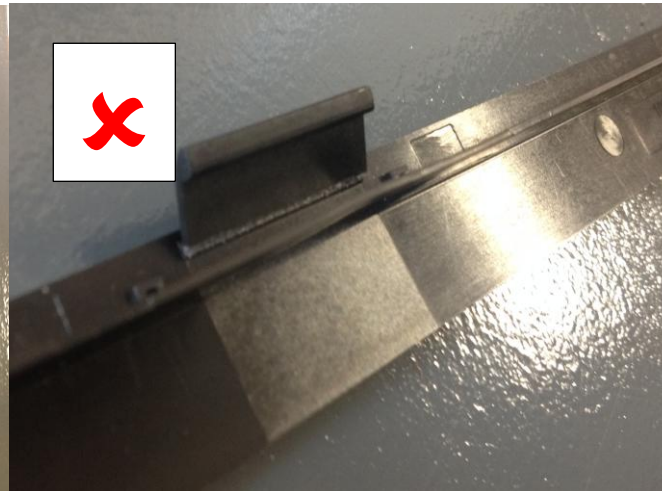
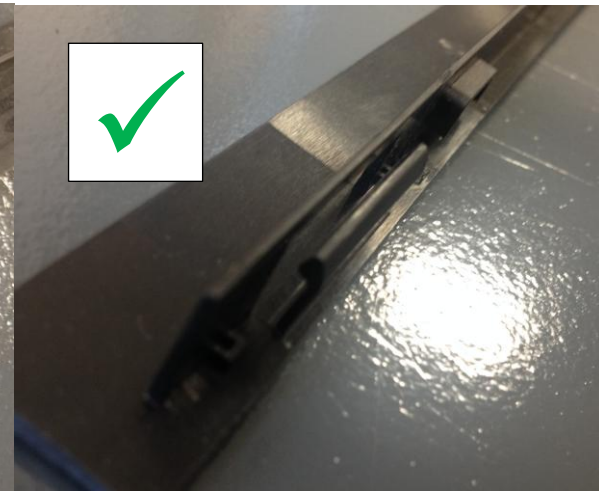
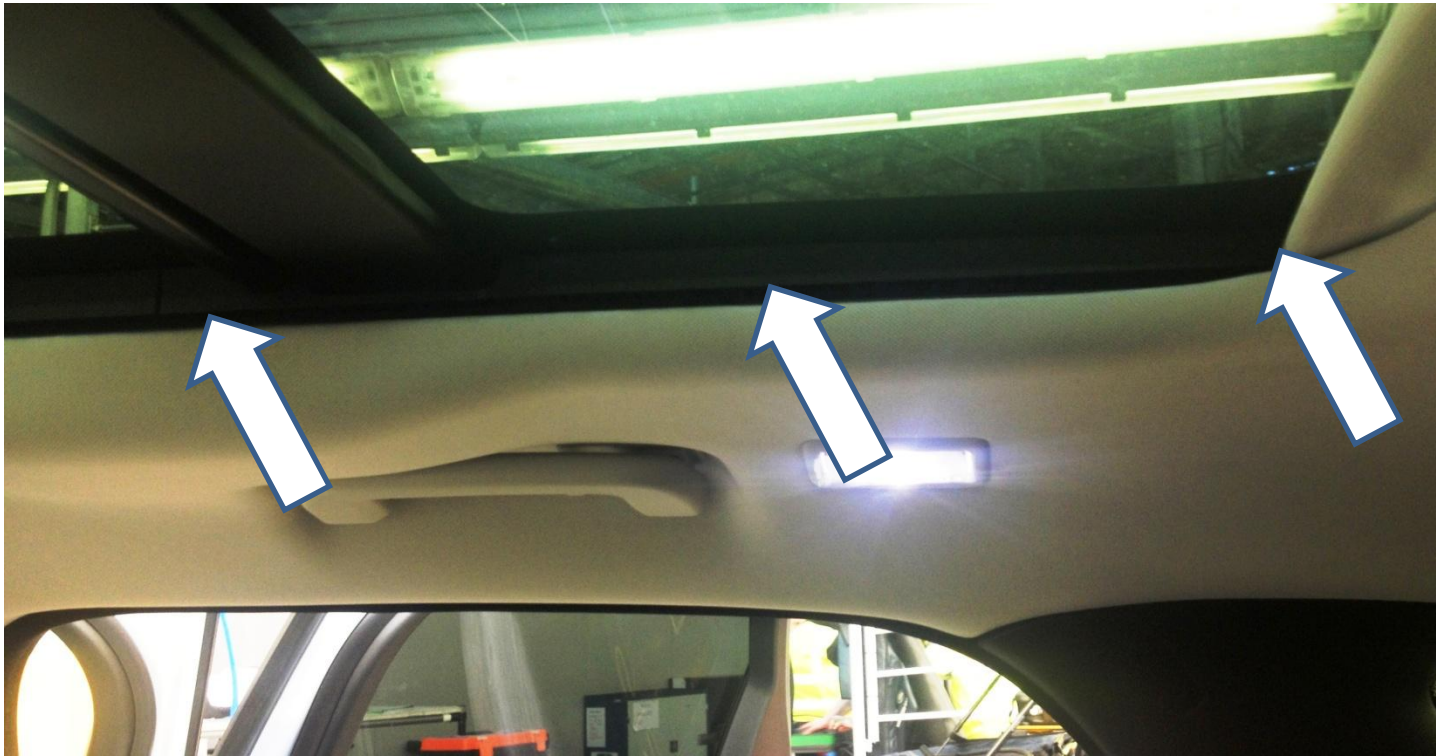
Removal of the inner cover damages the securing features which will result in rattles and poor appearance when the trim is refitted

Securing features are one time fit only.

Front right shown. Left side identical. Arrows show fixing locations. Lever off to remove.

Should a retailer need to remove sliding roof inner cover, lever it off and then discard as it is a non serviceable part.

Recover any detached securing features before reassembly.

Replace with new part upon reassembly. New part clips into place.

Start refitting from rear and work forwards.

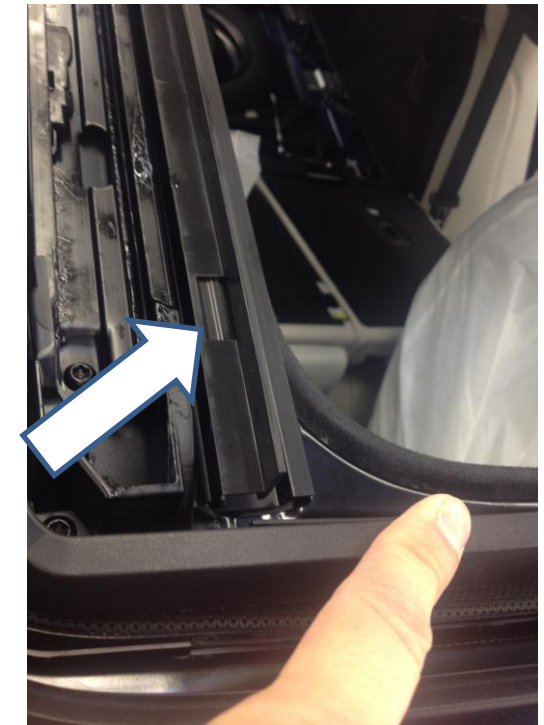
Rear right shown.
Left rear identical.

Viewed
from
outside
looking
rearward.

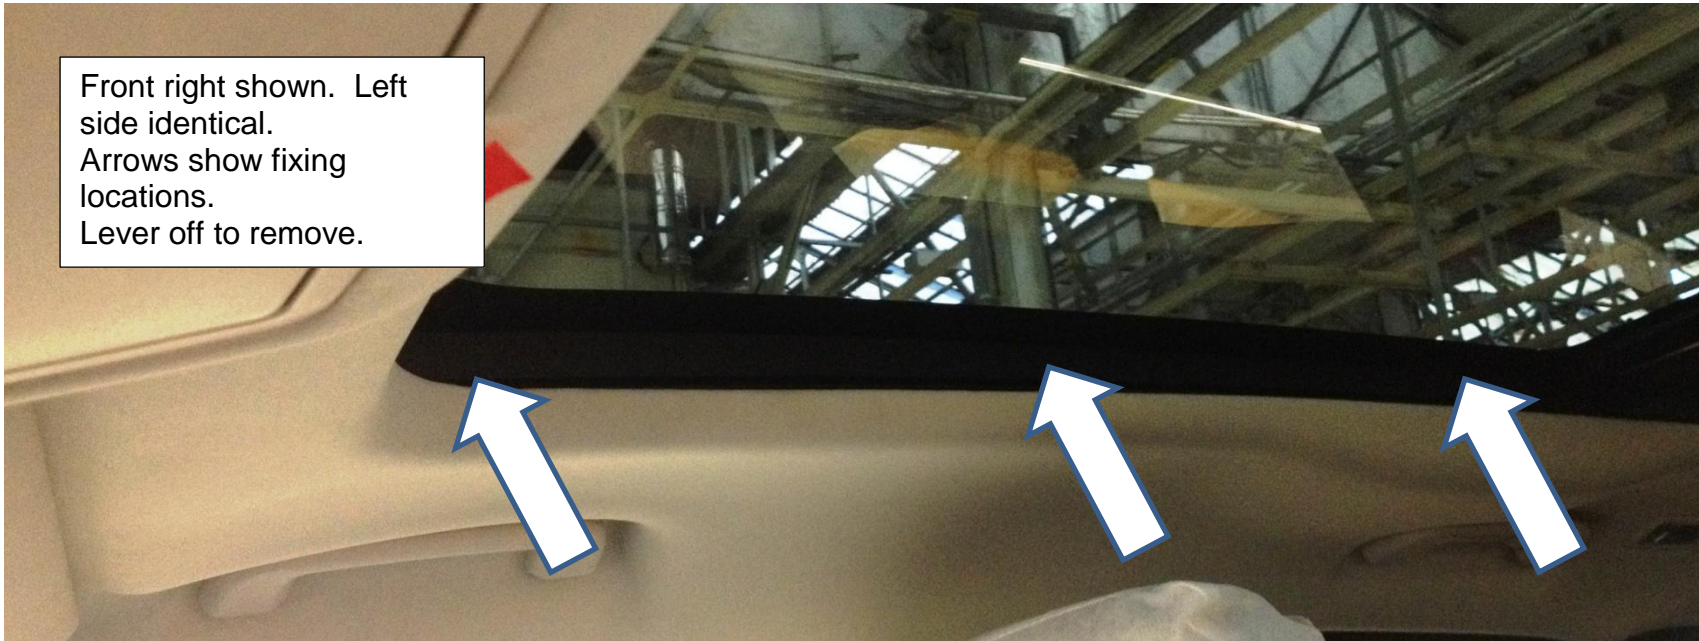
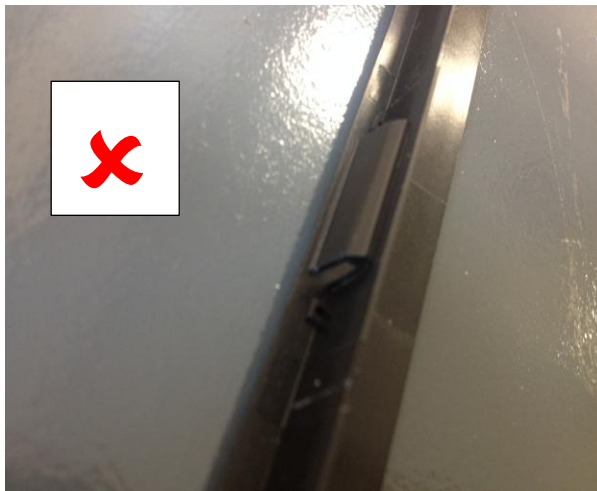
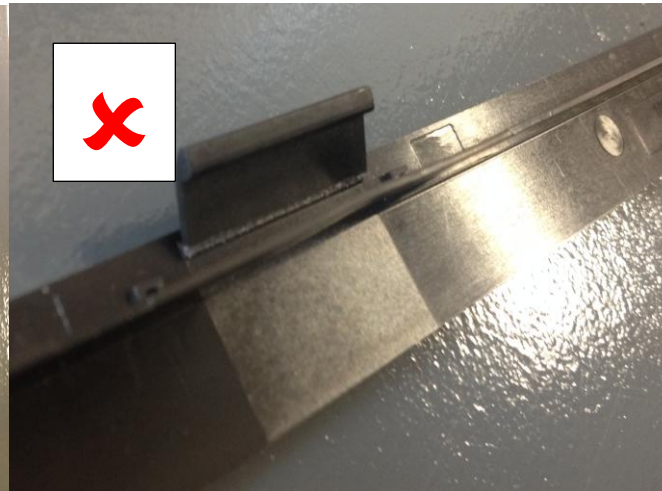
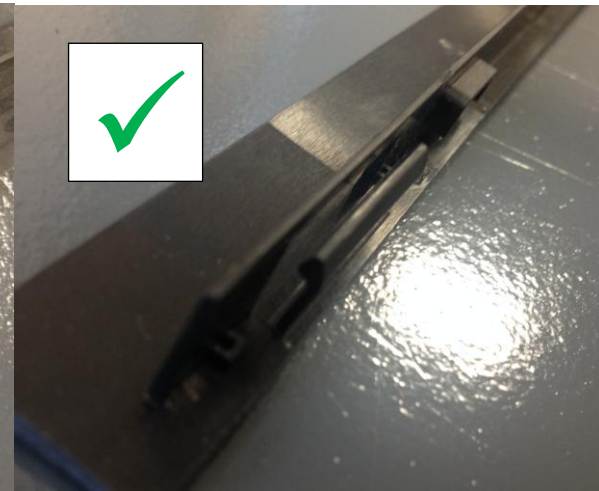
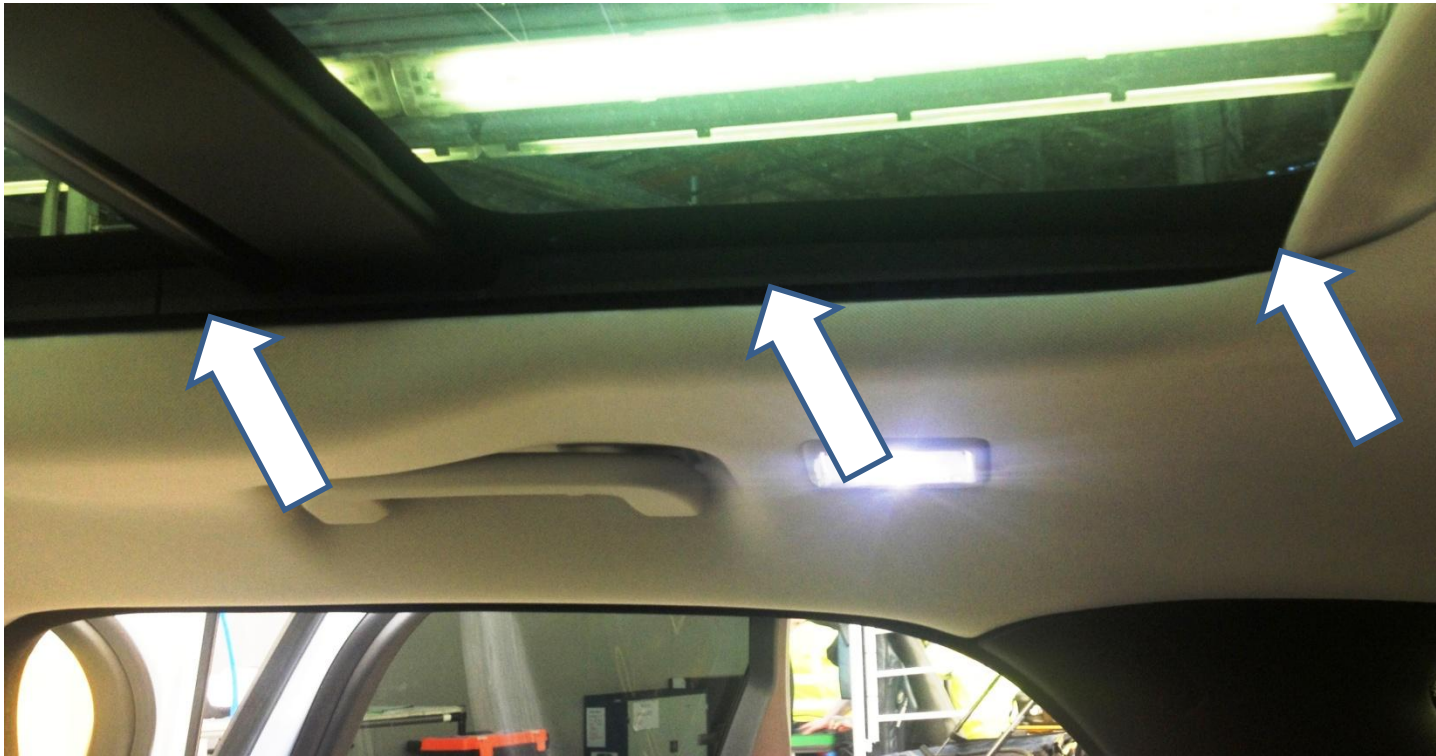
Front right shown. Left side identical. Arrows show fixing locations. Lever off to remove.

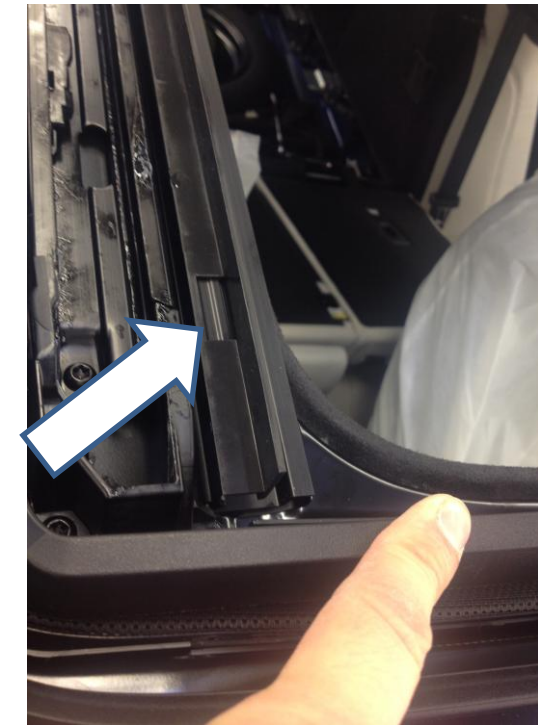
Rear right shown.
Left rear identical.

Viewed from
outside
looking
rearward.
