H079 UPS11917-3BNAS1

TECHNICAL BULLETIN

20 APR 2018

Update Prior to Sale: Anti-Lock Braking System (ABS) Module Water Ingress

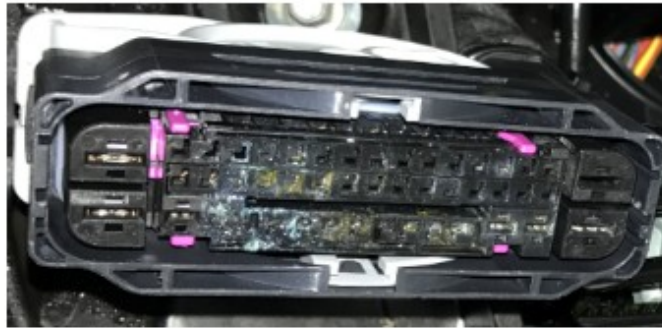
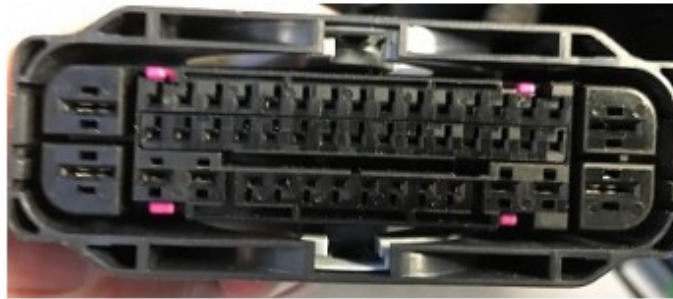
E220336

Visually inspect the ABS control module connector for water ingress.

- If there is no evidence of water ingress (✓), go to step 11.
- If there is evidence of water ingress (✗), go to Workshop Procedure 'B'.

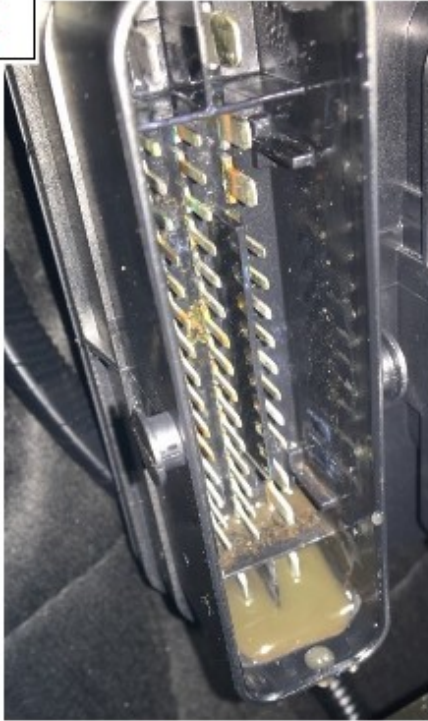
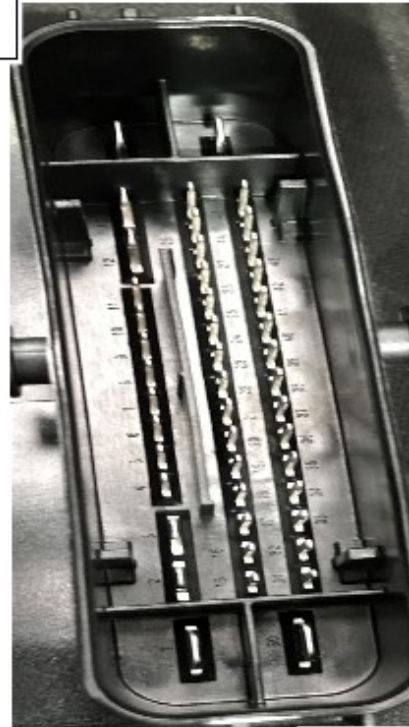
E220337

Visually inspect the ABS control module for water ingress.

- If there is no evidence of water ingress (✓), go to step 12.
- If there is evidence of water ingress (✗), go to Workshop Procedure 'B'.
