H111 UPS3918-1bNAS1

**TECHNICAL BULLETIN**

303-03B / -03C: Engine Cooling

Update Prior to Sale: Engine Coolant Hose Incorrectly Routed

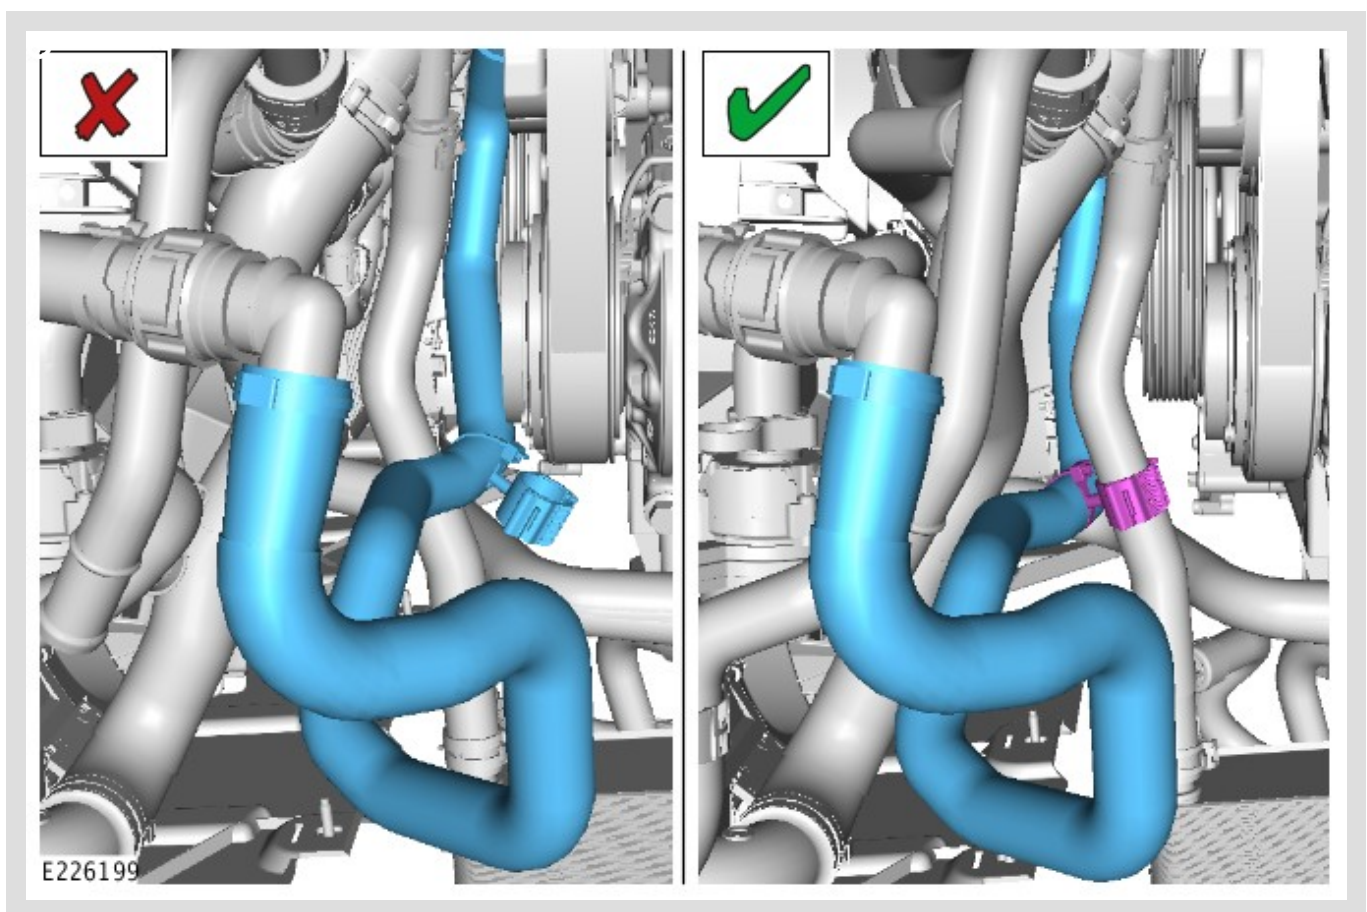
3

Inspect the engine coolant hose.

- If the engine coolant hose IS installed correctly (✓), go to Step 8.

- If the engine coolant hose **IS NOT** installed correctly (X) and the hose **IS NOT** damaged, go to Step 4.
- If the engine coolant hose **IS NOT** installed correctly (X) and the hose **IS** damaged, continue to hold the vehicle until further instructions are supplied.
  - Do not submit a claim for any vehicle which fails the inspection process and the hose is damaged at this time.
