Technical Service Bulletin

Subject: CHECK ENGINE LIGHT ON WITH DTC P0456	Bulletin No.: 01-013/18
	Last Issued: 05/11/2018

2016-2018 CX-3
2013-2018 CX-5
2007-2018 CX-9
2011-2018 Mazda3
2014-2018 Mazda6

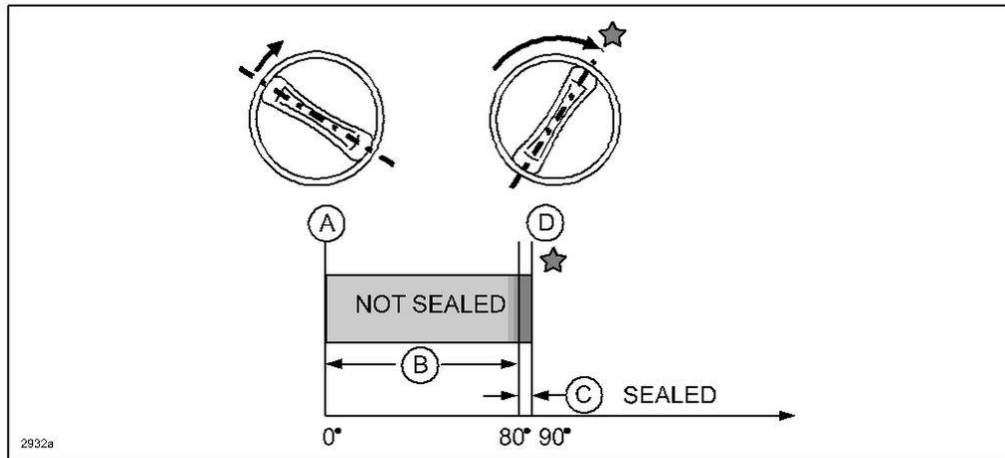
2011-2013 MAZDA3 and 2007-2015 CX-9:

- **DO NOT** replace any parts without detecting a leak using MGSS diagnostics.
- Explain to the customer that the fuel cap must be turned at least 80 degrees (C) or until two (2) or more click sounds are heard (D) to be properly sealed.
- If the fuel cap is not completely closed, it may stay in the B range, (because the C range is so small) and will likely leak.

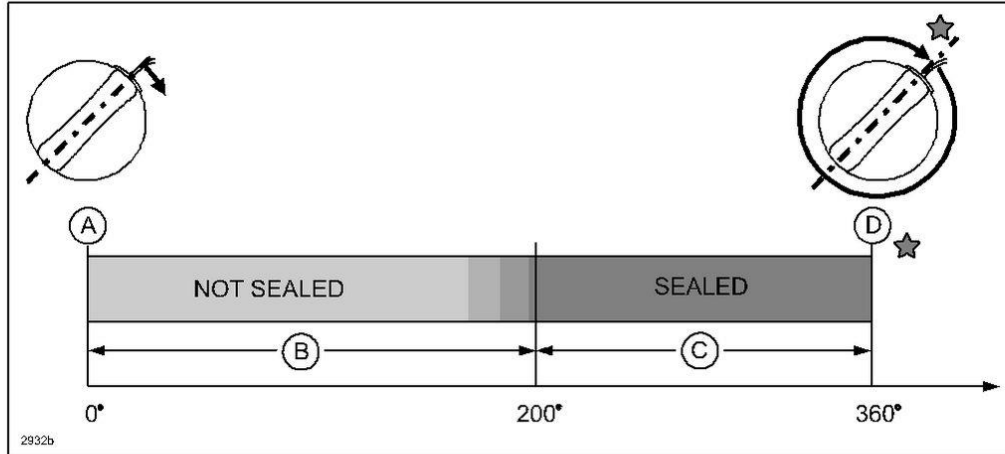
2016-2018 CX-3, 2013-2018 CX-5, 2016-2018 CX-9, 2014-2018 MAZDA3 and 2014-2018 MAZDA6:

- If the fuel cap is turned less than 200 degrees (B), it is not sealed.
- If the fuel cap is turned between 200 ~ 360 degrees (C), it is sealed.
- If the fuel cap is turned 360 degrees or more, it is sealed and a clicking noise (D) is also heard.

NOTE: The fuel cap may stay within the (C) range, since it is a large range. A leak is unlikely to occur, even if the fuel cap was not closed completely (until clicking sound is heard (D)).
