# Technical Service Bulletin

**AIR CONDITIONER DOES NOT BLOW COLD AIR DUE TO CRACKED  
COOLER PIPE (HI) A (REFRIGERANT LEAK)**

**Bulletin No.:** 07-004/18

2016-2018 MX-5 with VINs lower than JM1ND\*\*\*\*\*204305 (built before February 28, 2018)

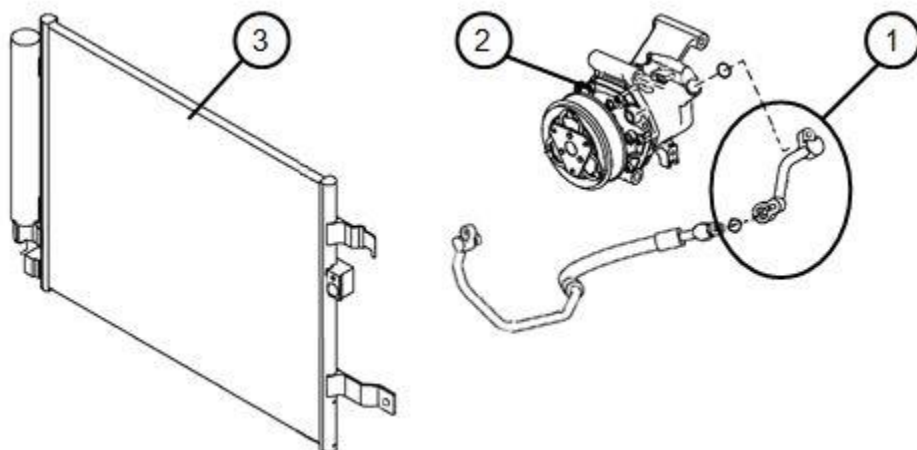
Some vehicles may experience that the A/C does not blow cold air (blows warm air) due to a refrigerant leak. This is caused by a crack in the cooler pipe (HI) A (1) due to engine vibration. To correct this issue, the material and thickness of the cooler pipe (HI) A has been changed to increase durability.

| (1) | Cooler pipe (HI) A |

1. Verify customer concern.
2. Inspect the cooler pipe (HI) A.
  - If the cooler pipe (HI) A is cracked, replace the cooler pipe (HI) A with a modified one according to the instructions on MGSS (REFRIGERANT LINE REMOVAL/INSTALLATION).
  - If the cooler pipe (HI) A is not cracked, this TSB is not applicable. Refer to troubleshooting procedure on MGSS (NO COOL AIR [CLIMATE CONTROL SYSTEM]).
3. Verify repair.
