Technical Service Bulletin

**AIR CONDITIONER DOES NOT BLOW COLD AIR DUE TO CRACKED
COOLER PIPE (HI) A (REFRIGERANT LEAK)**

Bulletin No.: 07-004/18

2016-2018 MX-5 with VINs lower than JM1ND*****204306 (built before March 1, 2018)

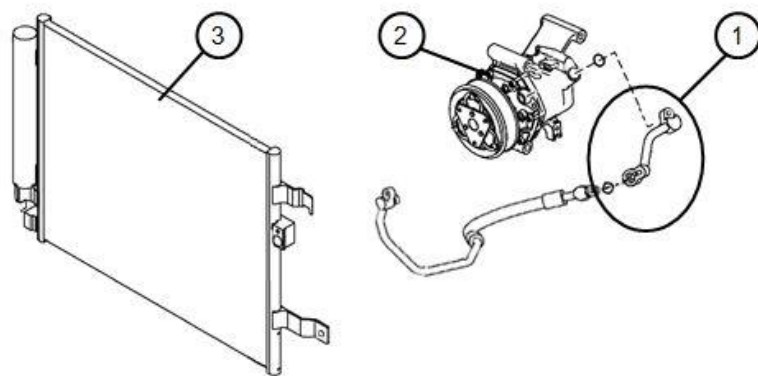
Some vehicles may experience that the A/C does not blow cold air (blows warm air) due to a refrigerant leak. This is caused by a crack in the cooler pipe (HI) A (1) due to engine vibration. To correct this issue, the material and thickness of the cooler pipe (HI) A has been changed to increase durability.

(1)	Cooler pipe (HI) A
(2)	A/C compressor
(3)	Condenser

1. Verify customer concern.
2. Inspect the cooler pipe (HI) A.
 - If the cooler pipe (HI) A is cracked, replace the cooler pipe (HI) A with a modified one according to the instructions on MGSS (REFRIGERANT LINE REMOVAL/INSTALLATION).
 - If the cooler pipe (HI) A is not cracked, this TSB is not applicable. Refer to troubleshooting procedure on MGSS (NO COOL AIR [CLIMATE CONTROL SYSTEM]).
3. Verify repair.
