Technical Service Bulletin

ACCESSORY ROOF RACK DIFFICULT OR CANNOT INSTALL

Bulletin No.: 09-022/18

Last Issued: 05/01/2018

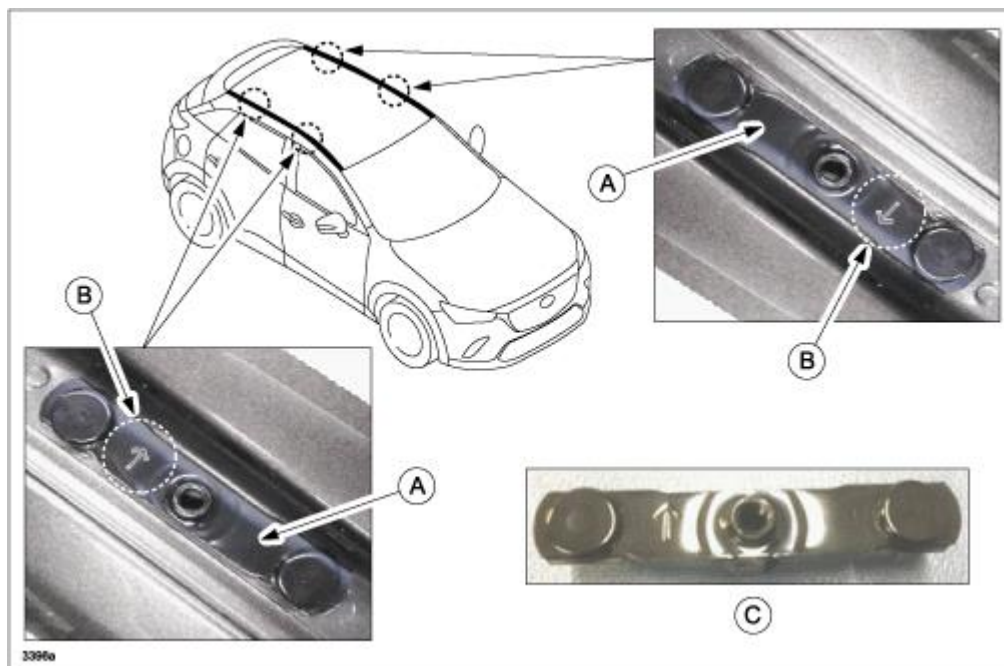
(C) - Bracket Unit

On some vehicles, one or more roof carrier brackets (A) may be installed in reverse (with arrows (B) facing outward). In this case, accessories, such as a roof carrier cannot be installed. Even if the accessory installation was possible, it may cause loose fitting, water leaks or other concerns.

This concern was caused by improper assembly during vehicle production.

1. Verify the customer concern.
2. If any roof carrier bracket(s) are not installed correctly, remove the affected bracket(s) and install new ones in the correct direction, according to the ROOF CARRIER BRACKET REMOVAL/INSTALLATION instructions.
NOTE: All four (4) roof carrier brackets must be installed so the arrows face inward.
3. Verify the repair.
